**Construction Completion Report  
Port Gamble Interim Remedial Action  
Woodwaste Removal Project  
Port Gamble, Washington**

**Prepared for  
DNR**

**June 13, 2008  
17318-01**

Prepared by  
**Hart Crowser, Inc.**

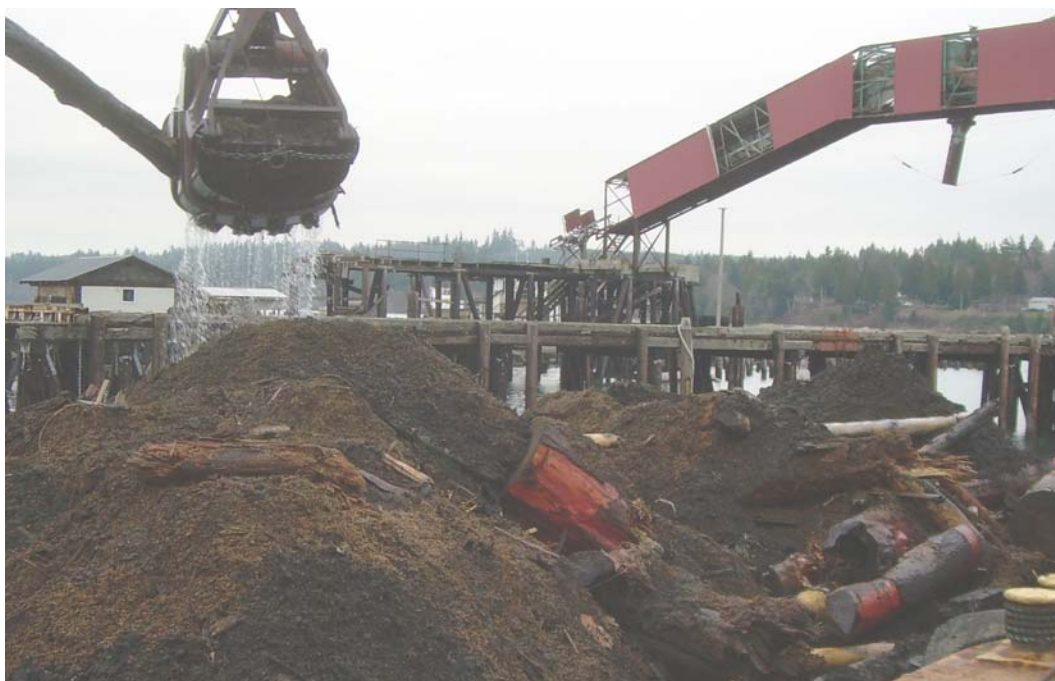
**Sawdust-Like Material.** Dredged material consisted of light brownish orange sawdust and fine-grained wood chips (Photographs 4 and 5). Relatively limited biological activity was observed in this material, i.e., sparse presence of vegetation, benthic organisms, and burrows. This material typically drained quickly, stacked well on the materials barges, and was relatively easy to handle during offloading and placement in the sparging basin. This material comprised roughly 20 percent of the total dredged material removed and was most prevalent in northern portion of dredge prisms D and E and northwest corner of prism F.

Photograph 4 - View of sawdust-like dredged material (light color), heterogeneous sediment/woodwaste (dark color), and large wood debris.

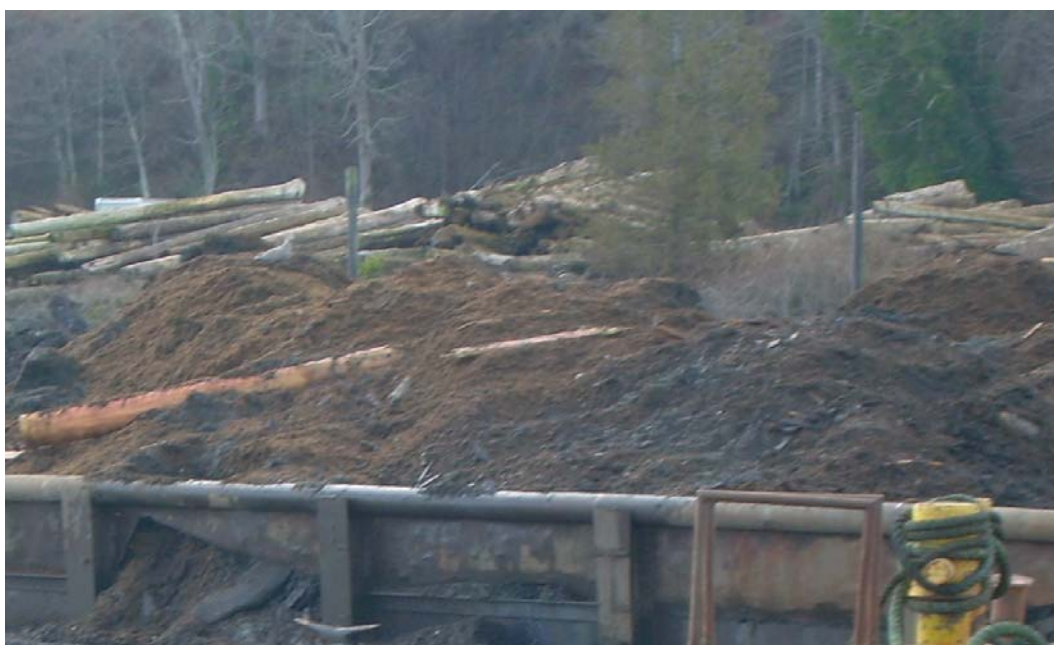
Photograph 5 - Example of sawdust-like dredged material (left) and silty, sandy woodwaste (right) on barge.

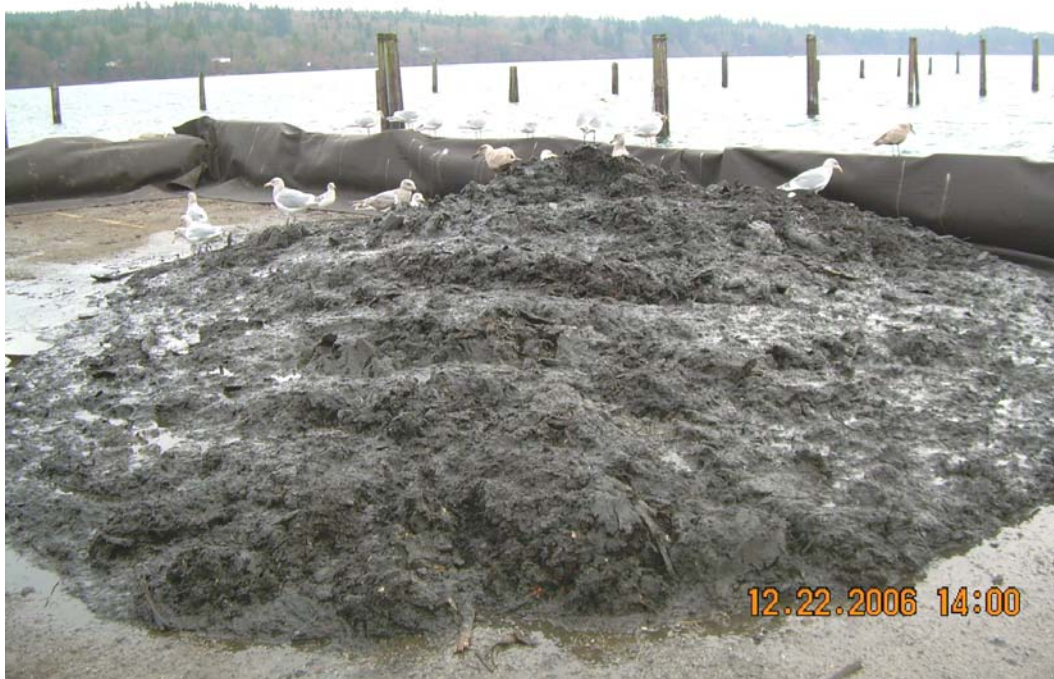
Photograph 6 - Wet dredge sediment excavated during test dredge (12/22/06). Sediment is predominantly the heterogeneous, dark (sandy) sediment/woodwaste-type dredged material.

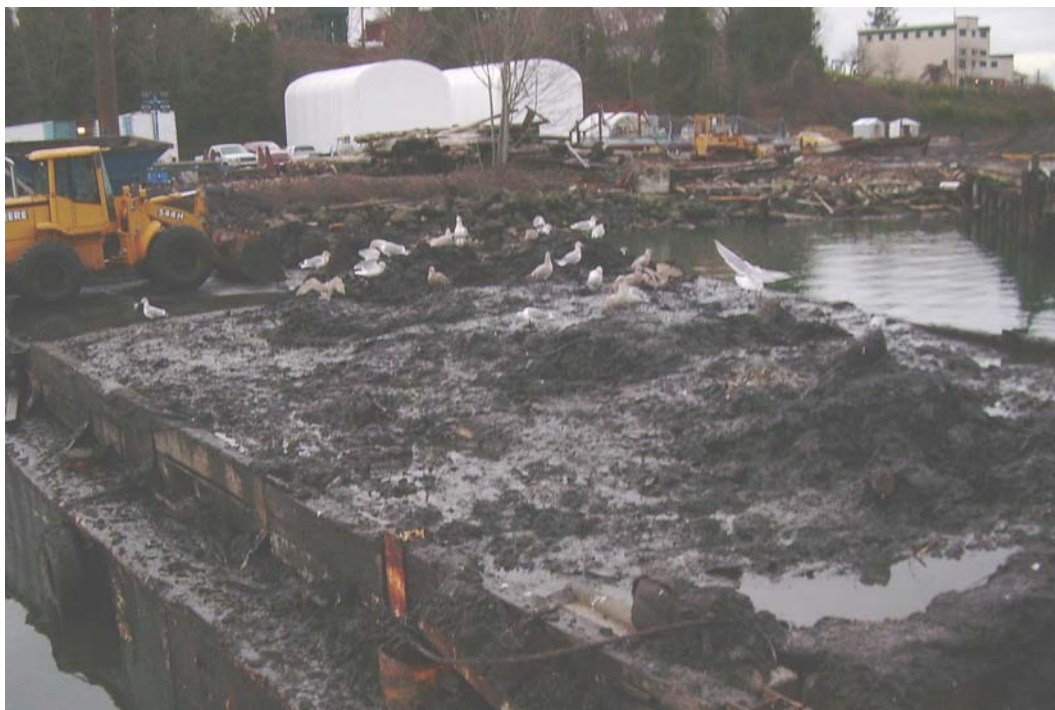
Photograph 7 - Wet silty, heterogeneous sediment/woodwaste dewatering/decanting on barge.

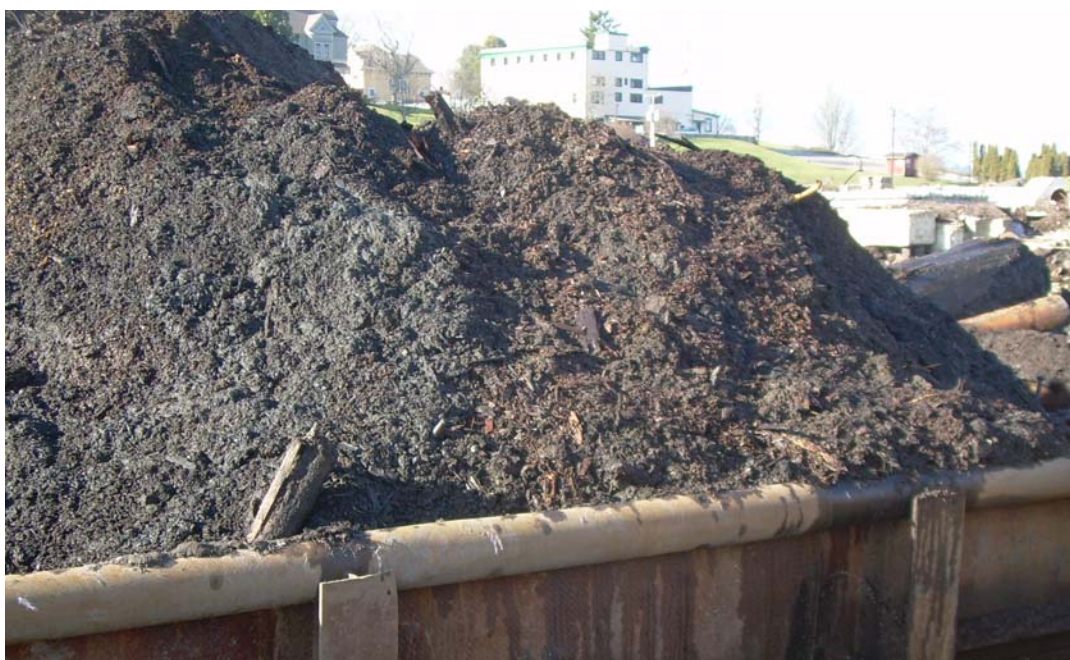
Photograph 8 - Dewatered sandy sediment on barge containing more wood material and less silt.

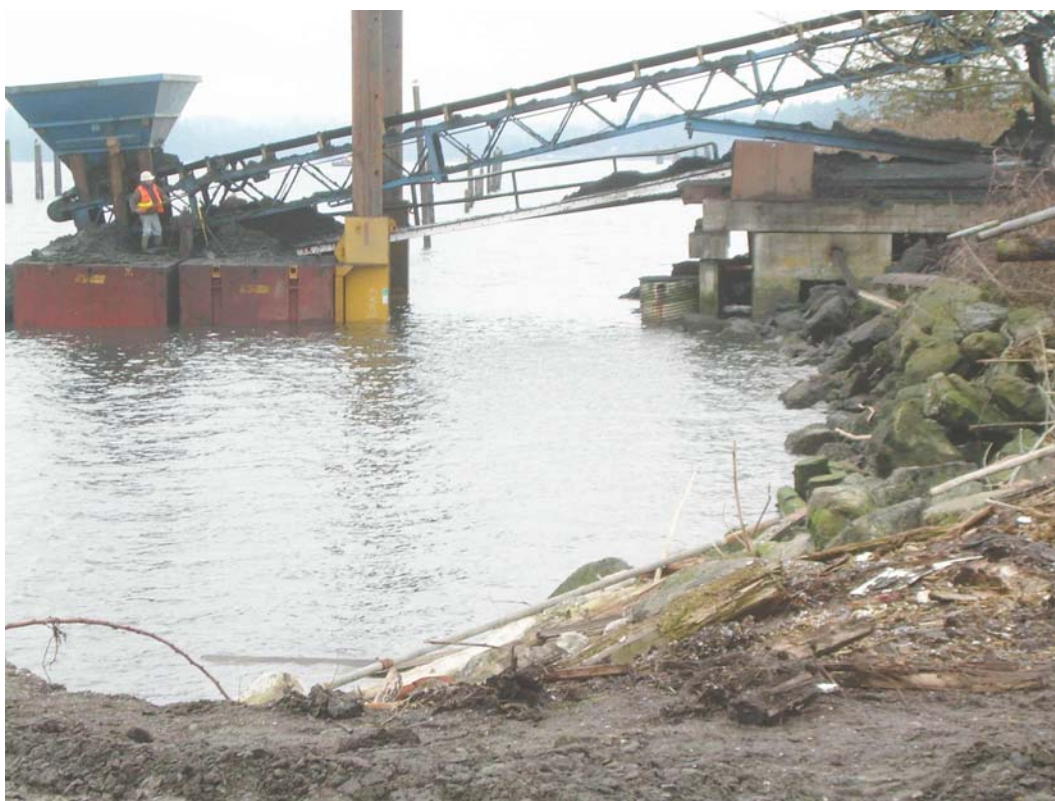
Material loss was also observed from the conveyor line due to wind and mechanical vibrations. In this instance, wetter material would fare better on the conveyor line, as it tended to be more cohesive and project a lower profile into the wind. The bulk of wind transported material deposited on the adjacent uplands and away from the beach areas. This aspect of material loss was unavoidable and was generally away from the water and easily addressed. Mechanical vibrations appeared to be highest in the central portion of the conveyor line, which spanned the gap between the flexi-float and the concrete bulkhead forming the staging platform landward of the flexi-float. To prevent loss to the water a 16-foot by 8-foot plywood assembly (planking) was installed over the gap (Photographs 13 and 20). The accumulating material on the plywood required cleanup at roughly the same frequency as the flexi-float.

Photograph 13 - Offloading setup after planking installed between flexi-float (left) and upland structure (right) to catch sediment spilling off of conveyor.

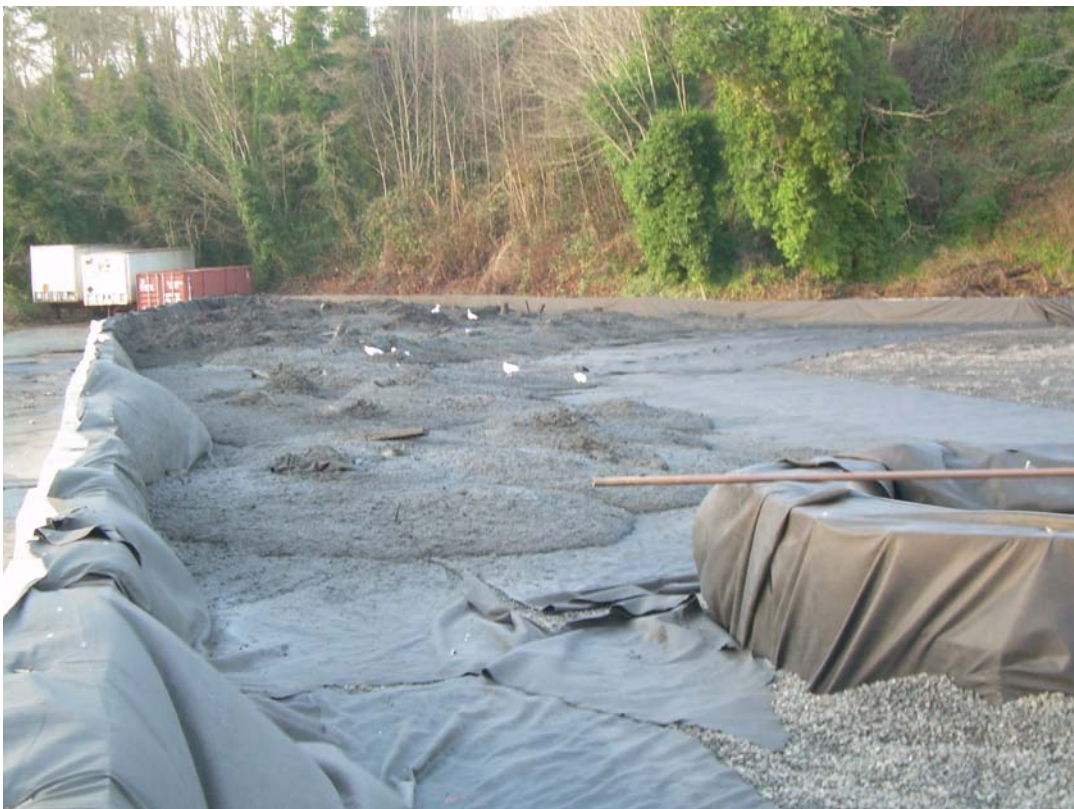
Photograph 16 - South end of sparging basin with wet silty dredge sediment at beginning of project. Note outfall inlet ecology blocks and geotextile at right in foreground.

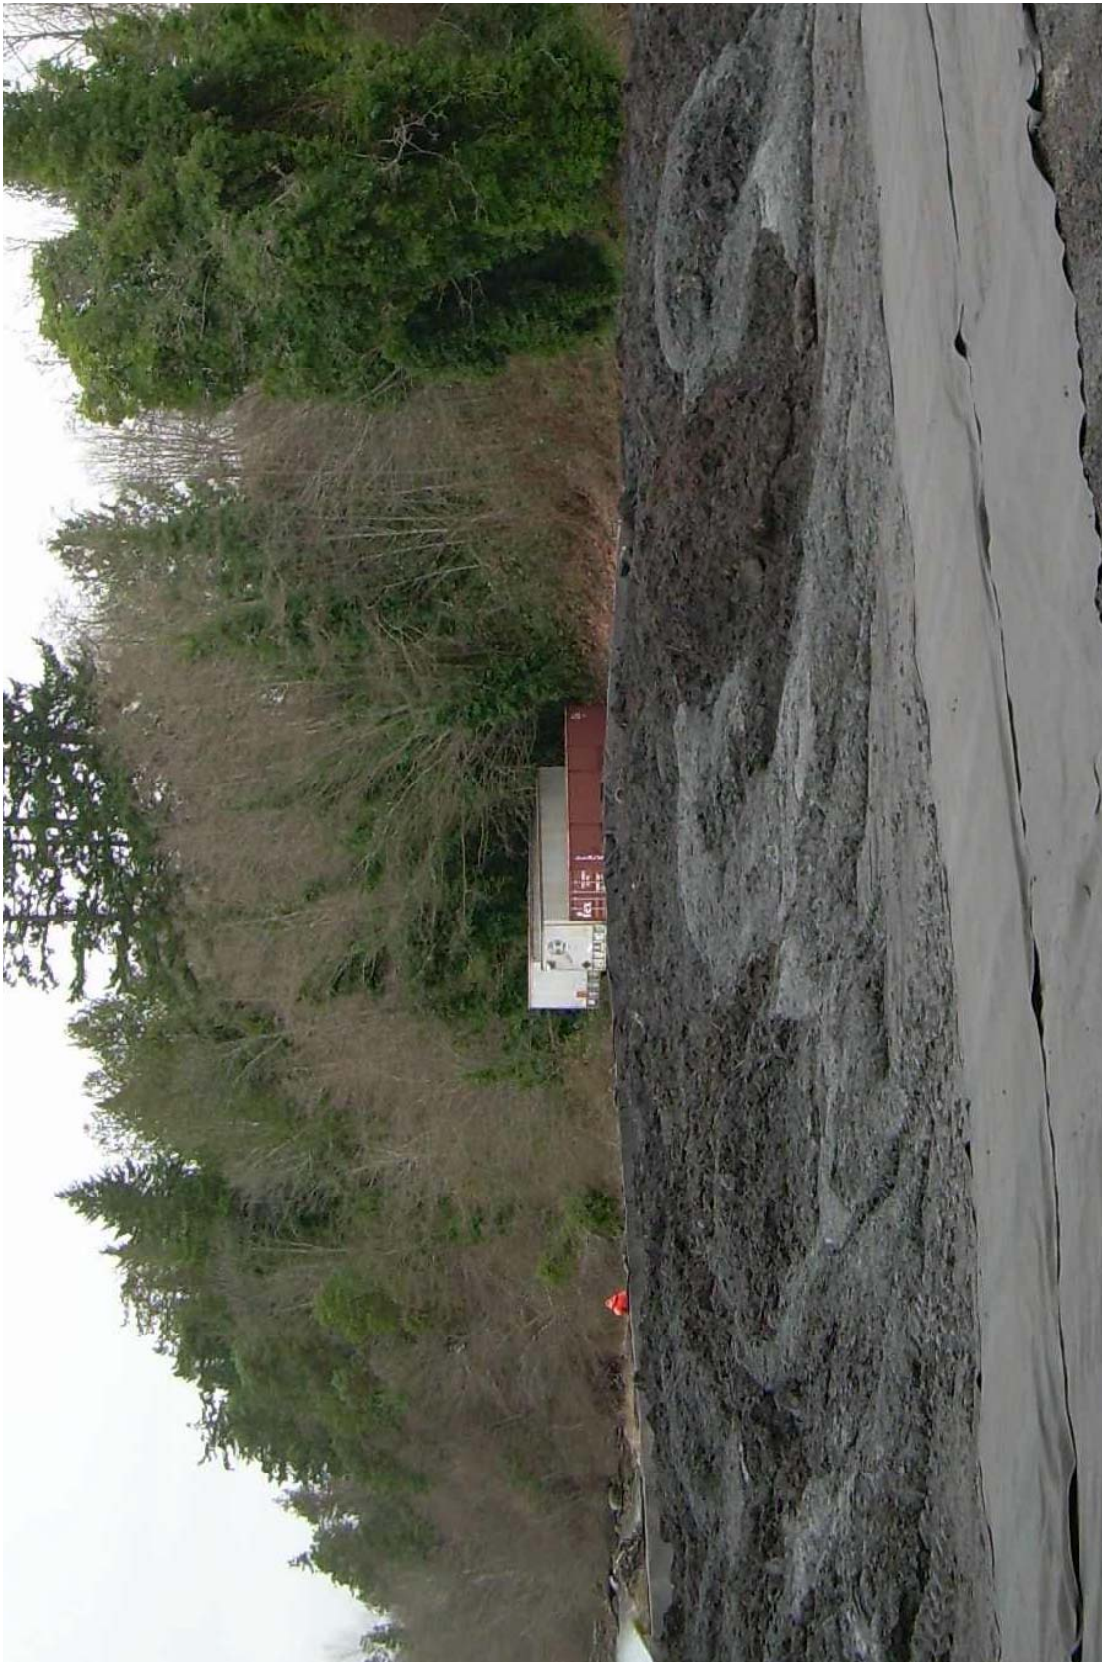
Photograph 17 - South end of sparging basin on January 19, 2007. Note the variability of the material.

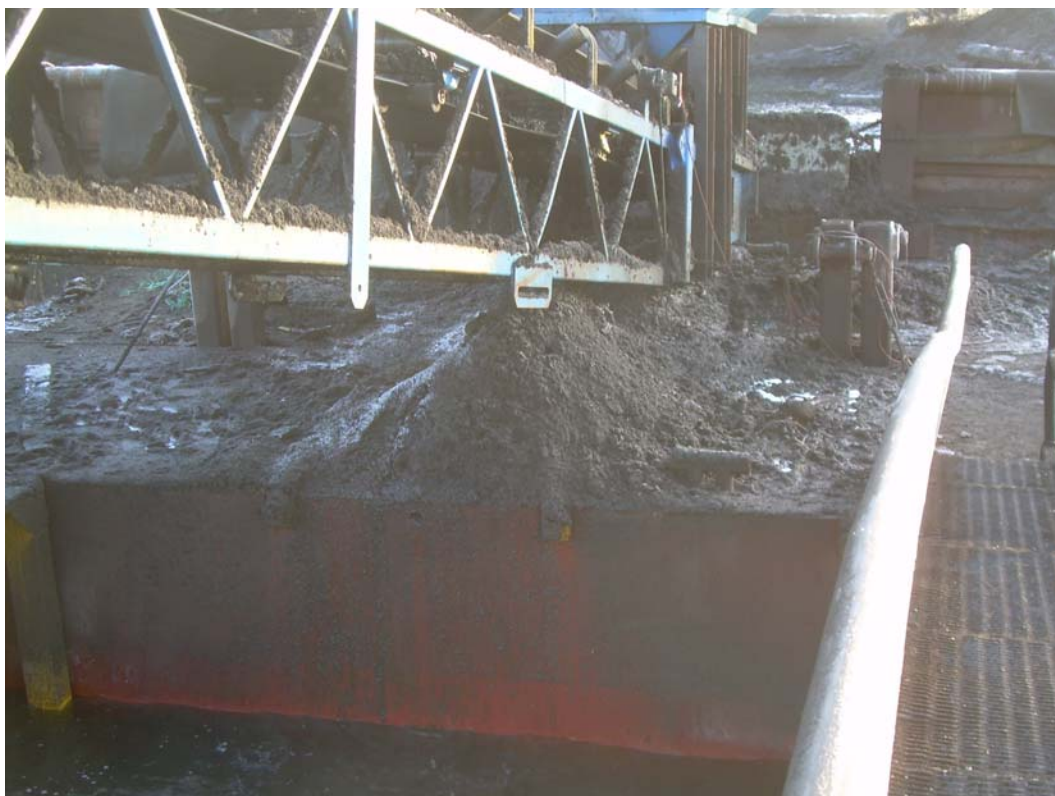
Material loss was observed from time to time during operation of the hopper and conveyor for dredged materials offloading. This was primarily caused by the gap between the hopper and conveyor belt, which caused material to be “squeezed out” and lost before being placed onto the belt. This was particularly evident with wetter materials. Materials lost through the hopper base would accumulate on the flexi-float and required frequent attention to keep the area cleanup up (Photograph 19). Between barge loads crews would hand shovel the materials onto the conveyor belt and transfer them to an awaiting dump truck. It is estimated that between roughly 1/4 cy to approximately 1 cy of dredged material could be lost through the hopper base and require cleanup during a given barge offload.

Photograph 19 - Spilling of wet sediment off of offloading conveyor prior to installation of planking to catch sediment.

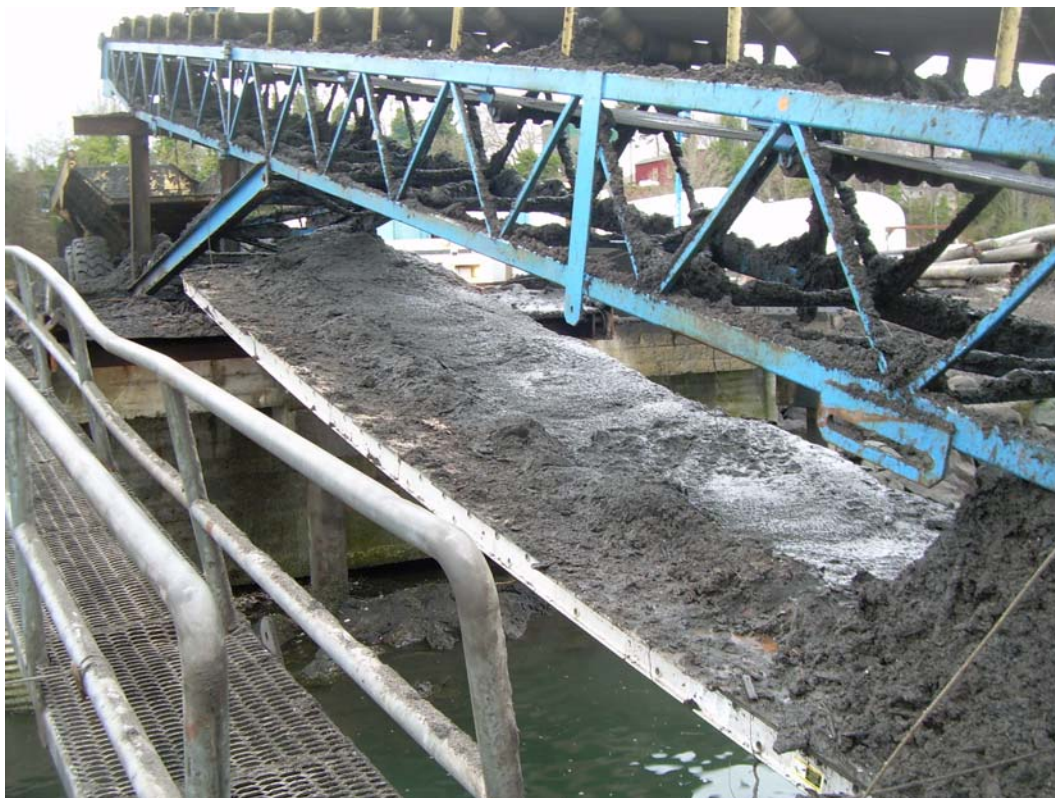
Photograph 20 - Close up of planking under offloading conveyor.

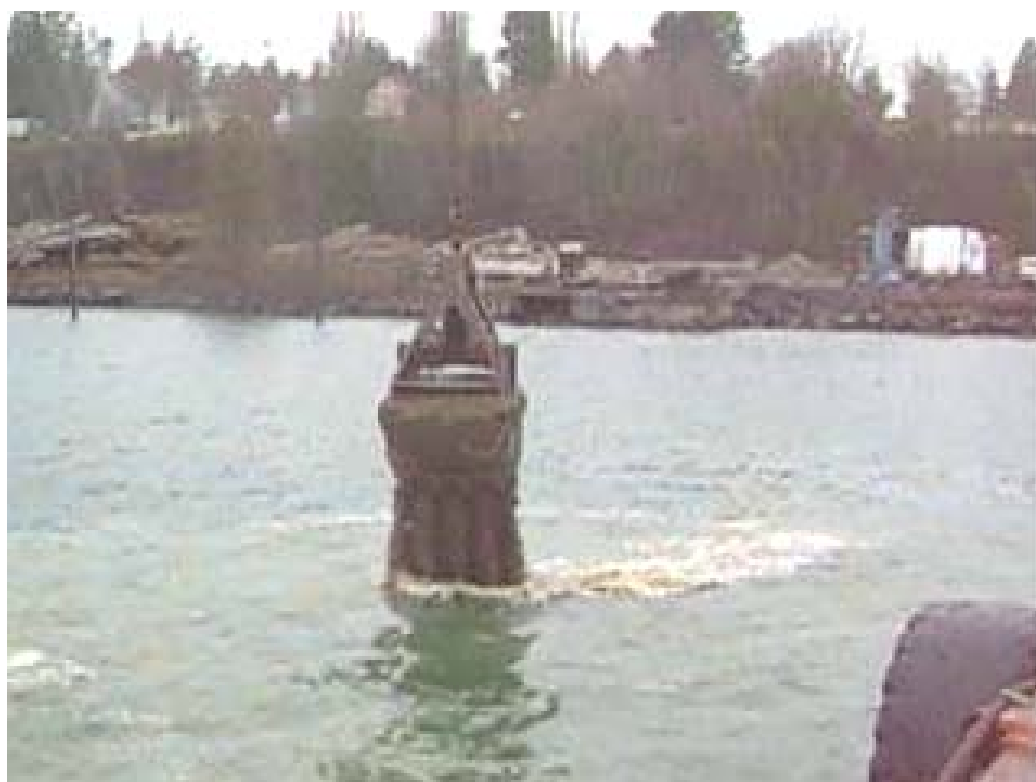
During placement of cover material from the over-water clamshell bucket, localized water discoloration and turbidity were noted near the surface. Air bubbles were conspicuous as the sand fell through the water column and appeared to contribute to keeping particulates in suspension (Photograph 21).

The near-surface turbidity tended to linger and be carried away from the application point by currents. During most of the placement process; however, turbidity dissipated before exceeding water quality limits at the downcurrent compliance points. In shallower waters, a secondary turbidity plume was observed after the bulk of the material impacted the seafloor. This secondary plume visibly appeared to settle within a few minutes after placement.

Photograph 21 - Sand cover placement with bucket above water to attain thin placement thickness. Note trail of air bubbles.
