Periodic Review

Becker Buick Sprague Avenue
636 East Sprague Avenue
Spokane, Washington 99202

Completed by:
Washington State Department of Ecology
Eastern Regional Office
Toxics Cleanup Program

October 2014

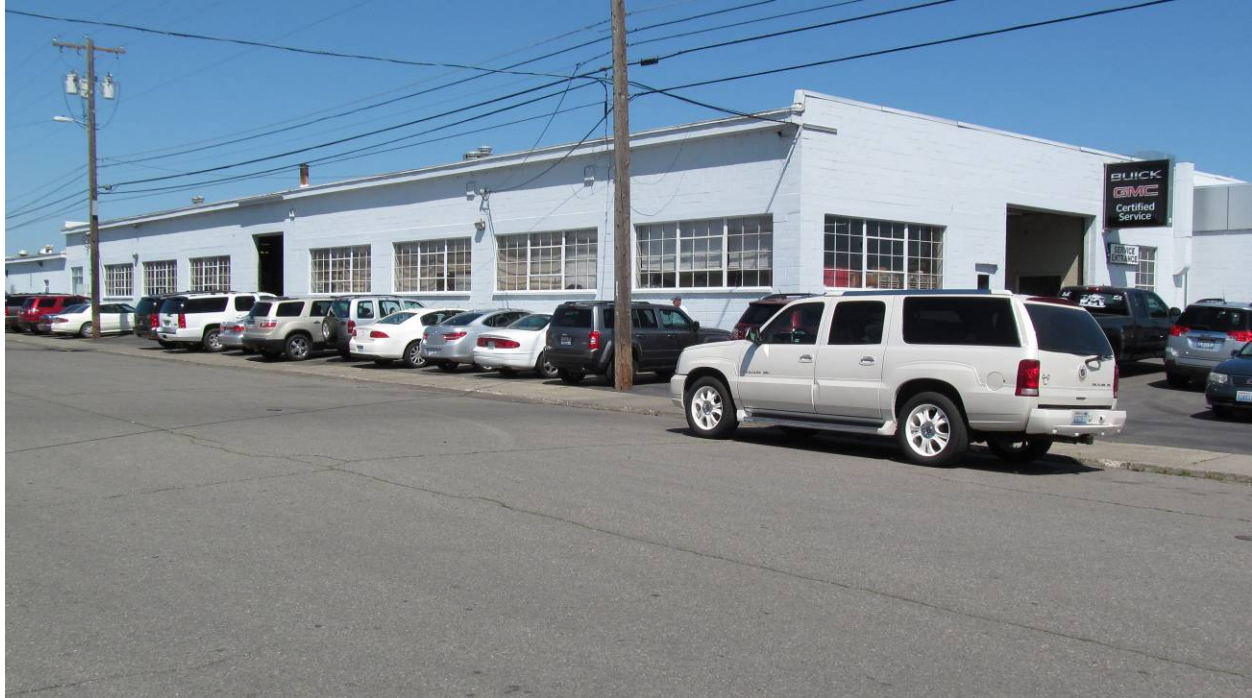
Photo 1: Becker Buick Service Building - from the southeast

Based upon the Site visit conducted on June 4, 2014, the building and concrete cover at the Site continue to eliminate direct exposure pathways (ingestion, contact) to contaminated soils. The concrete surface appears in excellent condition and no repair, maintenance or contingency actions have been required. The Site continues to be occupied by the Becker Buick Automotive Dealership, and provides automotive sales and service. A photo log is available as Appendix 6.5.

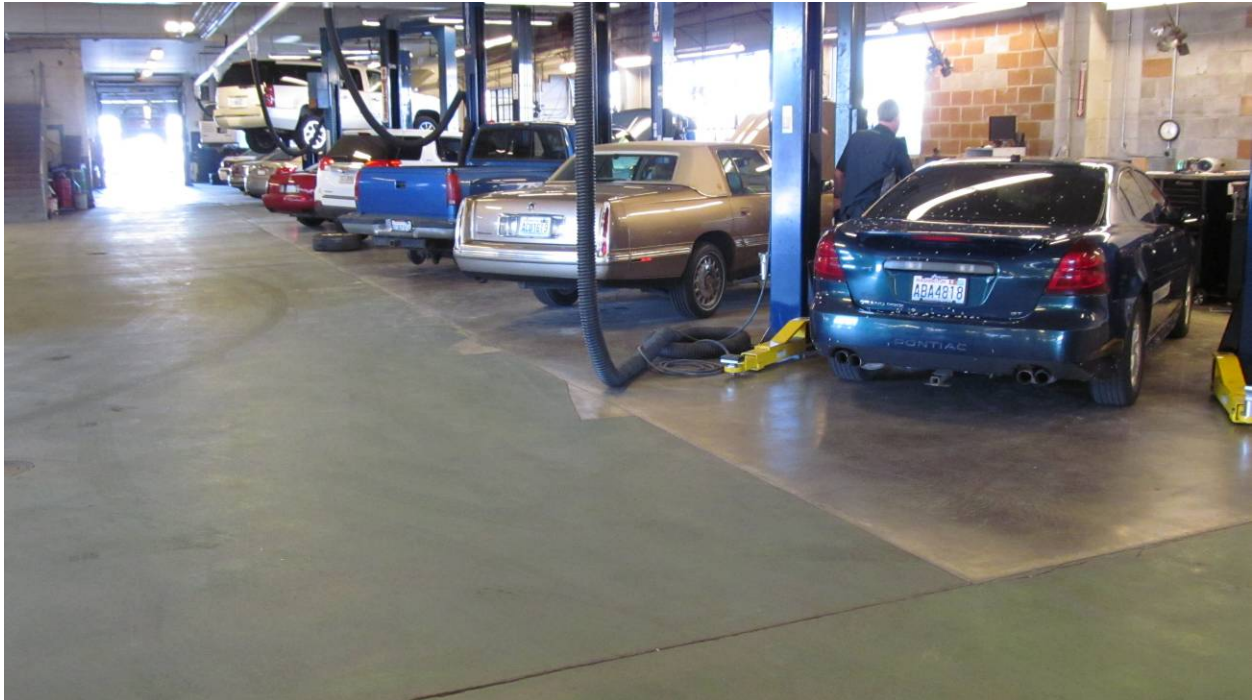
Photo 3: Western Hoist Area - from the southeast

Samples from the hoist locations DP-7 and DP-8 exceeded the Site-specific cleanup level. No additional soil was removed due to unstable conditions in the excavation and proximity of the building foundation. Soil data from these borings is available as Appendix 6.3.
