Re: **Stormwater Video Survey Report**
Shell Oil Products US Harbor Island Terminal
Seattle, Washington
Consent Decree No. 99-2-07176-0SEA

On behalf of Shell Oil Products US (Shell), URS Corporation (URS) is providing the Washington Department of Ecology (Ecology) this Stormwater Video Survey Report conducted near the Shell Harbor Island Terminal located in Seattle, Washington (Figure 1). This report summarizes the findings of the video survey conducted in accordance with the *Stormwater Survey Work Plan – TX-03A Area* dated September 6, 2013.

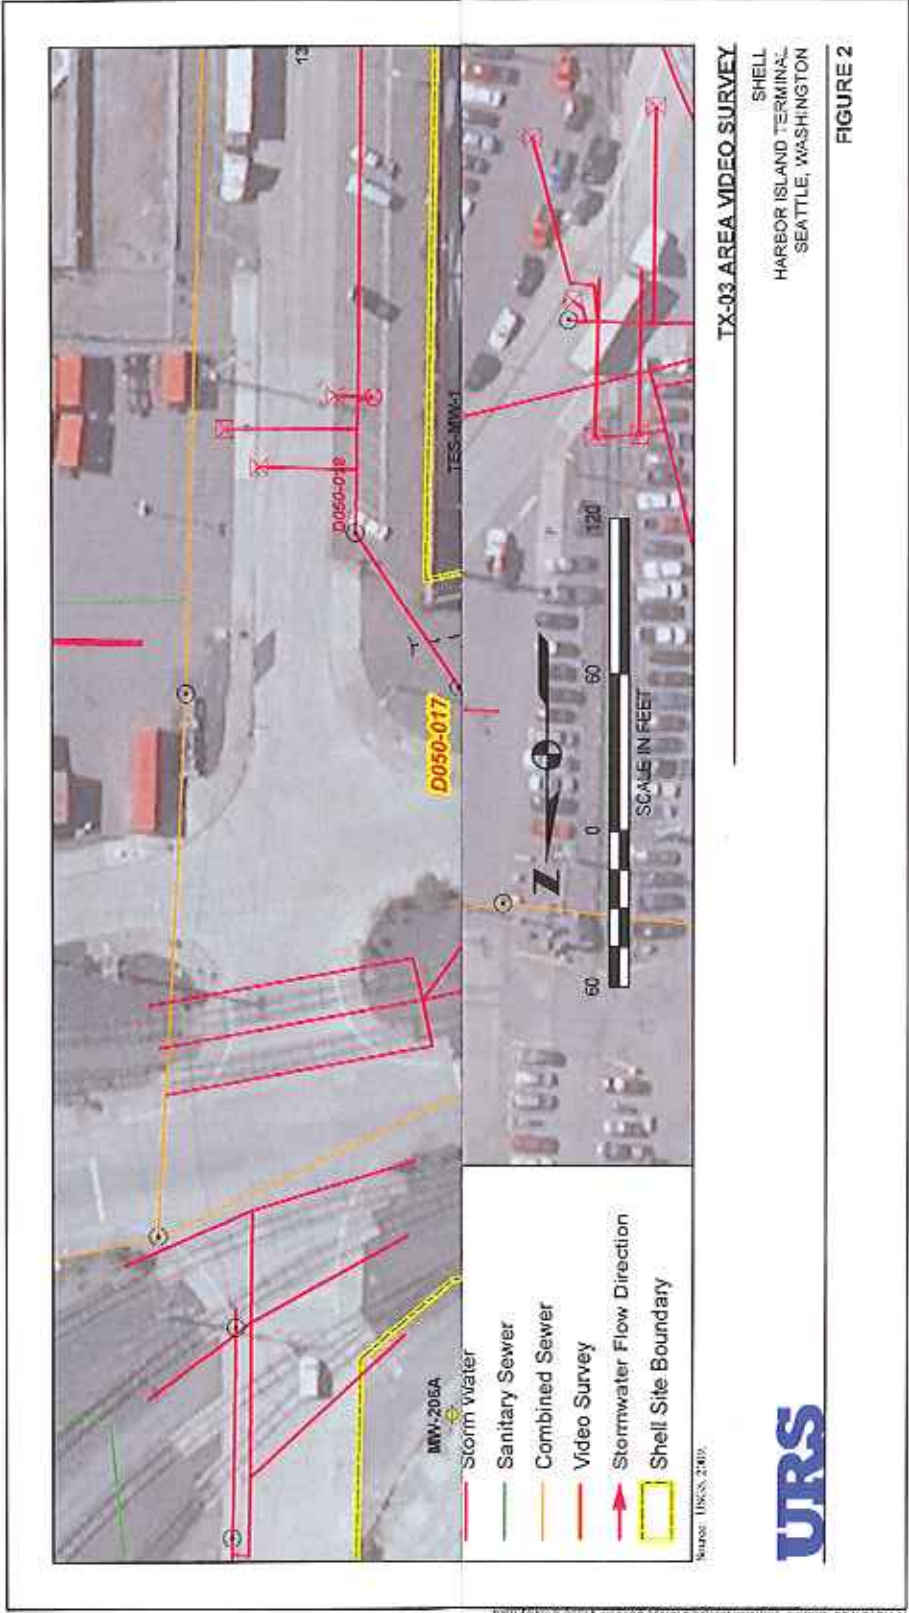
Figure 2 – TX-03A Area Video Survey

Water was observed in the stormwater pipe at manhole D050-016. The stormwater pipe was approximately 24 inches in diameter. No cracks or water was observed infiltrating the stormwater pipe. An absorbent boom was observed at 142.85 feet and the survey was abandoned before manhole D050-17 at 143.10 feet east of manhole D050-016. See Note 1 on the attached Figure 2 and photographs included Section 1 in Attachment B.

Cracks were observed at 143.60 feet, 143.65 feet, and 204.60 feet west of manhole D050-16. Water infiltration was observed weeping from the crack at 174.60 feet and also running at 197.20 feet west of manhole D0550-16. See Notes 2 through 5 on Figure 2 for the location of these observations and photographs included in Section 2 of Attachment B.

Water was observed in the stormwater pipe at manhole D050-014 and at 98.80 feet west of manhole D050-014. The stormwater pipe is approximately 24 inches in diameter. No cracks were observed between manhole D050-14 and D050-015, however; water was observed infiltrating at 214.50 feet west of manhole D050-014. See Note 6 for the location of this observation.

The video survey observed groundwater infiltrating the stormwater pipe in the TX-03A area at three locations between manholes D050-015 and D050-017. Groundwater does not enter the stormwater system between manhole D050-14 and D050-015.

Based on the manhole survey and the groundwater elevation data (Table 1) it appears that the groundwater is contacting the stormwater pipes along Florida in the vicinity of the Shell Terminal. URS will prepare a work plan for sampling the stormwater system to characterize the water quality of the stormwater system in the area video surveyed. This work plan will be prepared during the first quarter of 2014.

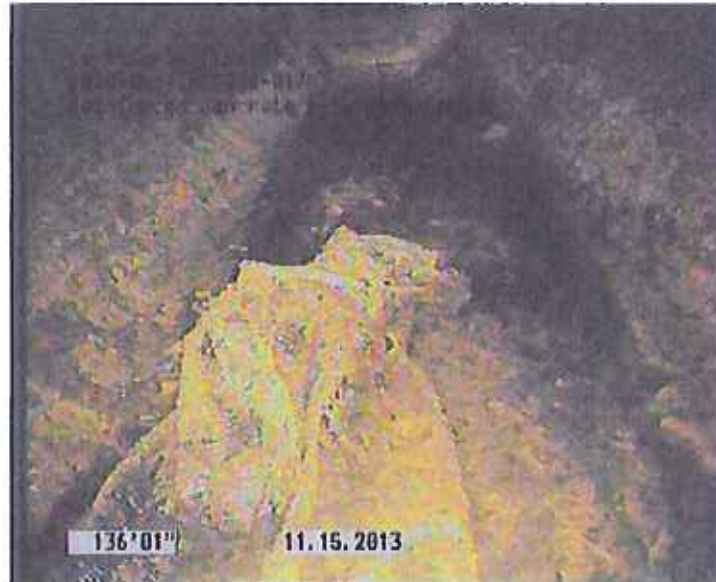
133.50	TF	Tap Factory Made, at 10 o'clock, 8", within 8 inches of joint: NO		
	138.00	DSZ	Deposits Settled Other, 5 %of cross sectional area, from 06 to 07 o'clock, , within 8 inches of joint: YES / Unknown	D050-017_D050-016_ SW Florida St_15112013_083248_A.JPG	M 2

Photo: D050-017_D050-016_SW Florida St_15112013_083248_A.JPG, VCR No.: URS 136FT, Deposits Settled Other, 5 %of cross sectional area, from 08 to 07 o'clock, , within 8 inches of joint: YES / Unknown

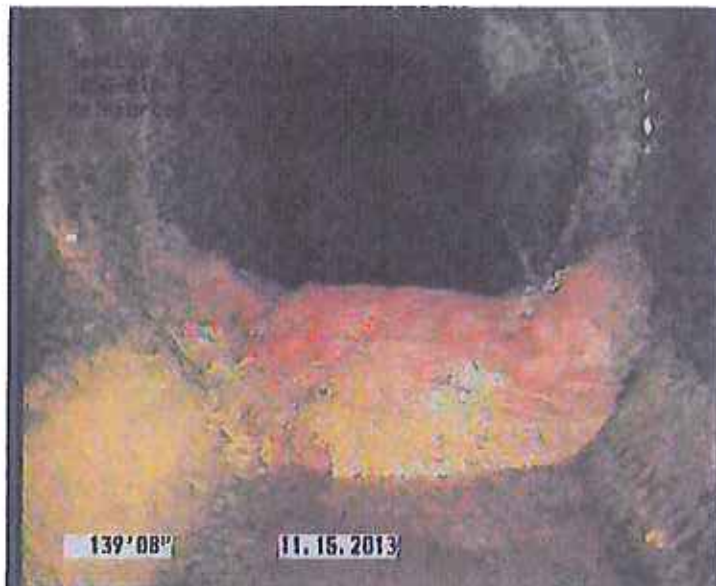
142.85	TFA	Tap Factory Made Active, at 10 o'clock, 8", within 8 inches of joint: NO		
	142.85	OBZ	Obstacles Other, 25 %of cross sectional area, from 04 to 08 o'clock / Absorbent Boom	D050-017_D050-016_ SW Florida St_15112013_083630_A.JPG	M 4

Photo: D050-017_D050-016_SW Florida St_15112013_083630_A.JPG, VCR No.: URS 142.85FT, Obstacles Other, 25 %of cross sectional area, from 04 to 08 o'clock / Absorbent Boom

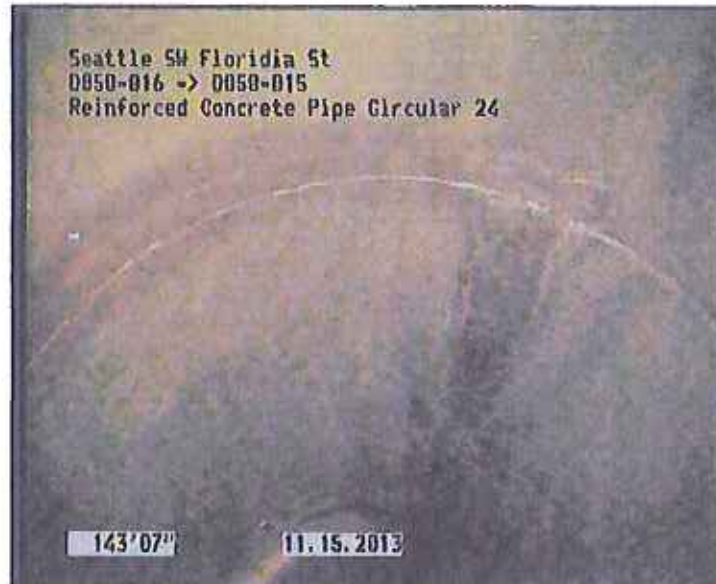
106.85	TFC	Tap Factory Made Capped, at 09 o'clock, 8", within 8 inches of joint: NO		
	143.60	CC	Crack Circumferential, 6", from 09 to 12 o'clock, within 8 inches of joint: YES	D050-016_D050-015_SW Florida St_15112013_085950_A.JPG	S 1

Photo: D050-016_D050-015_SW Florida St_15112013_085950_A.JPG, VCR No.: URS
 143.6FT, Crack Circumferential, 6", from 09 to 12 o'clock, within 8 inches of joint: YES

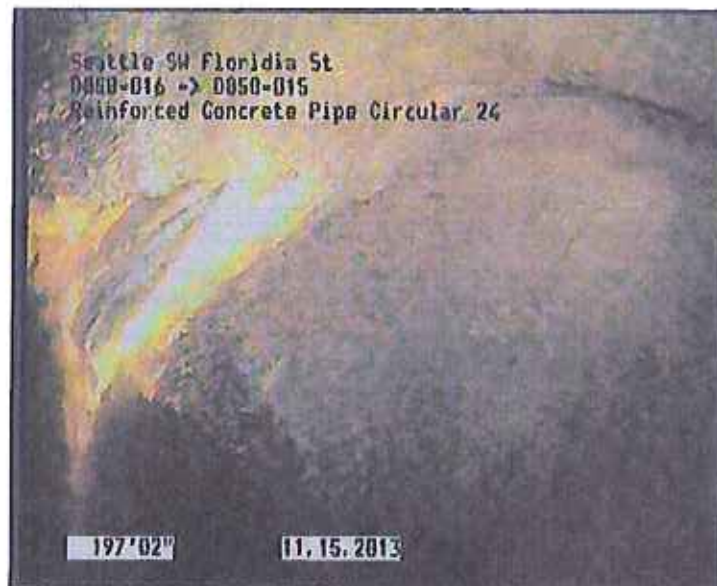
1:486	Position	Code	Observation	Photo	Rate
	197.20	IR	Infiltration Runner, from 07 to 08 o'clock, within 8 inches of joint: YES	D050-016_D050-015_ SW Florida St_15112013_091045_A.JPG	M 4

Photo: D050-016_D050-015_SW Florida St_15112013_091045_A.JPG, VCR No.: URS
 197.2FT, Infiltration Runner, from 07 to 08 o'clock, within 8 inches of joint: YES

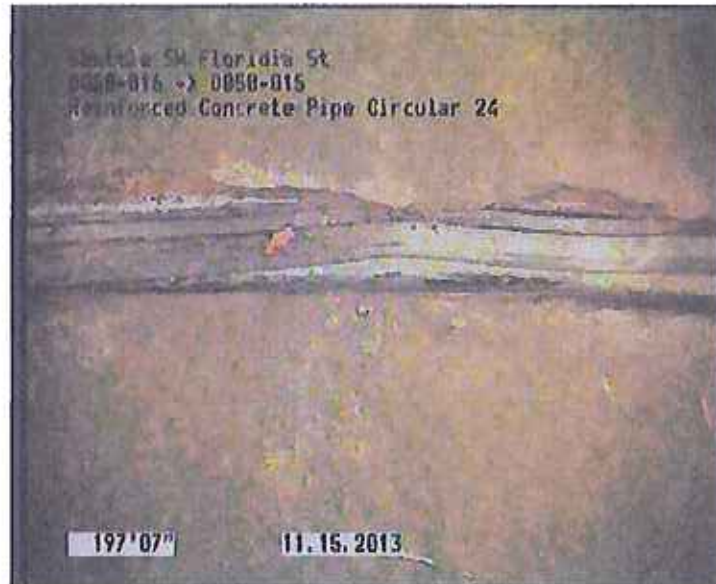
197.55	ISSR	Intruding Sealing Ring, 20 %of cross sectional area, from 09 to 03 o'clock	D050-016_D050-015_ SW Florida St_15112013_091234_A.JPG	M 3
	197.55	DAE	Deposits Attached Encrustation, 5 %of cross sectional area, from 03 to 05 o'clock, within 8 inches of joint: YES	D050-016_D050-015_ SW Florida St_15112013_091411_A.JPG	M 2

Photo: D050-016_D050-015_SW Florida St_15112013_091153_A.JPG, VCR No.: URS
 197.55FT, Intruding Sealing Ring, 20 %of cross sectional area, from 09 to 03 o'clock

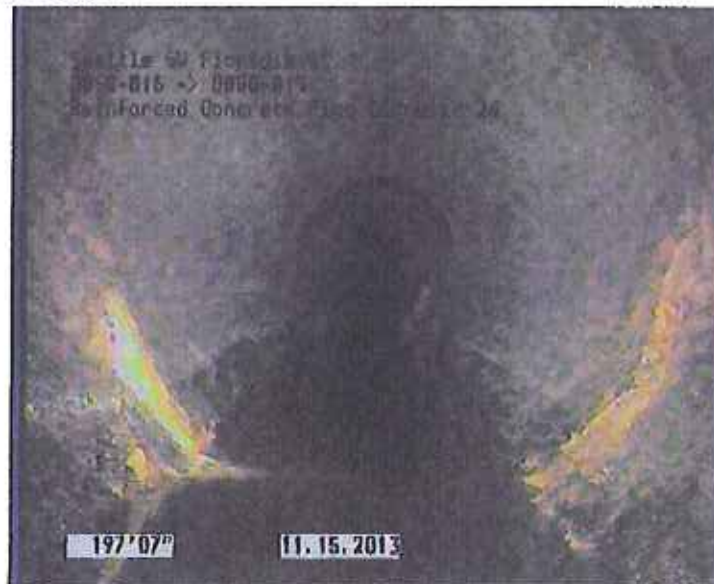
Photo: D050-016_D050-015_SW Florida St_15112013_091234_A.JPG, VCR No.: URS
 197.55FT, Deposits Attached Encrustation, 5 %of cross sectional area, from 03 to 05 o'clock, , within 8 inches of joint: YES

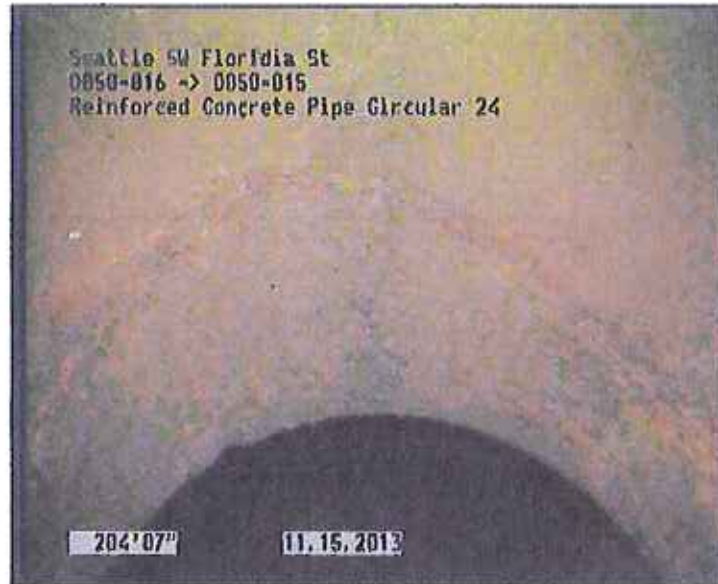
204.60	CC	Crack Circumferential, 10", from 09 to 03 o'clock, within 8 inches of joint: YES	D050-016_D050-015_ SW Florida St_15112013_091446_A.JPG	S 1
	204.60	DAE	Deposits Attached Encrustation, 5 %of cross sectional area, from 03 to 09 o'clock, within 8 inches of joint: YES	D050-016_D050-015_ SW Florida St_15112013_091446_A.JPG	M 2

Photo: D050-016_D050-015_SW Florida
 St_15112013_091411_A.JPG, VCR No.: URS
 204.6FT, Crack Circumferential, 10", from 09 to 03 o'clock, within 8
 inches of joint: YES

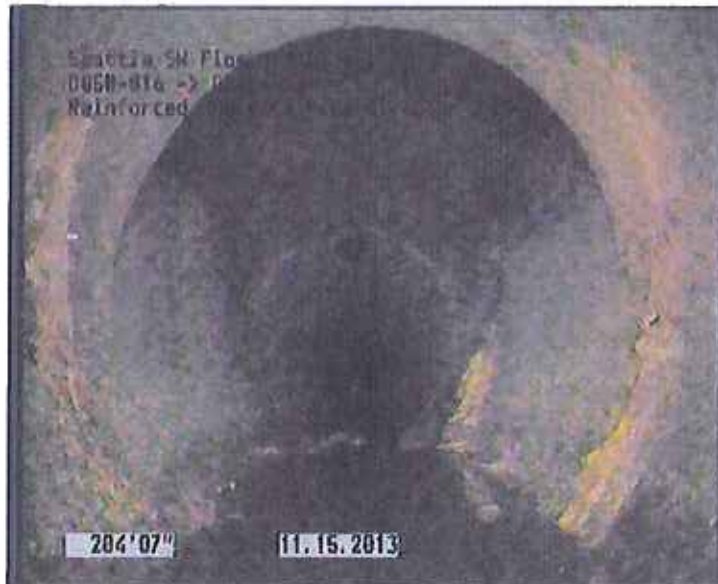
Photo: D050-016_D050-015_SW Florida
 St_15112013_091446_A.JPG, VCR No.: URS
 204.6FT, Deposits Attached Encrustation, 5 %of cross sectional area,
 from 03 to 09 o'clock, , within 8 inches of joint: YES
