Cap Inspection Report
Former Cascade Timber
No. 3 Log Sort Yard
Port of Tacoma
Tacoma, Washington

Consent Decree No. 94-2-03590-3
Consent Decree Date: April 11, 1994
Inspection Date: August 28, 2014

December 15, 2014
19000-04

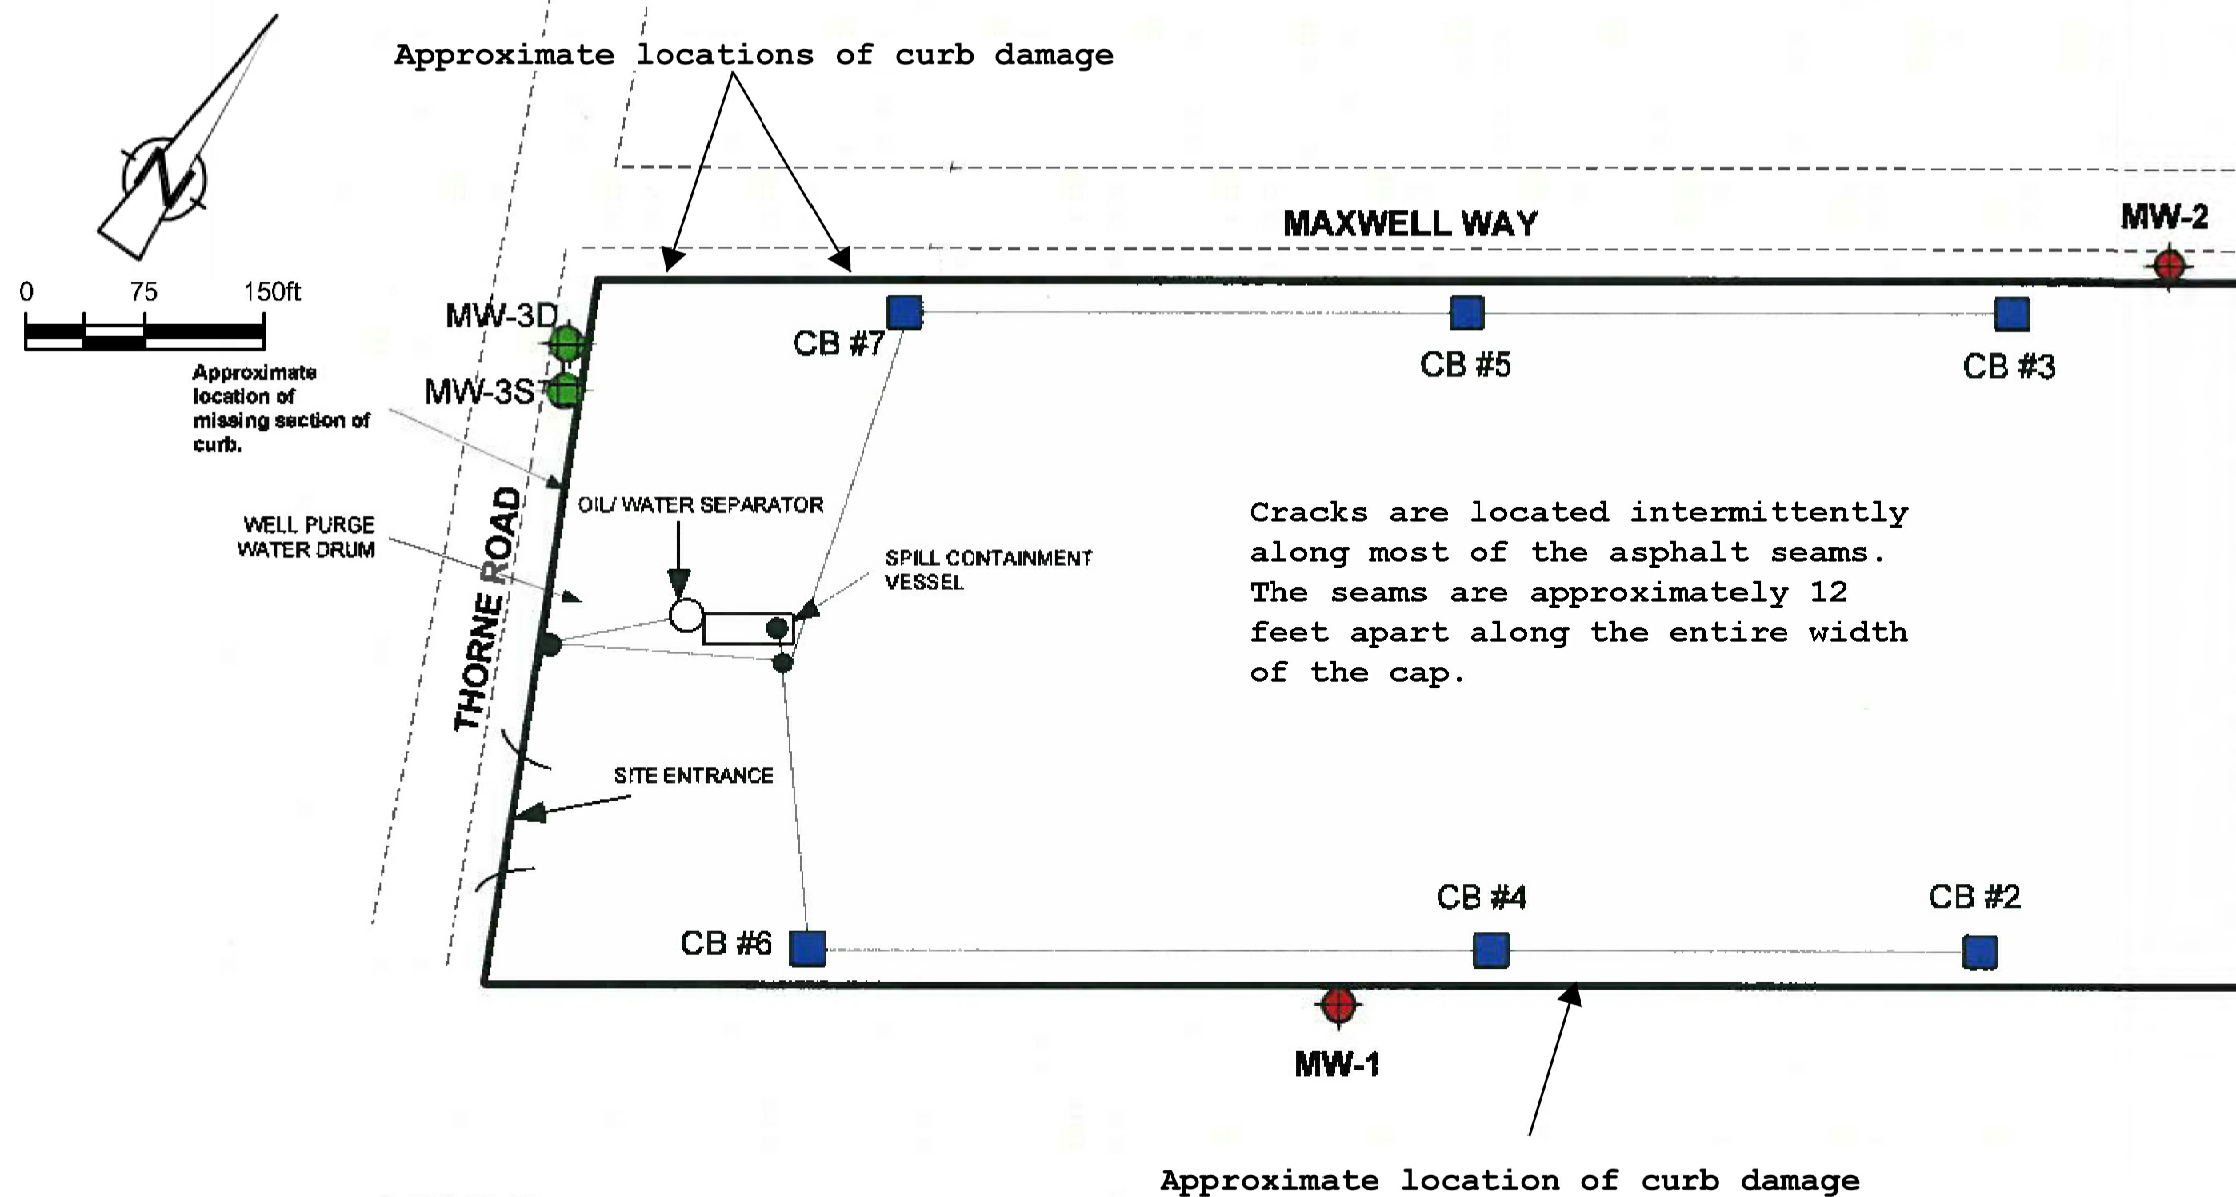
Figure 2

- Approximately 3,350 linear feet of cracks greater than 1/8 inch wide were observed along the majority of the northeast-southwest trending asphalt seams of the cap. Cracking and potholes in the asphalt cap were observed near the site entrance.
- Areas of the curb around the pavement edge are broken or deteriorated (Appendix B).
- The sediment trap in Catch Basin #2 has deteriorated.
- Oil-water separator access was not found and is suspected to have been under equipment at the time of inspection.
- The central and northern portions of the asphalt cap were under shipping containers or trailers and were not accessible to inspection.

- Seal approximately 3,350 linear feet of cracks observed along asphalt seams and repair potholes.
- Repair curb damage around pavement edge.
- Replace sediment trap in Catch Basin #2.

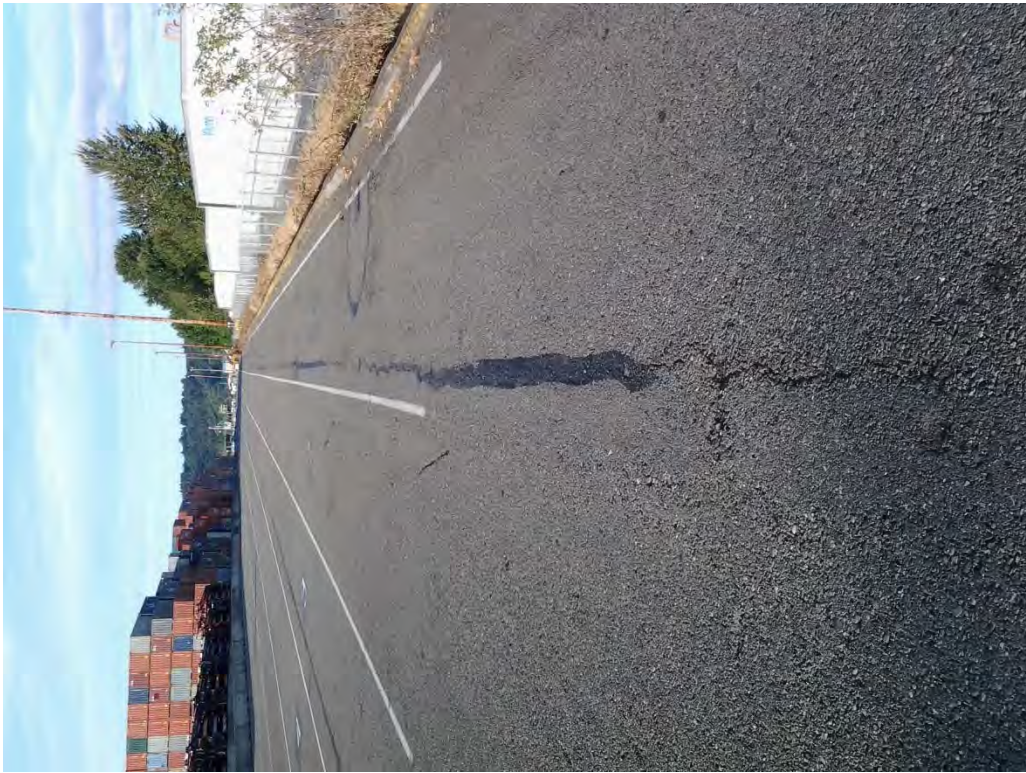
Photograph 1 – Pavement crack and deteriorating seal. (← Up)

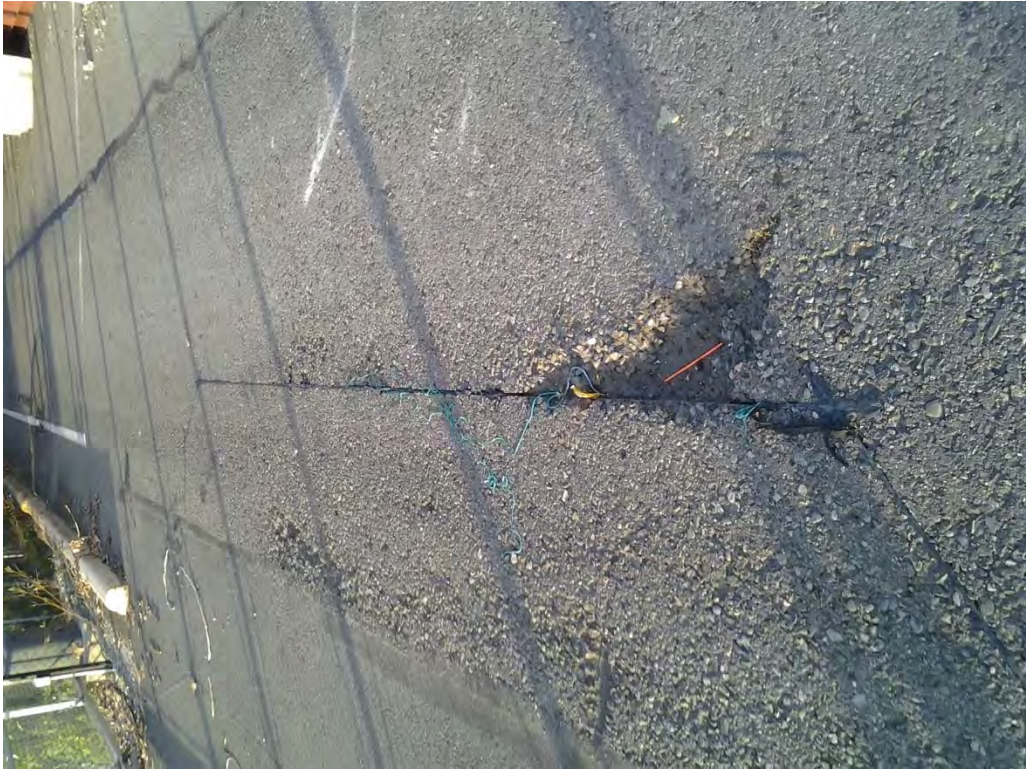
Photograph 2 – Exposed pavement sub-base. (← Up)

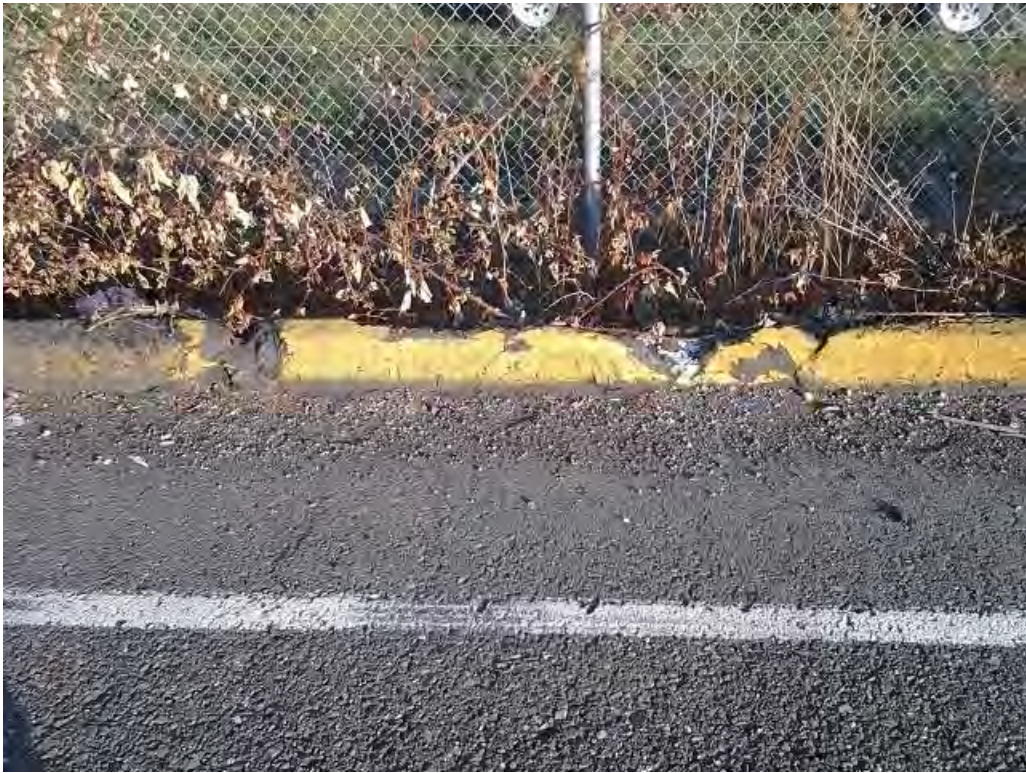
Photograph 3 – Southern curb damage.

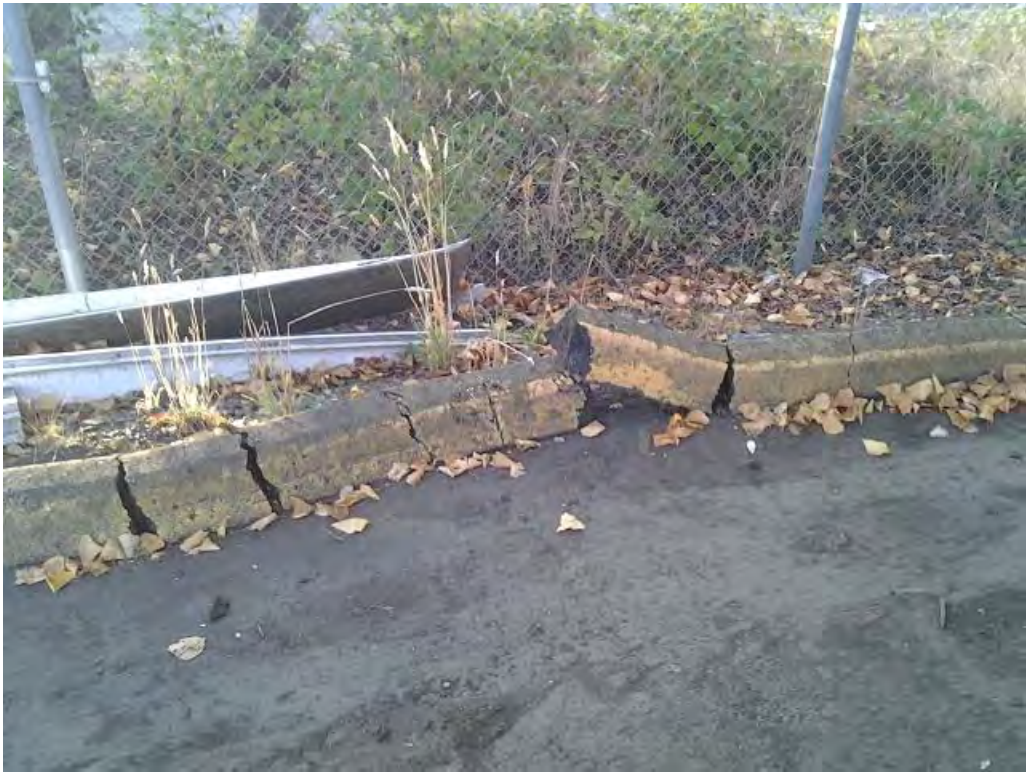
Photograph 4 – Northern curb damage.

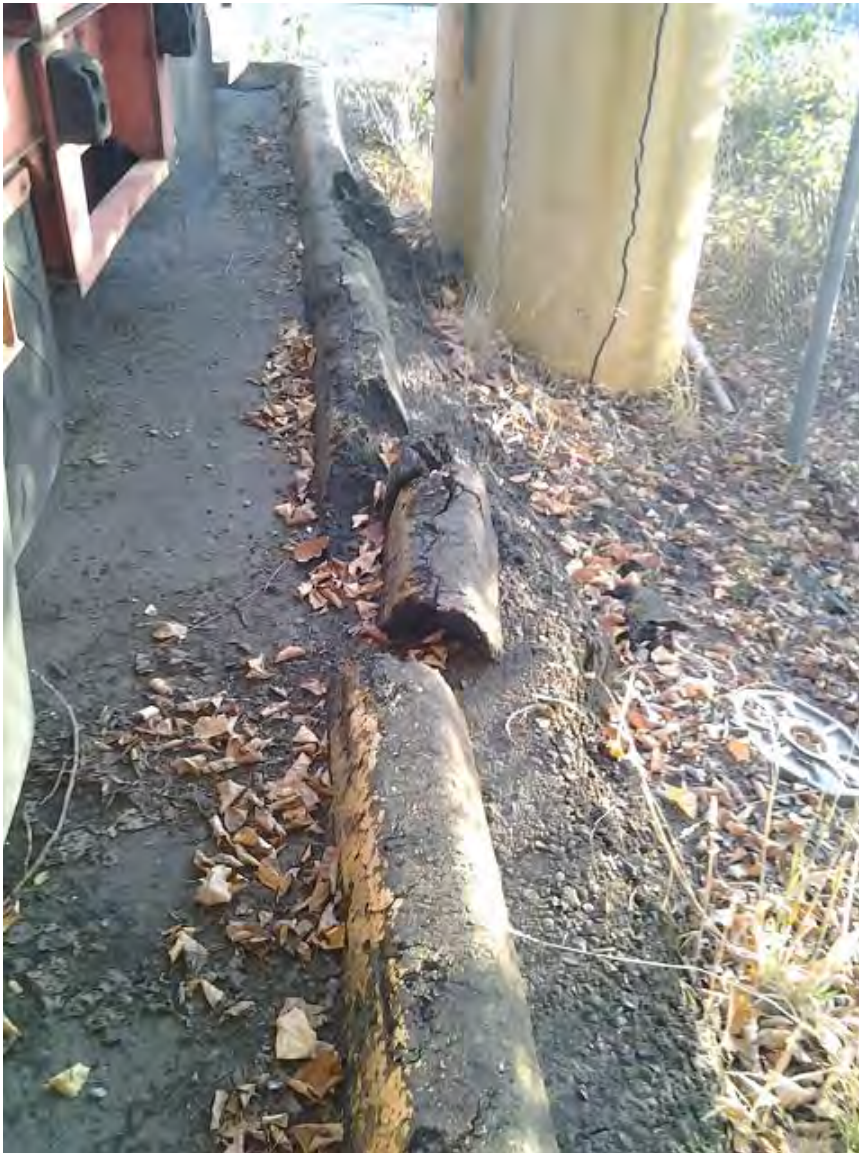
Photograph 5 – Northern curb damage.
