Cap Inspection Report
Former Portac Facility
Port of Tacoma
Tacoma, Washington

Order on Consent No. DE 88-S326
Order on Consent Date: September 22, 1988
Cap Inspection Date: August 21, 2014

December 16, 2014
19000-07

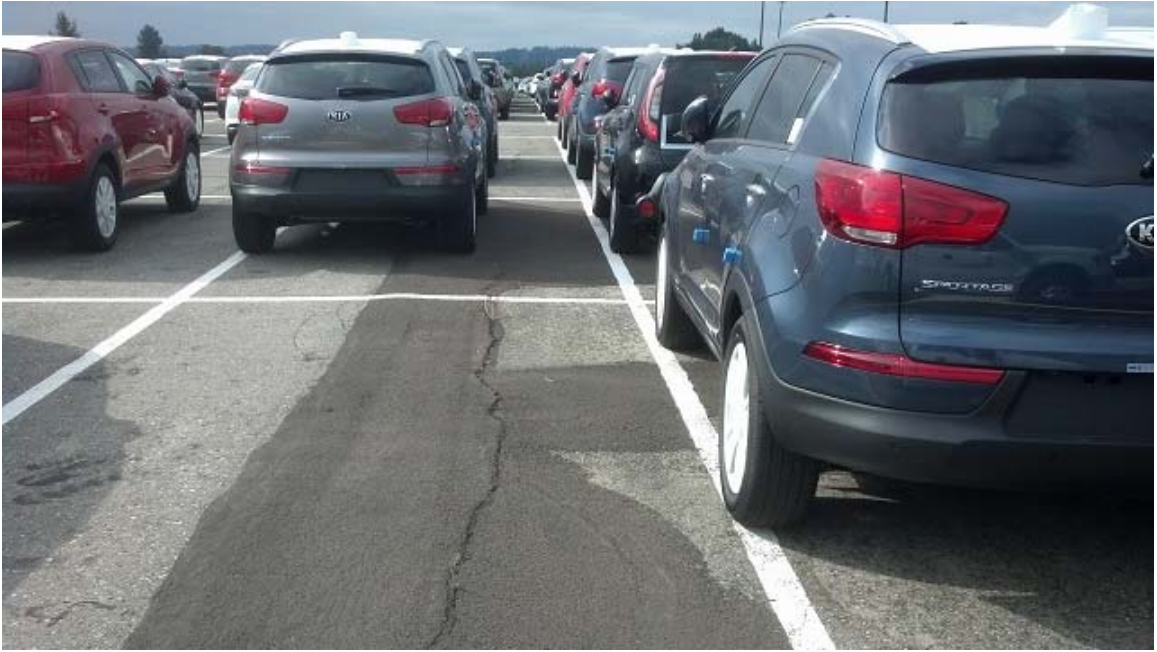
- Approximately 4,727 linear feet of cracks greater than 1/8 inch wide are present throughout the capped area. Field observations indicate that cracking is primarily along what appears to be former damaged areas that were previously sealed (Appendix B), with a higher density of cracking observed in the western portion of the cap.
- The grate is broken on the oil-water separator catch basin.
- Catch Basins #9 and #10 are in an area heavily overgrown with vegetation and were not accessible for inspection.
- Catch Basin #11 is covered with vegetation, and its filter sock appears to be deteriorating.

Photograph 1 – Observed cracks in cap.

- Seal or reseal approximately 4,727 linear feet of cracks throughout the capped area.
- Replace the grate on the oil-water separator catch basin.
- Clear vegetation from Catch Basins #9 and #10 to ensure proper function.
- Clear vegetation from Catch Basin #11.
- Replace the filter sock in Catch Basin #11.

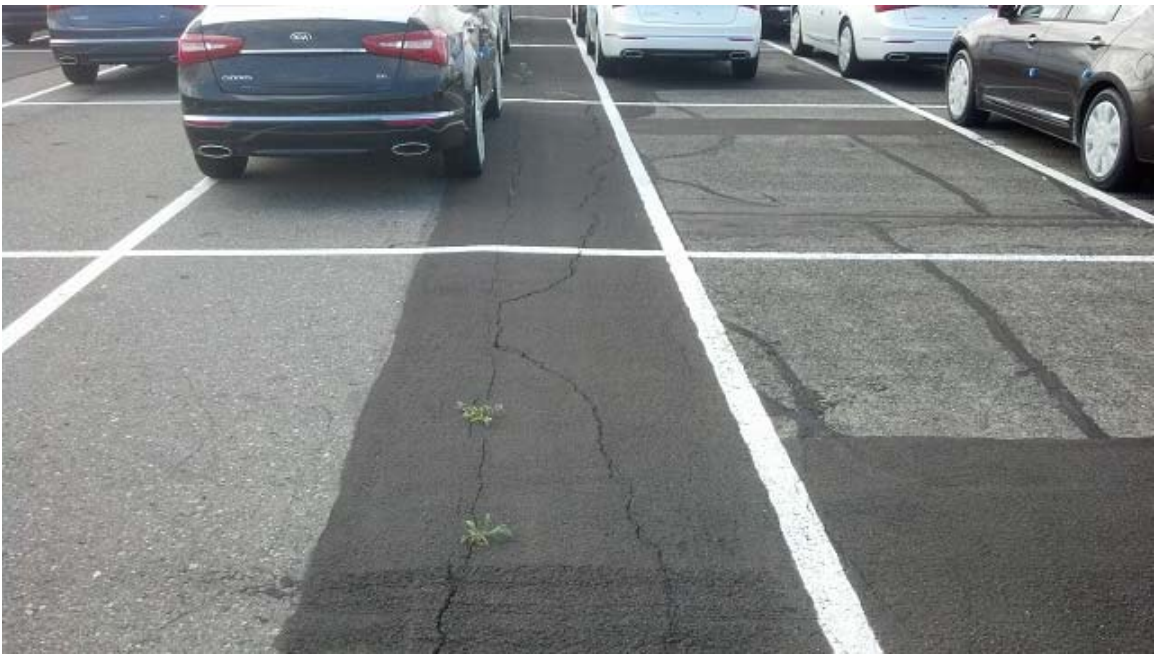
Photograph 2 – Observed cracks in cap.

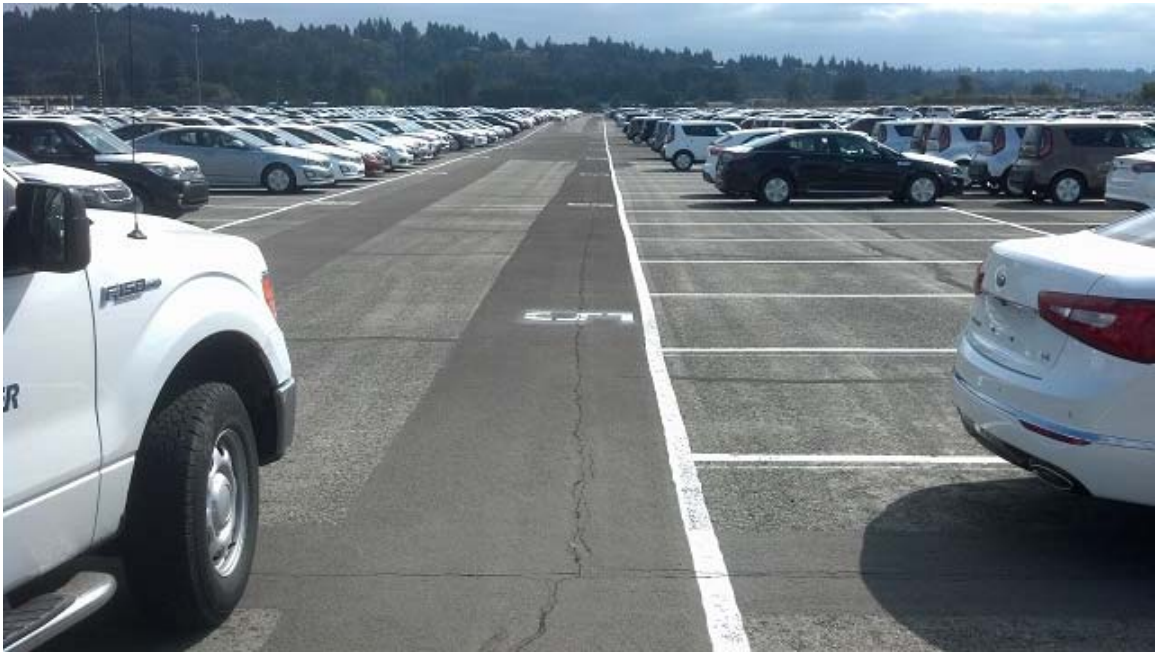
Photograph 3 – Observed cracks in cap.

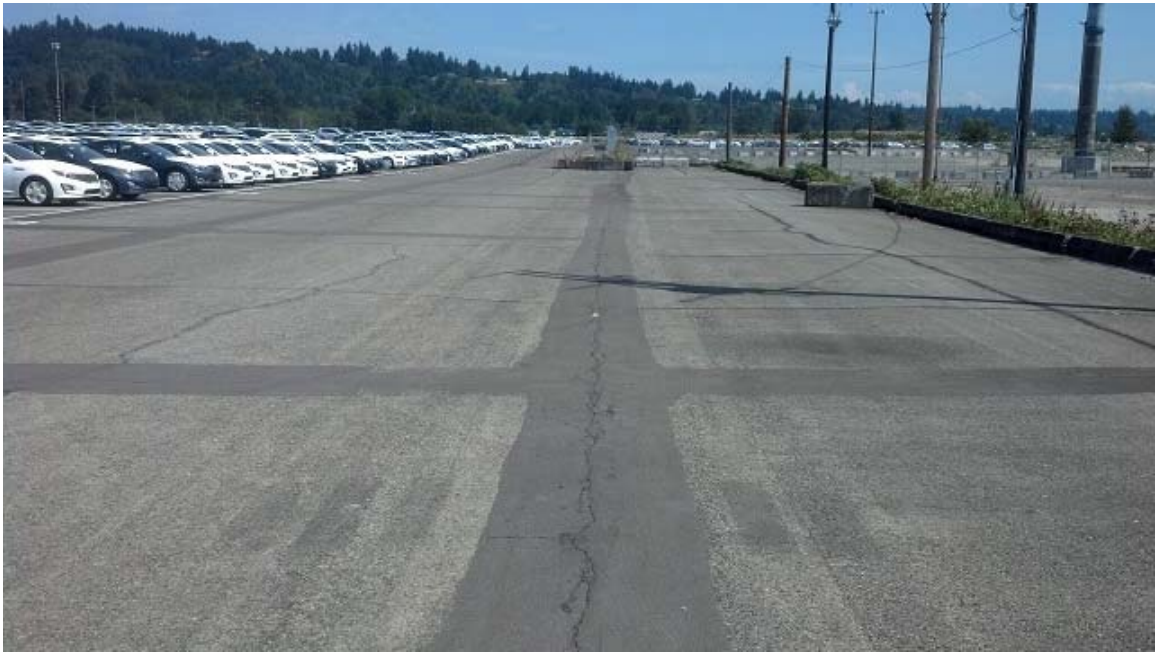
Photograph 4 – Observed cracks in cap.
