REPORT ON THE

LANDSBURG MINE DRUM REMOVAL

PROJECT

Burlington Environmental, Inc. Seattle Field Service Division

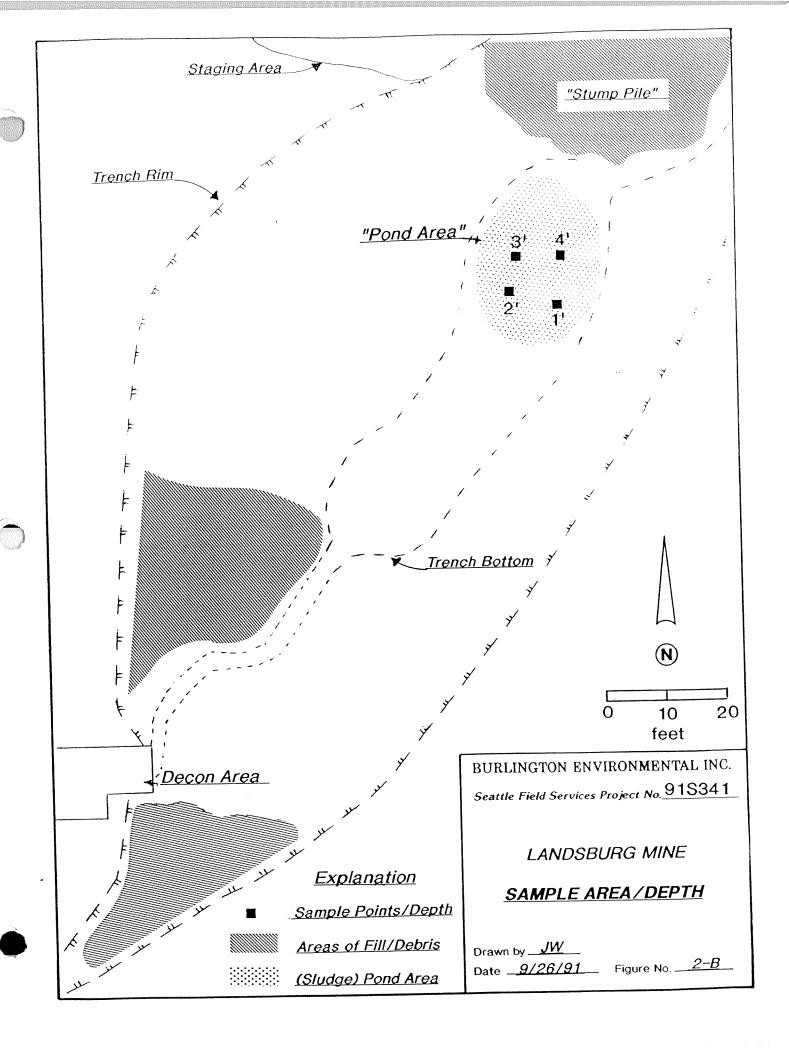
Initial site assessment and drum recovery operations began on August 22nd in Area 2 (see Figure 1). drums were found in two localities, informally named the "pond" and the "stump pile" (see Figure 2-A). The "pond" is an area of soft oily sludge about 24 feet in diameter in the bottom of the trench where water accumulates during wet months. The "pond" contained eleven drums in varying stages of deterioration. Ten were open top drums without lids lying on their sides with some of their contents spilled onto the ground. One drum containing sludge was a bung type with a ruptured top. Drum assessment was done in Level B It was observed that when the sludgey soil was disturbed, a 1 to 2 second spike of 500 to 700 ppm was recorded on the organic vapor analysis (OVA) meter. It was also observed that the sludge in the pond area was composed of various different colored layers probably representing episodic dumping of sludge from tanker trucks.

The stump pile consists primarily of logging and construction debris and soil located on the northwest bank of the trench just north of the "pond". The total length of the pile is about 350 feet and it varies in width from 15 to 60 feet. Depth of the pile is unknown. Two bung type drums with closed tops were found beneath southern end of stump pile. One was basically empty and the other contained green solids.

All the drums found in Area 2 had multiple bullet holes or punctures.
