SITE HAZARD ASSESSMENT

Boathouse Inc. Renton Skyway
12548 Renton Avenue S
Seattle, King County, WA 98118

Cleanup Site ID: 567

Site Scored/ranked for the August 2014 Hazardous Sites List Publication

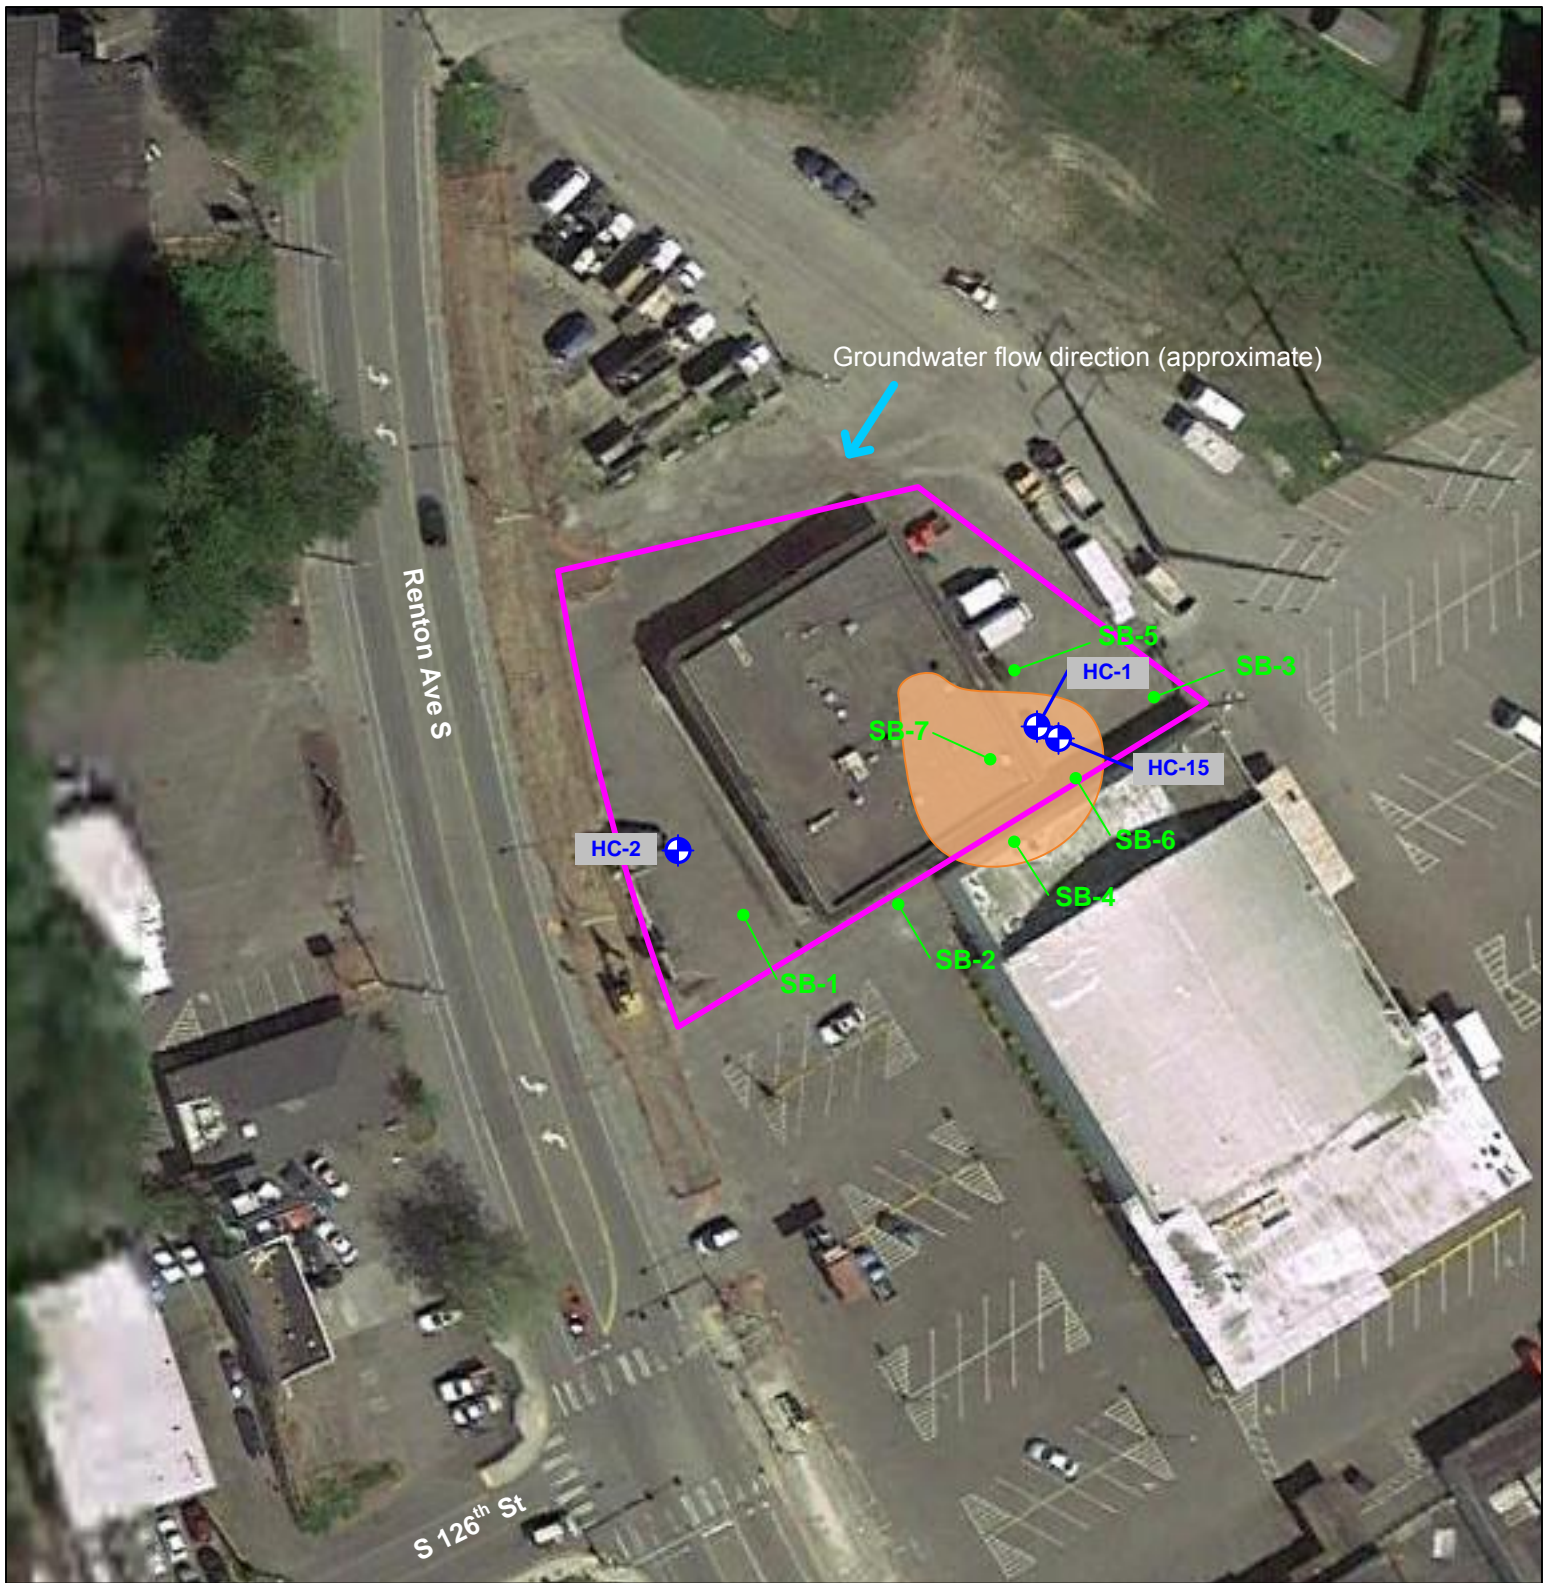
Site Overview Map

Groundwater and soil contamination was identified at the Site during a 2001 Preliminary Remedial Investigation. Impacted soil was detected in the southeast section of the property, possibly extending beyond the southern property boundary, and underneath the existing building.
