SITE HAZARD ASSESSMENT
WORKSHEET 1
Summary Score Sheet

TC Systems Inc.
1032 W Marine View Dr
Everett, WA 98201

Site scored/ranked for the February 2015 Hazardous Sites List Publication

November 14, 2014

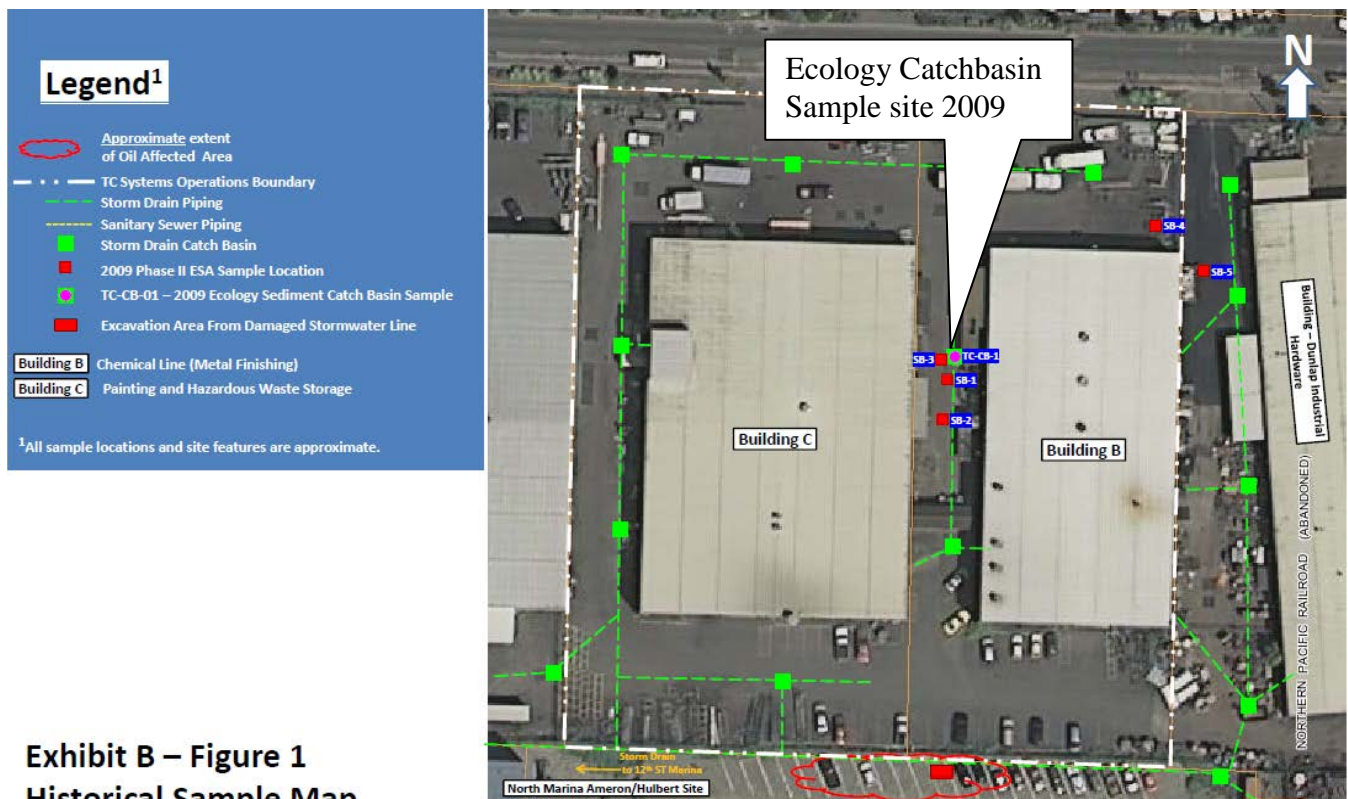
**Exhibit B – Figure 1
Historical Sample Map**

In November 2004, soil samples were collected from a stormwater pipeline repair work near the North Marina Ameron/Hulbert and TC Systems property line (see Exhibit B – Figure 1 Historical Sample Map). The stormwater pipeline is located south of Buildings B & C. Test results show concentration of cPAHs, PCBs, zinc & copper above the Model Toxics Control Act (MTCA) Method A soil cleanup levels for unrestricted land uses in two samples.¹ It is not clear if the catchbasin is down gradient from TC Systems.

During a stormwater inspection in September 2009, Department of Ecology took a soil sample from a stormwater catch basin near the compressor shed between Buildings B & C. Sample results show that the concentrations of cadmium, chromium, copper, lead, zinc, PCBs (Arochlor-1248 and 1254), benzoic acid, bis(2-ethylhexyl)phthalate exceeded the Sediment Quality Standards (SQS) and in some cases also exceeded MTCA (see Table 2). In addition, the sample result for TPH, as lube oil, was reported at 3,800 mg/kg.¹
