STATE OF WASHINGTON
DEPARTMENT OF ECOLOGY

February 20, 2015

Re: Further Action at the following Site:

Site Name: Columbia Park Marina
Site Address: 1776 Columbia Park Trail, Richland
Facility/Site No.: 84244226
VCP Project No.: CE0396

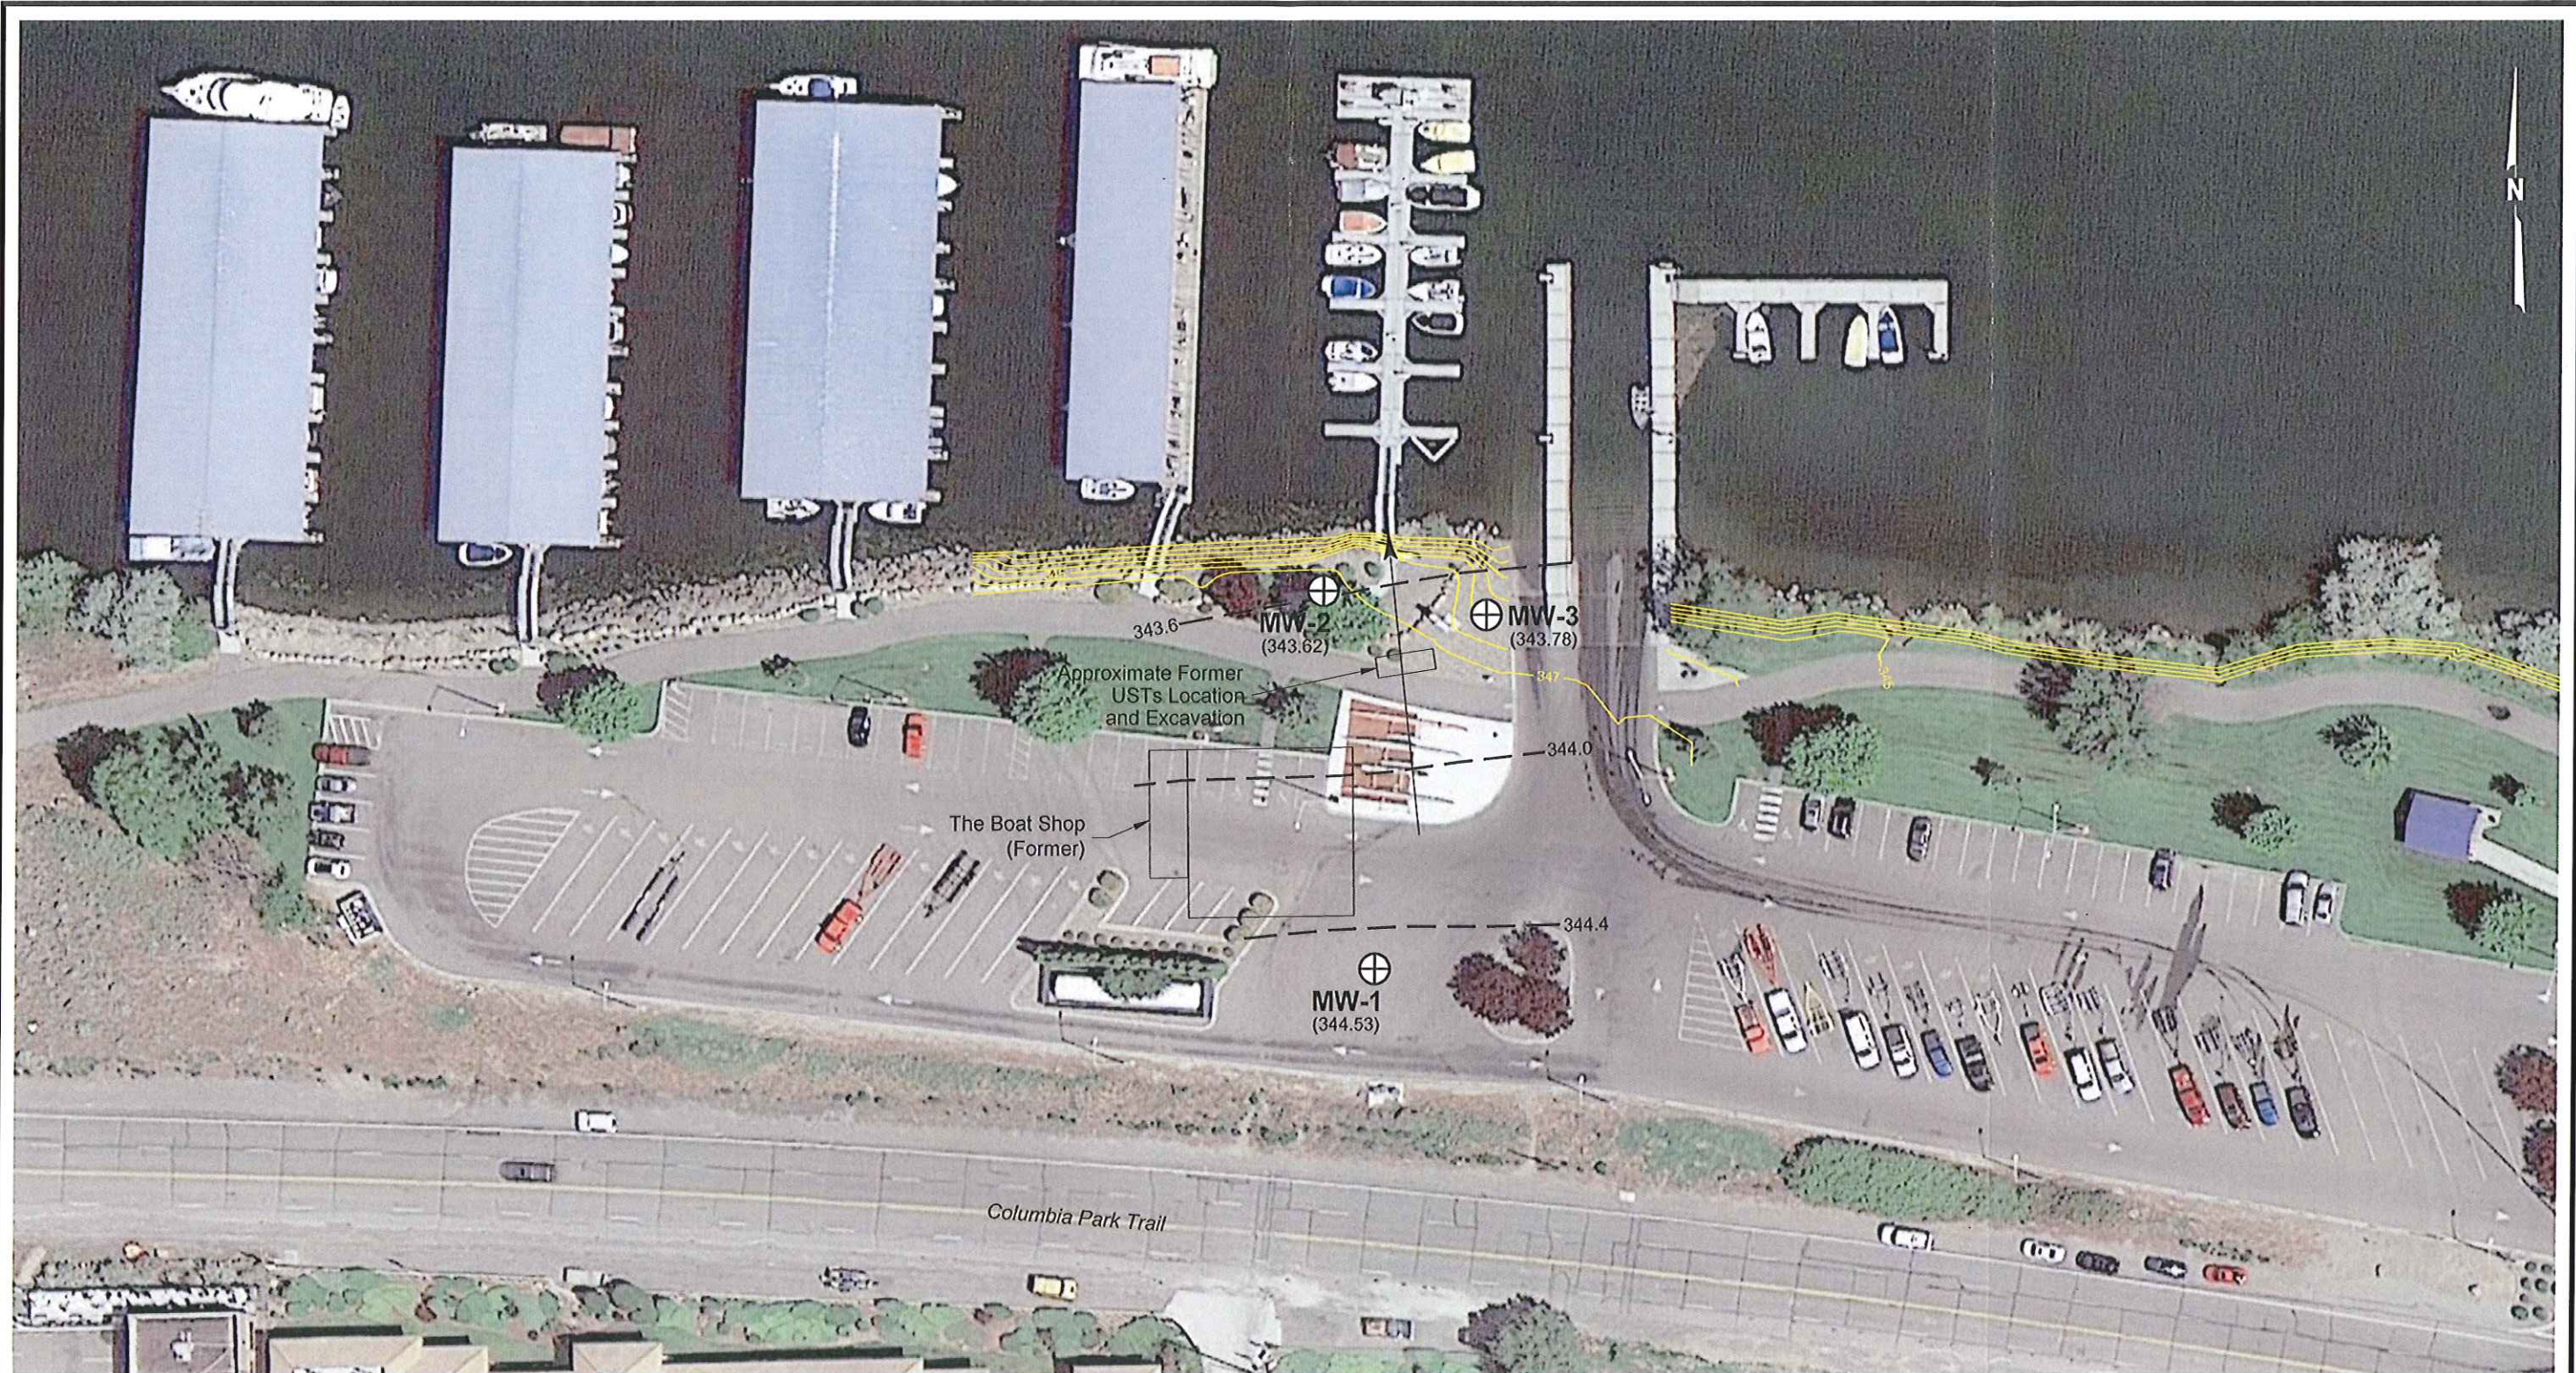
FIG. 2

- Groundwater sampled from monitoring wells for two quarters appears to be clean, with the exception of one turbid sample with a concentration of Pb above the cleanup level.

- No human or ecological receptors are known to be affected by the release at the Site, but will be confirmed with the TEE.
- Groundwater at the Site is present between 6 to 9.7 feet below ground surface based on two quarters of groundwater monitoring. In February and September 2014, the measured elevations show a hydraulic gradient toward the north and the river. The hydraulic gradient in March is essentially flat across the Site and likely represents a rising river-water recharge scenario.

**SITE PLAN AND
MONITORING WELL LOCATIONS**

- Groundwater samples should be collected from all monitoring wells for four consecutive quarters.
- Groundwater samples should be analyzed for GRPH, BTEX, and Pb for all four quarters.

- Groundwater samples should be analyzed for fuel additives and blending compounds (EDB, EDC, MTBE, TBA, TAME, and ETBE) for at least one quarter.
- Additional monitoring and/or remedial actions may be necessary if groundwater results exceeded cleanup levels.
- All environmental data must be submitted to Ecology's EIM database before a final opinion letter can be issued for the Site.
- A Terrestrial Ecological Evaluation (TEE) Form must be submitted before a final opinion letter can be issued for the Site.
