## **PERIODIC REVIEW**

Southwest Harbor Project Remediation Area 2 – Salmon Bay Steel Site

Harbor Avenue and SW Hanford Street  
Seattle, Washington  
FSID# - 2385

Prepared by  
Washington State Department of Ecology  
Northwest Regional Office  
Toxics Cleanup Program  
Bellevue, WA

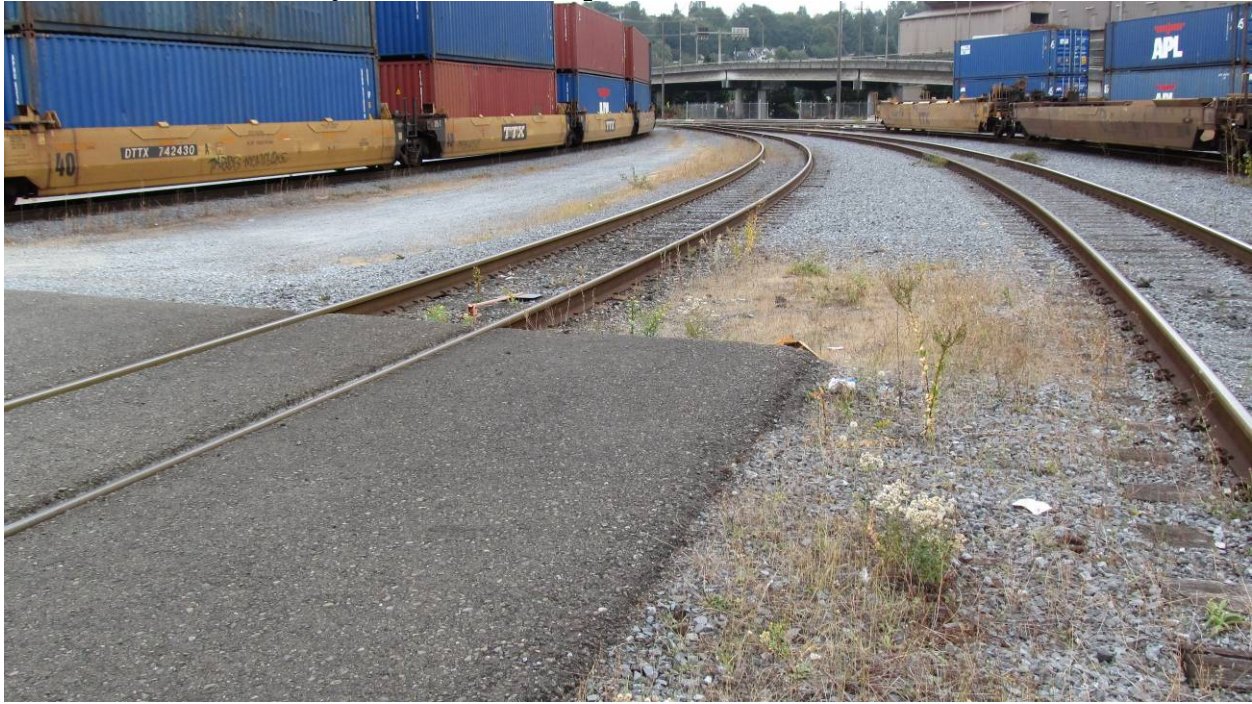
**Photo 1: Restricted Railyard Area with Asphalt and Permeable Cover – from the north**

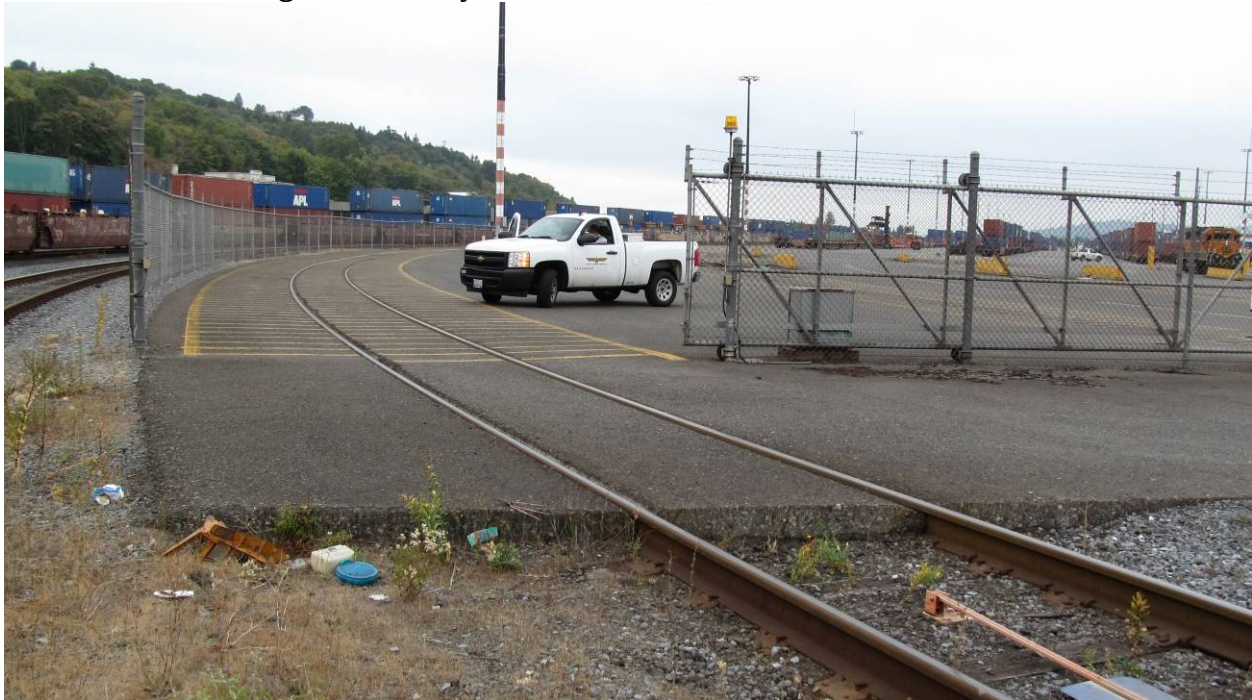
Another issue noted in this same area is the degradation of concrete supporting the fence posts for the fence dividing the IY entrance area from the rail area to the east. The concrete post footings have degraded and soil is being forced to surface; apparently by frost-heave. Other areas of cracking and asphalt uplift noted in the 2011 report have been addressed by the tenant.

**Photo 2: Site Fencing and Security – from the south**

The issues noted above are new. The tenant is coordinating with BNSF to address the asphalt issue. According to Eagle Marine, BNSF has recommended that the asphalt simply be rolled back into place, rather than repaired by removal/repaving. While this is probably satisfactory in terms of maintaining the pavement, it is likely the problem will re-occur until the underlying cause is assessed and corrected. The Port should follow up with the tenant as soon as possible to repair the fence posts.

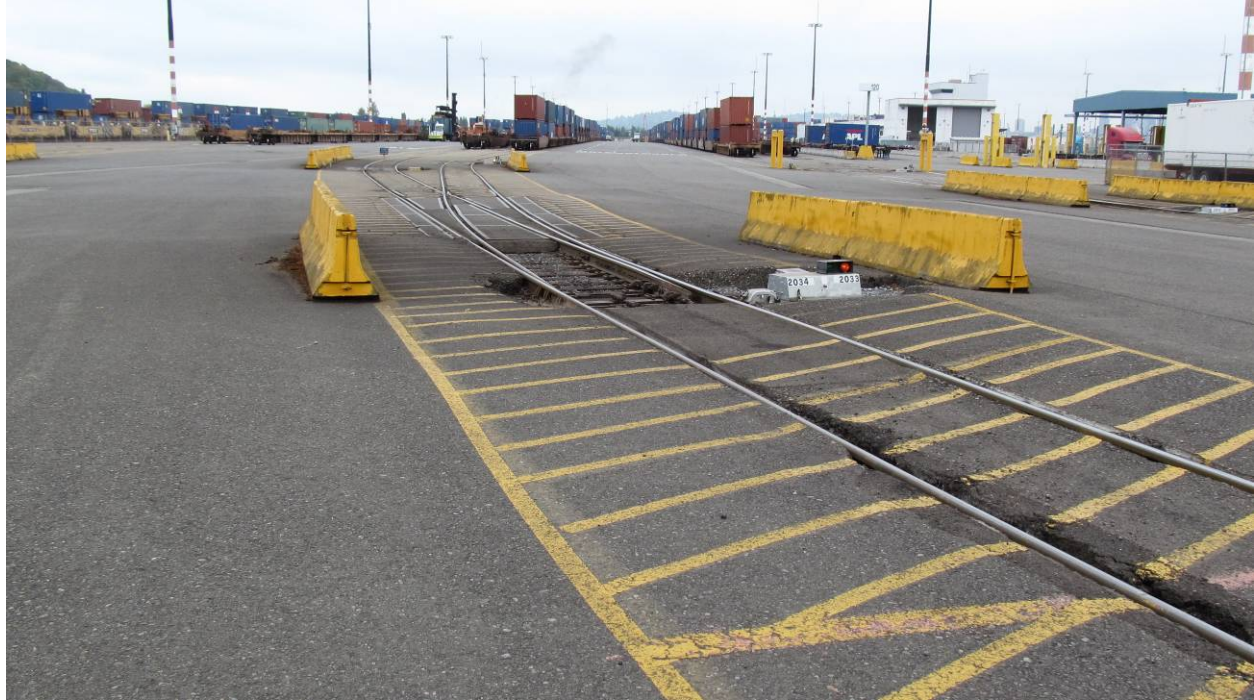
The most recent available inspection form was from July 2012. The inspection determined that the cap appeared to be generally intact with some exceptions noted. The exceptions included small areas of asphalt lifting near railroad tracks. A summary of the inspection report is available as Appendix 6.5.

With the exception of several limited areas of asphalt cap damage and cracking the environmental components at the subject areas within Terminal 5 are performing as expected and are in acceptable condition. The localized areas of damage consist of asphalt "uplift" adjacent to the IY rails where they turn from the east-west to north-south alignment in the southern portion of the terminal (within the RA-2 area).

**Photo 3: Asphalt Condition in Vicinity of Rail Lines – from the south**

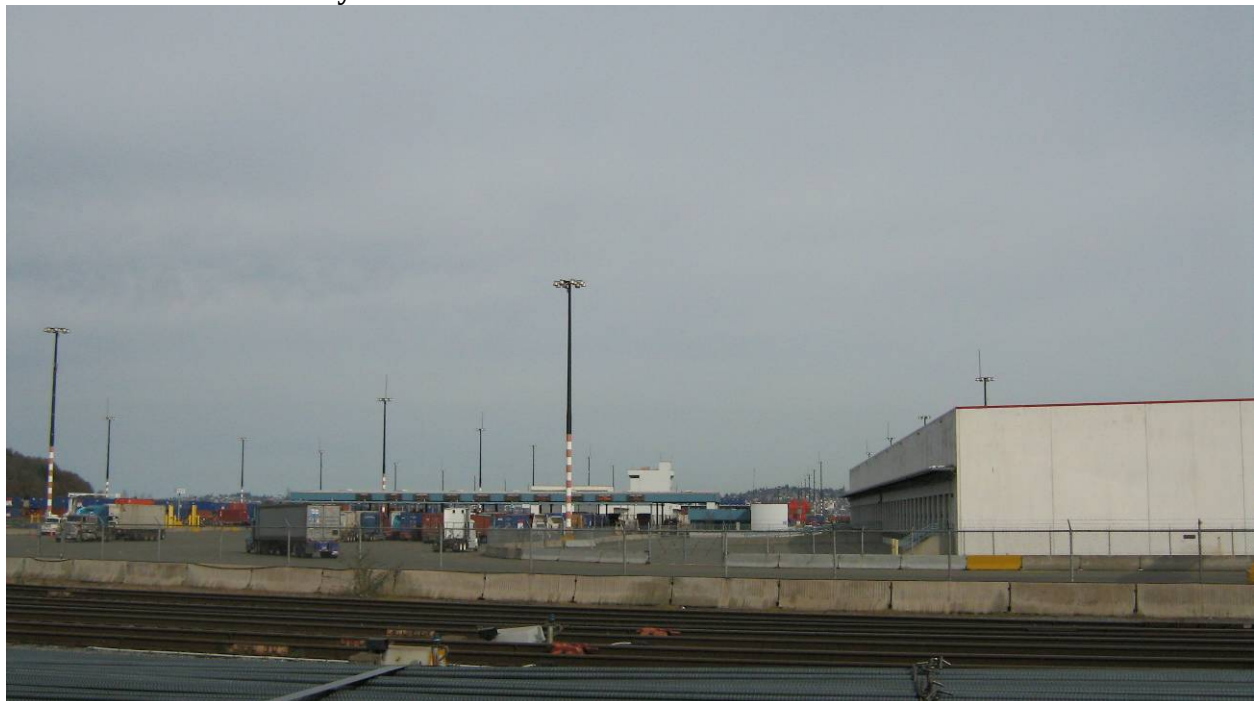
**Photo 4: South Boundary of RA-2 – from the south**
