North Boeing Field/ Georgetown Steam Plant Site Remedial Investigation/Feasibility Study

Assessment of Infiltration and Inflow to North Boeing Field Storm Drain System

February 2011

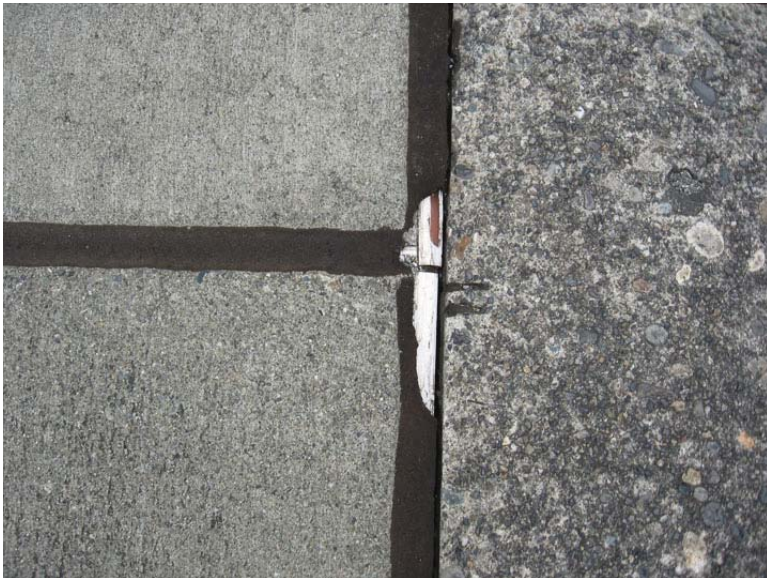
Photo 3. Degraded Caulk with Plastic Backing on the Flight Line

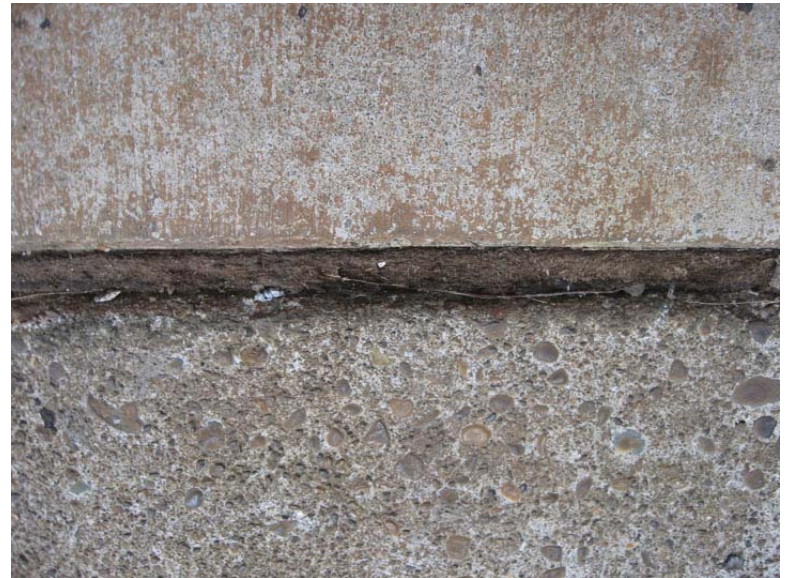
Photo 4. Fibrous CJM between Buildings 3-334 and 3-332

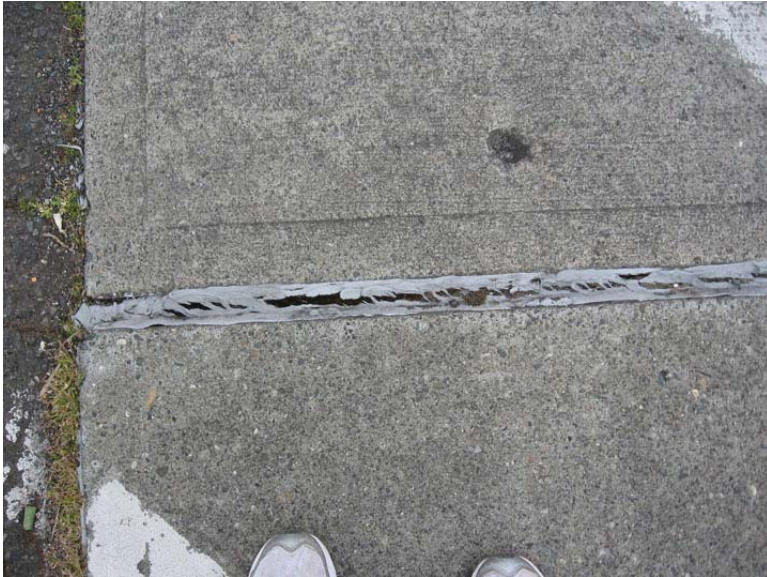
Photo 5. Degraded Caulk on the Sidewalk between Buildings 3-365 & 3-380

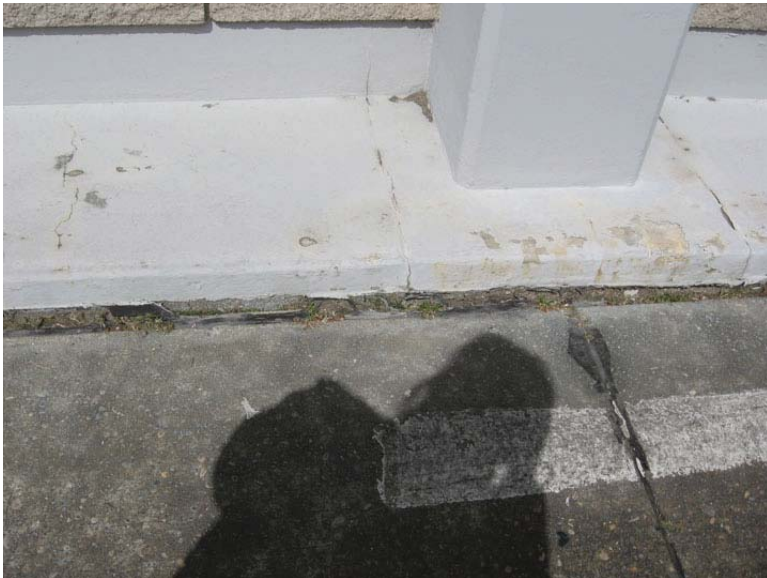
Photo 7. Degraded Caulk between Parking Lot and Sidewalk at Building 3-818

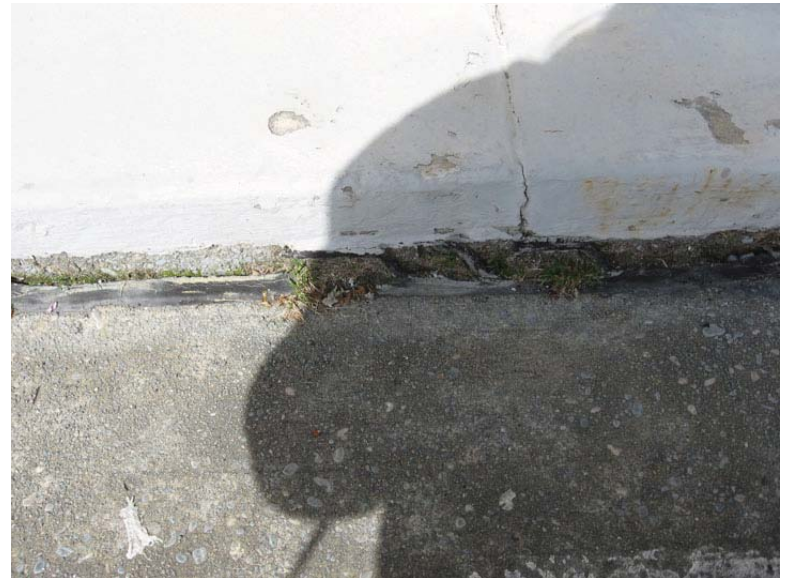
Photo 8. Degraded Caulk between Parking Lot and Sidewalk at Building 3-818 - Detail

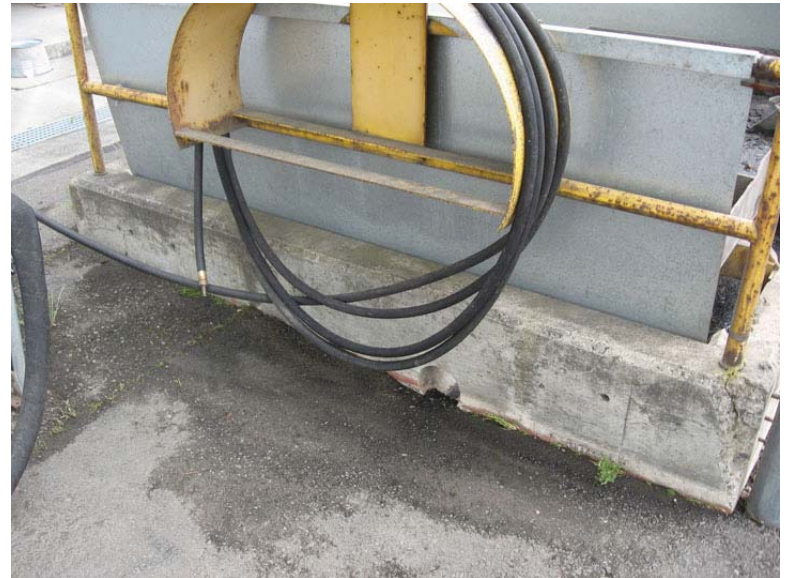
Photo 12. Detail of Drain from the Sweeper Decant Station (note apparent water staining on ground surface)

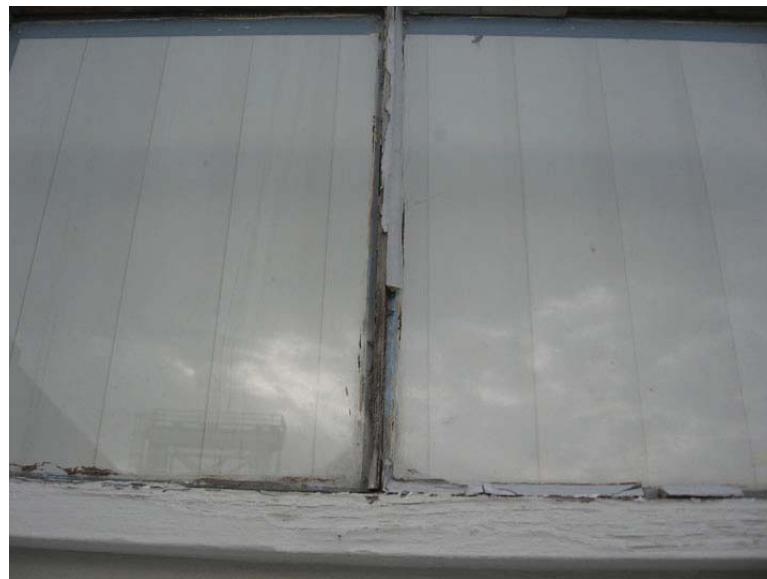
Photo 22. Degraded Window Caulk and Glazing at Building 3-365

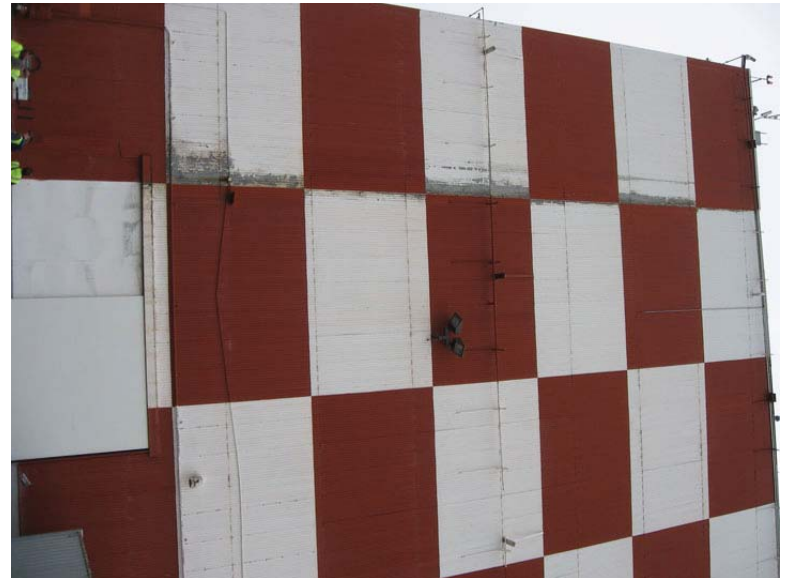
Photo 32. Degraded Paint on Building 3-390

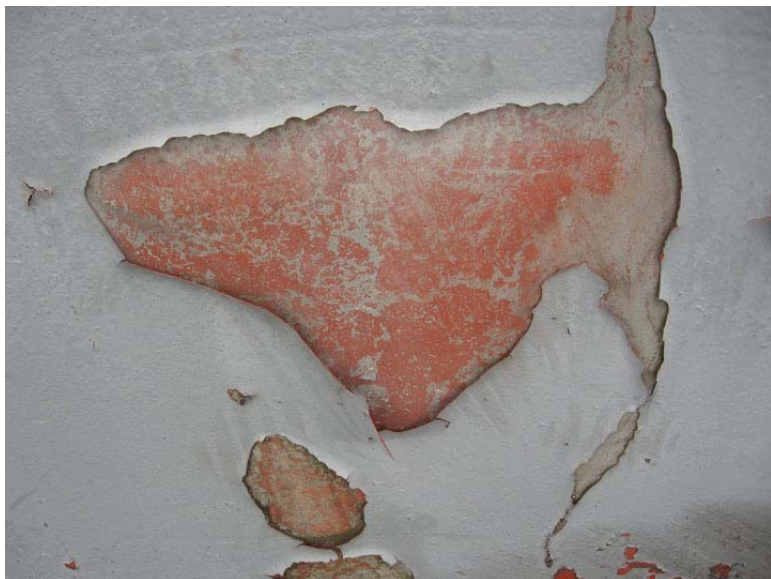
Photo 33. Degraded Paint on Building 3-390 - Detail 1

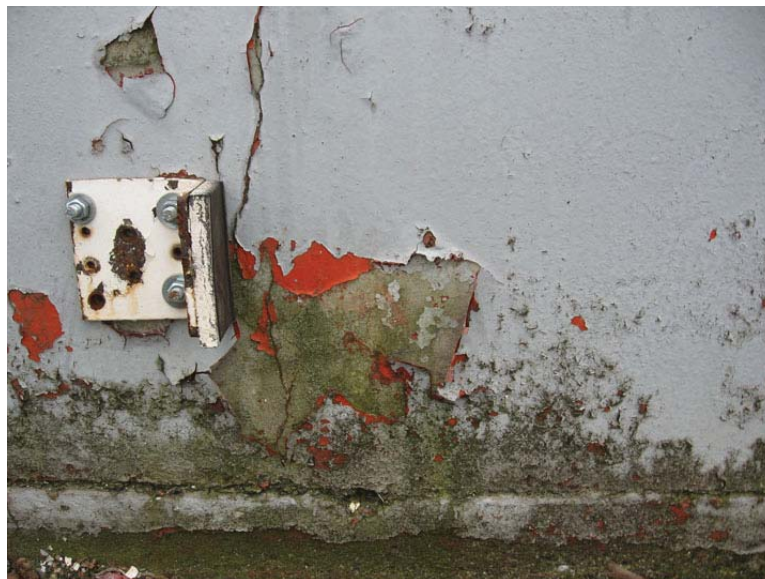
Photo 34. Degraded Paint on Building 3-390 - Detail 2

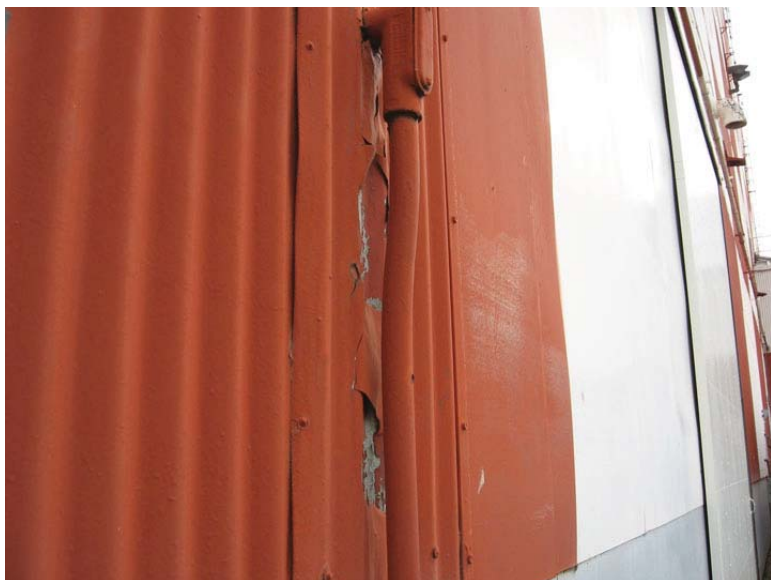
Photo 35. Degraded Paint on Building 3-390 - Detail 3

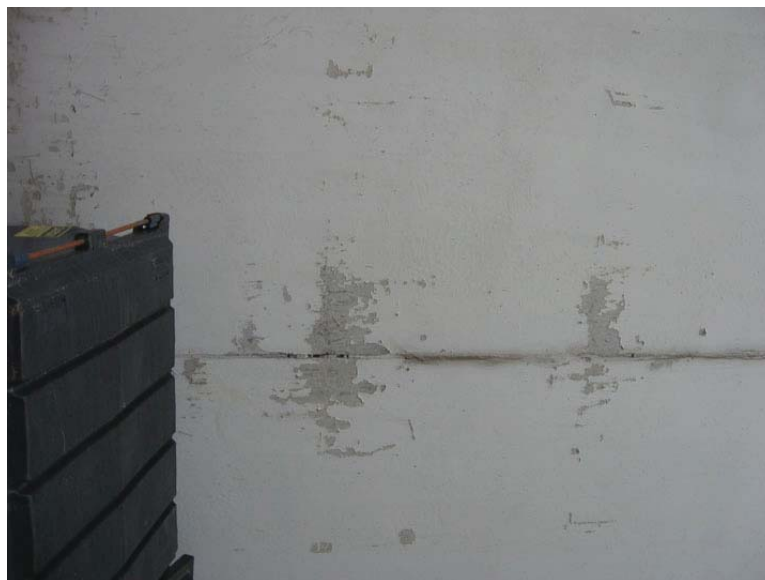
Photo 36. Degraded Paint on Building 3-315 (View 1)

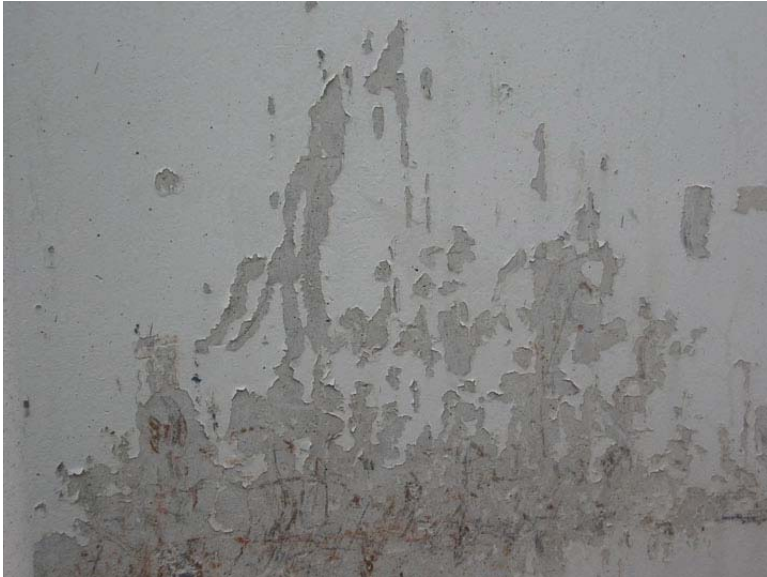
Photo 37. Degraded Paint on Building 3-315 (View 2)

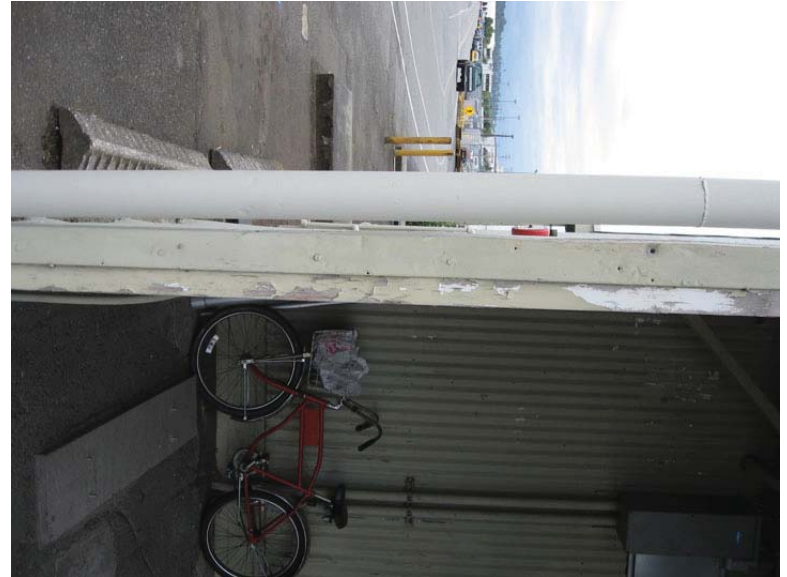
Photo 38. Degraded Paint on Building 7-027-1 (View 1)

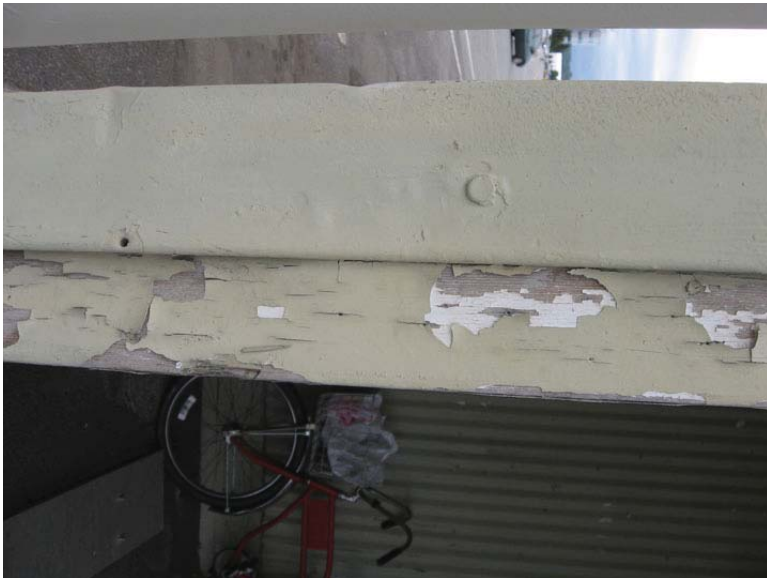
Photo 39. Degraded Paint on Building 7-027-1 - Detail of View 1

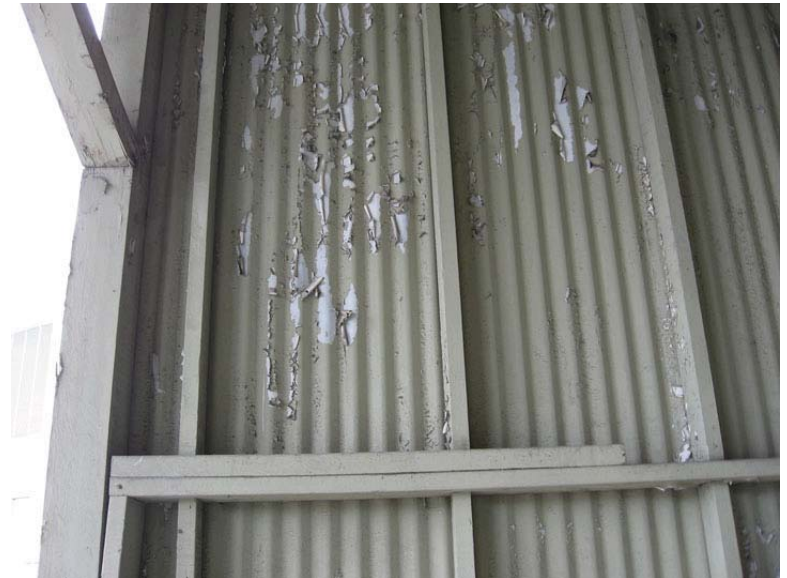
Photo 40. Degraded Paint on Building 7-027-1 (View 2)

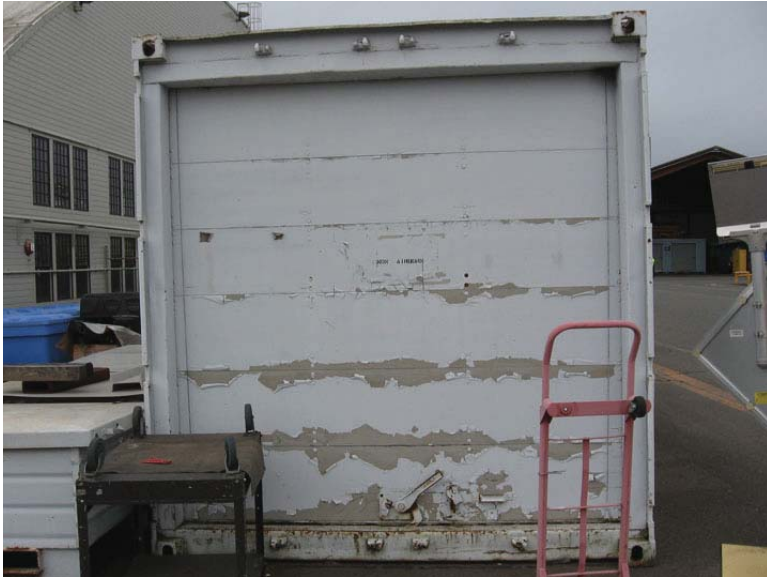
Photo 41. Degraded Paint on Container near Building 3-350

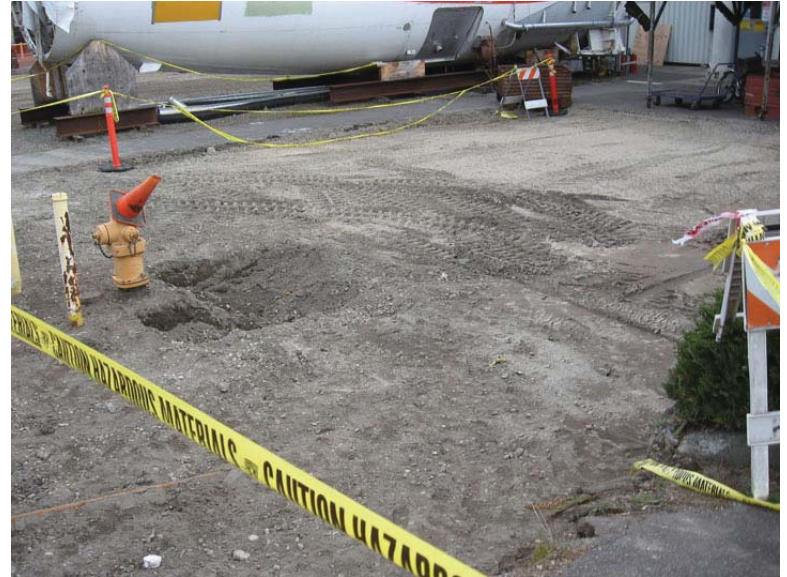
Photo 42. Degraded Paint on Bollard near Building 3-322

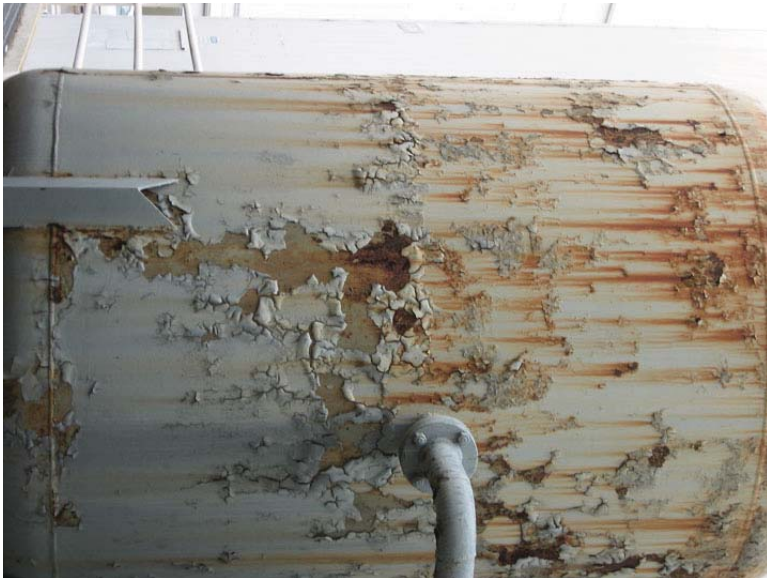
Photo 43. Degraded Paint on Tank or Boiler adjacent to Building 3-374

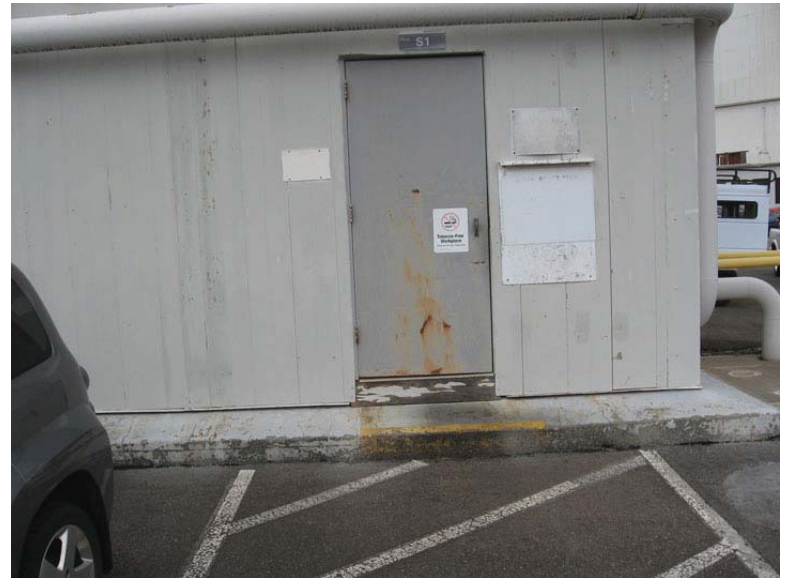
Photo 44. Degraded Paint on Building 3-374

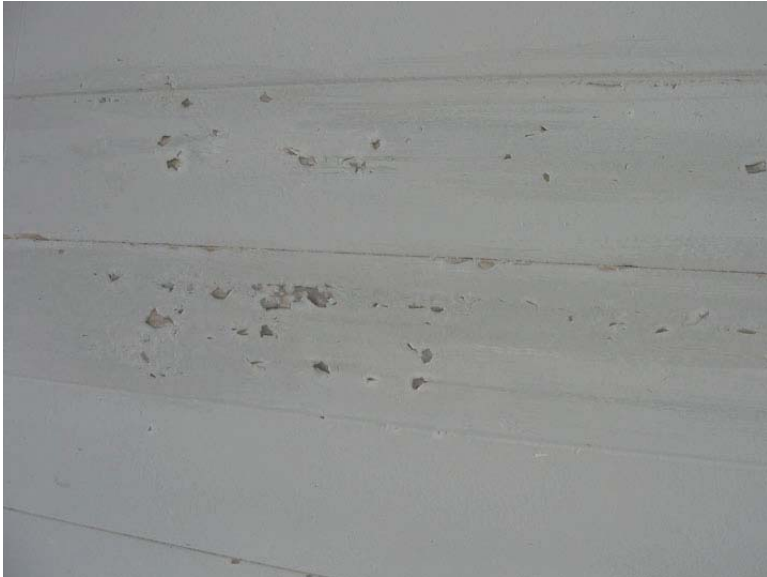
Photo 45. Degraded Paint on Building 3-374 - Detail

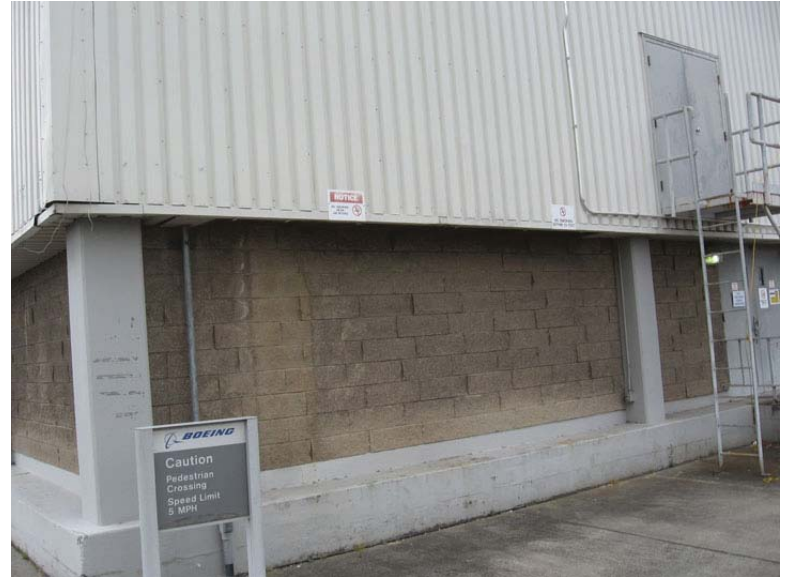
Photo 46. Degraded Paint on Building 3-818

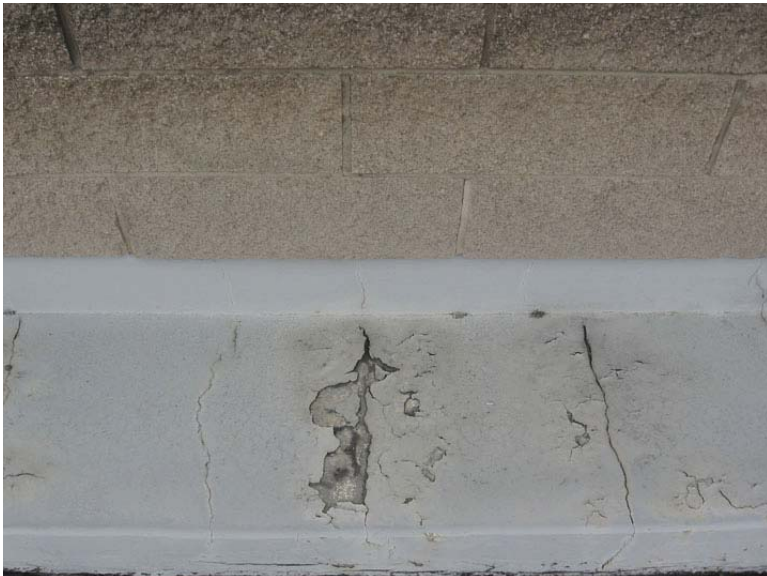
Photo 47. Degraded Paint on Building 3-818 - Detail (note that caulk or mortar between concrete blocks is also degraded)

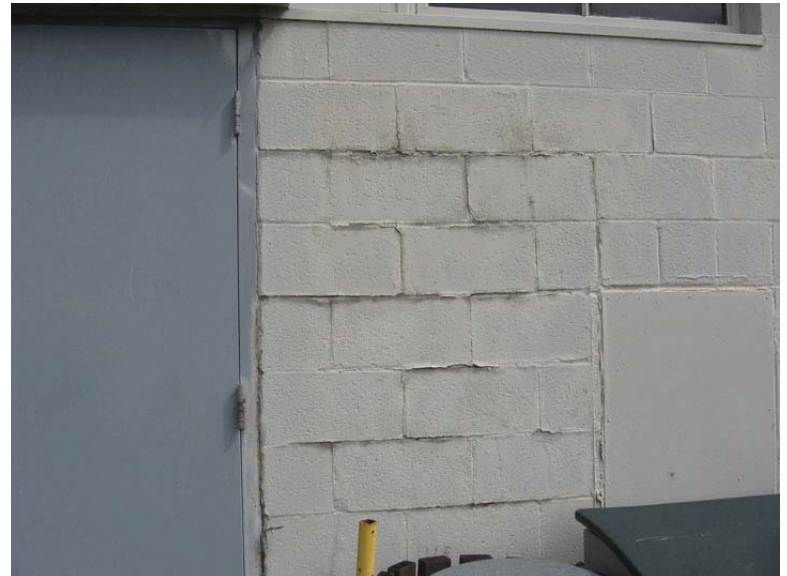
Photo 48. Degraded Paint on Building 3-822 (note that door caulk is peeling away from the door jamb)

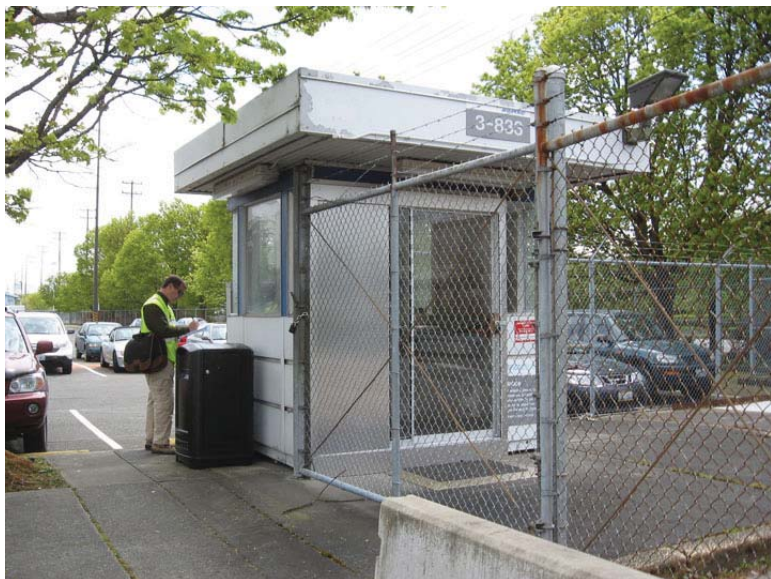
Photo 49. Degraded Paint on Building 3-833

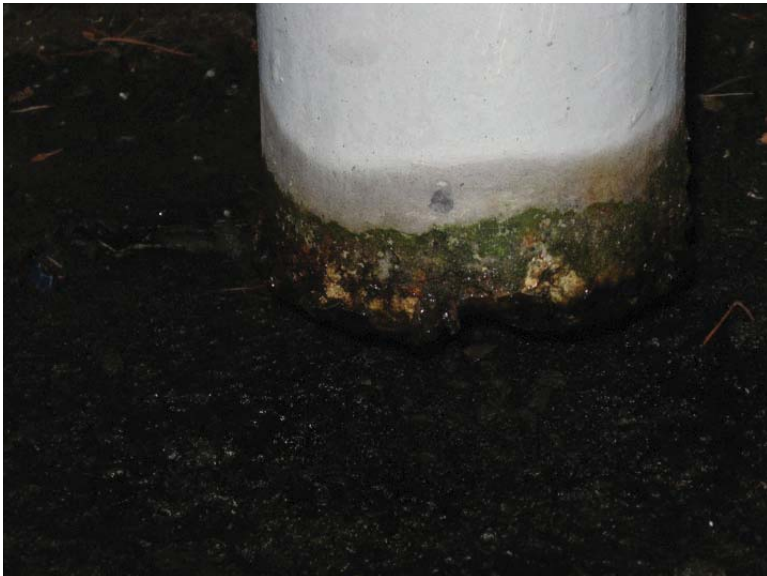
Photo 63. Roof Drain on Building 3-397 - Detail (note connection to SD system is broken)
