STATE OF WASHINGTON
DEPARTMENT OF ECOLOGY

October 27, 2014

Re: Opinion pursuant to WAC 173-340-515(5) on Proposed Remedial Action for the following Hazardous Waste Site:

- **Name:** Penthouse Drapery Cleaners
- **Address:** 1752 Rainier Avenue South
- **Facility/Site No.:** 23408
- **VCP No.:** NW2278
- **Cleanup Site ID No.:** 3184

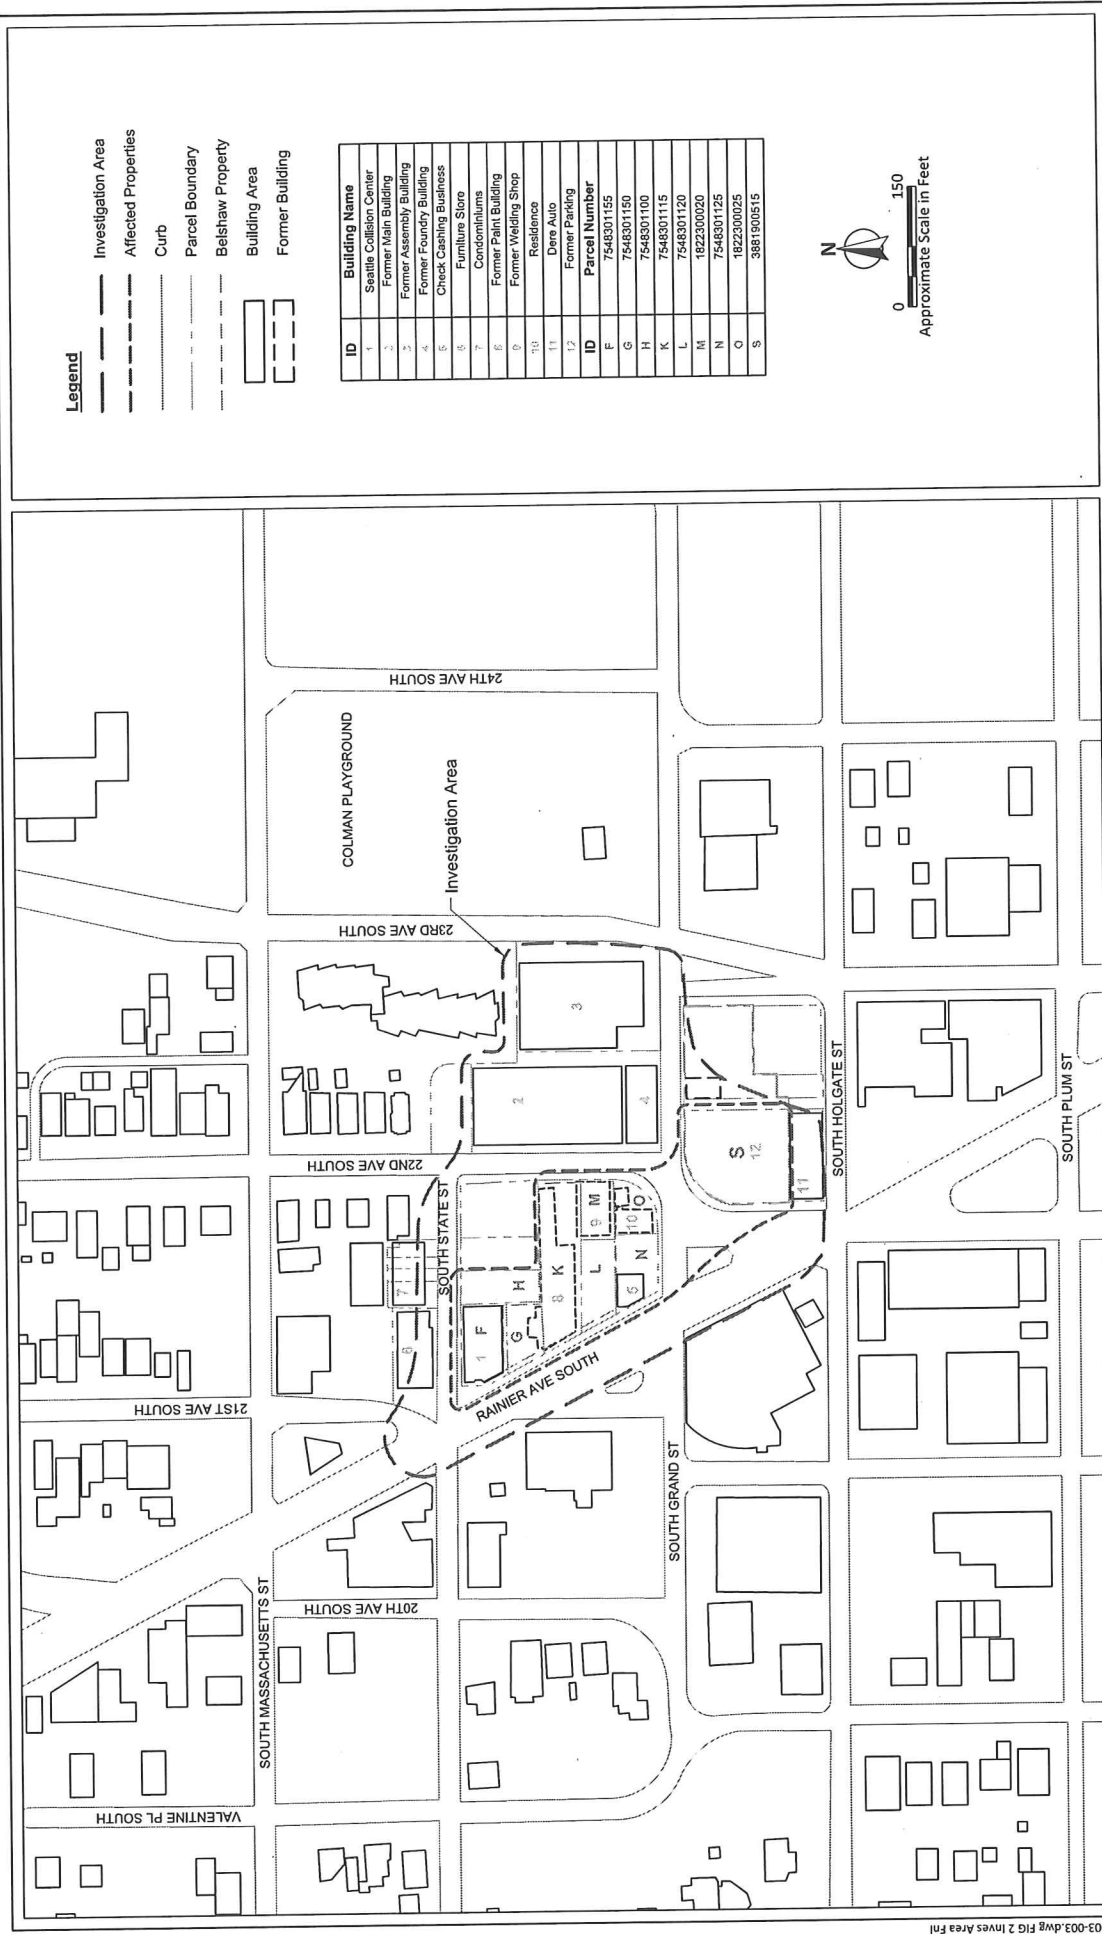
- On Figure 2, the "Investigation Area" boundary does not include the area including the MW-30 monitoring well cluster.

The estimated areal extent of the Site is shown on Figure 2 in the attached Site Diagrams. As illustrated, the Site includes the entire Penthouse property, portions of the adjoining properties to the south, and east, and a possible westward extension into the Rainier Avenue South right-of-way. The Site also appears to extend southward and eastward beyond Grand Street, based on PCE, TCE, and DCE detections in wells MW-1, MW-2, and MW-20.
