STATE OF WASHINGTON
DEPARTMENT OF ECOLOGY

October 7, 2013

Re: Opinion pursuant to WAC 173-340-515(5) on Proposed Remedial Action for the following Hazardous Waste Site:

- **Site Name:** Group Health Cooperative of Puget Sound
- **Site Address:** 801 SW 16th Street, Renton, WA 98055
- **Facility/Site No.:** 16471336
- **VCP Project No.:** NW 1770
- **Cleanup Site ID No.:** 5599

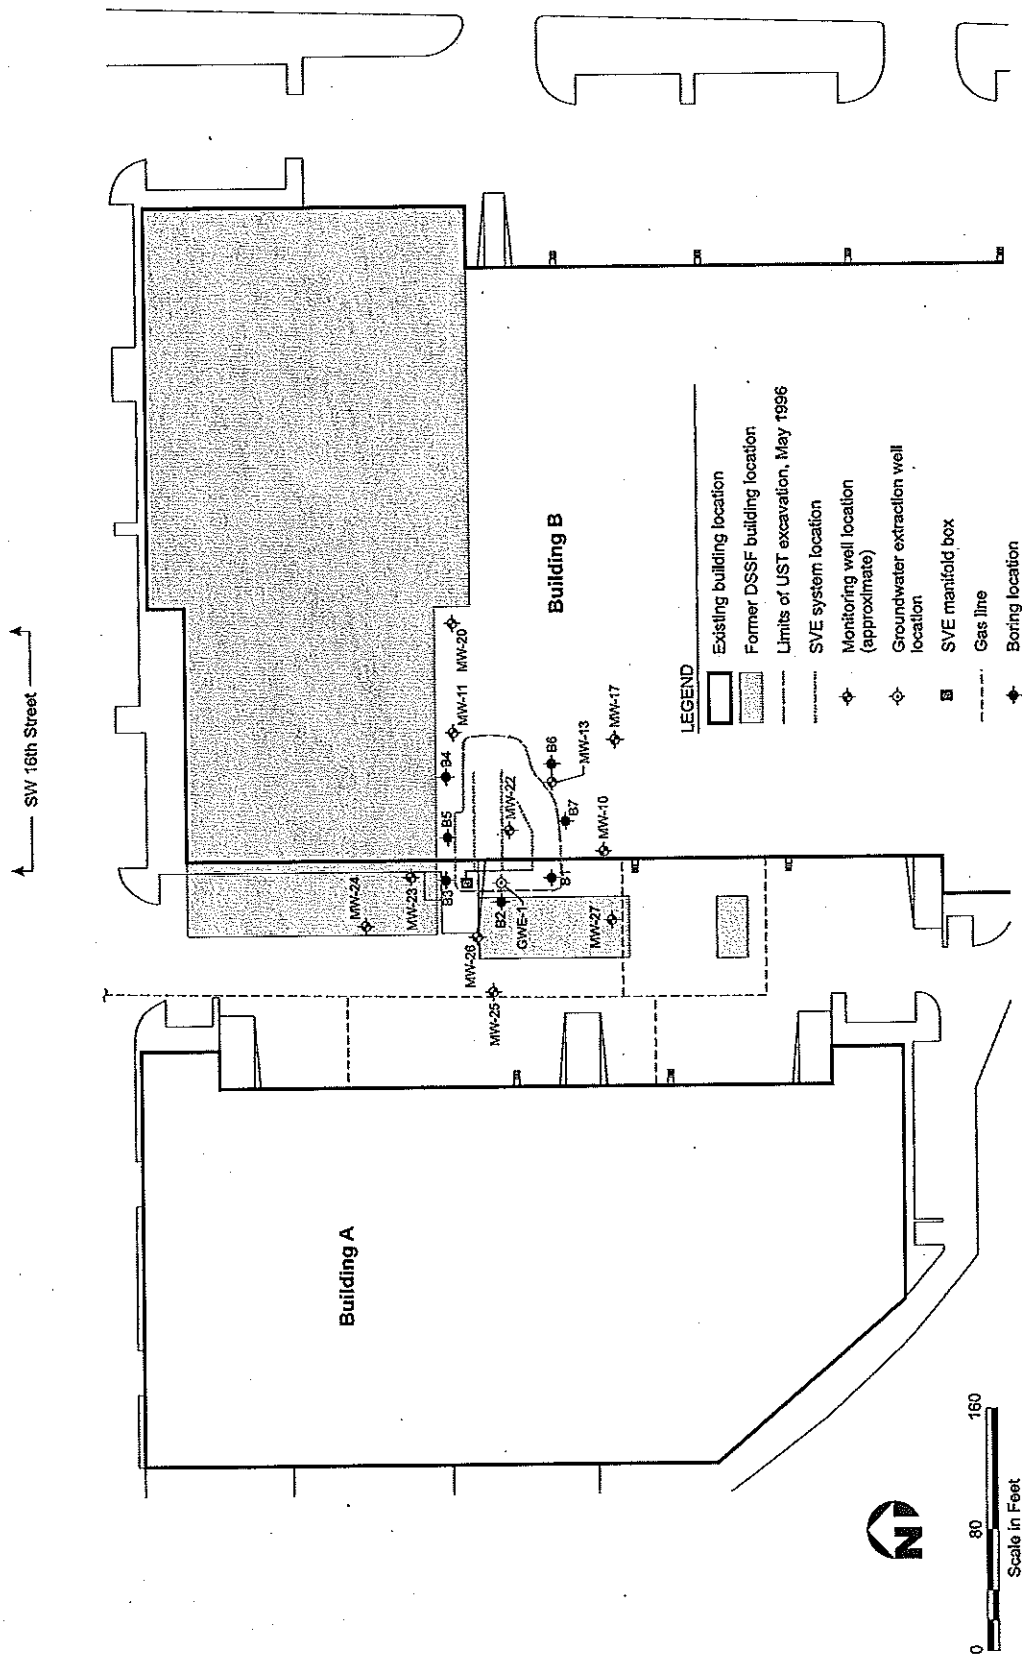
Figure 2

In 2010, seven soil borings (B1 through B7) were advanced around the perimeter of the area that had been excavated in 1991 to remove the UST. The soil borings were advanced in response to benzene exceedences above Method A in Site monitoring well MW-13 in 2008. The exceedences indicated that residual petroleum contamination may remain in native soil and be leaching to ground water. Soil borings B1 through B3 were drilled along the western edge of the former UST excavation. Borings B-4 through B7 were drilled within the warehouse along the northern perimeter of the former UST excavation where contaminated soil was reportedly left in place. Borings B-6 and B-7 were drilled adjacent to MW-13 which had benzene exceedences when last sampled in July and October 2008. The borings were drilled using direct push drilling methods and soil samples were collected continuously and field screened. Two soil samples per boring (from above and below the water table) were submitted for laboratory analysis for TPH-G and BTEX. TPH-G was detected in two borings at concentrations ranging from 5.1 to 45 mg/kg. Benzene and toluene were not detected. None of the 14 samples contained TPH-G or BTEX at concentrations exceeding Method A cleanup levels.

Soil Boring Locations
