April 2, 2014

Re: Draft Phase I Environmental Site Assessment Update
Cue Apartment Property
721 East Pine Street and 1523 Harvard Avenue
Seattle, Washington
19019-00

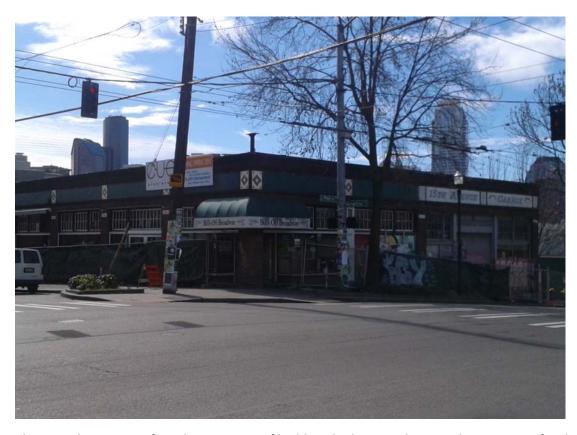
Photograph 1 – View of northeast corner of building, looking southwest. The entrances for the 15th Avenue Garage and Bill's Off Broadway can be observed behind the construction fencing.

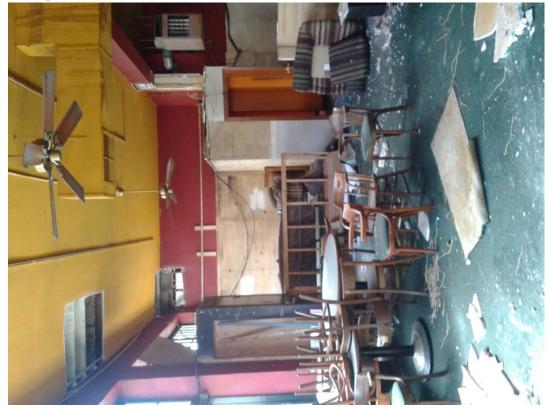
The interior of the restaurant contained furniture, a pizza oven, a natural gas furnace, and debris (Photograph 2). Holes were observed in the ceiling, and pieces of flooring material had

been removed as part of the HBM assessment. Mr. Cunningham stated that the remaining items had been left by the tenant, and were to be removed via sale or dumpster. No HBM material had been found within the restaurant.

Photograph 2 – Interior of Bill's Off Broadway restaurant. Note hole cut in ceiling for HBM testing and natural gas heater hanging from ceiling to the right of the photograph. ( $\leftarrow$  up)

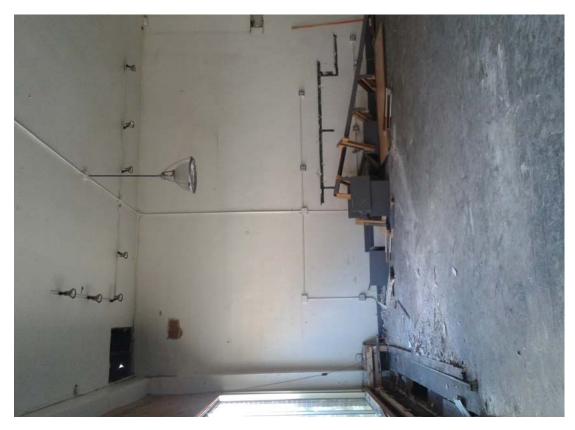
The motorcycle shop is empty, with only some shelving remaining (Photograph 3). Mr. Cunningham stated that the shop had been a custom motorcycle dealer which refurbished and sold motorcycles. There were no floor drains observed, and the concrete floor was in good condition. A trench had been cut in the floor along the east wall to access the soil beneath the building. Mr. Cunningham stated that no obvious environmental issues had been observed in the trench, but no soil samples had been collected.

Photograph 3 – Interior of Red Label Moto space. Note the trench cut in the floor on the left side of the photograph. ( $\leftarrow$  up)

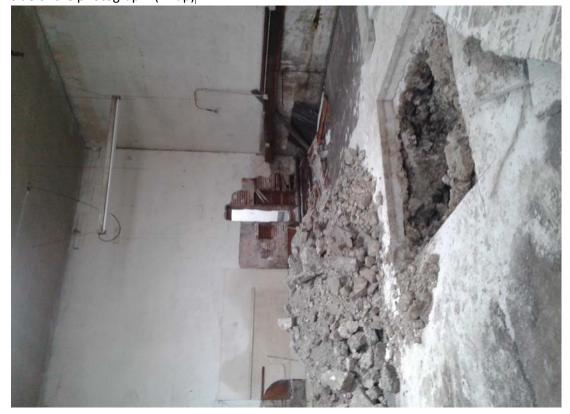
Photograph 4 – Interior of 15th Avenue Garage, looking east. Note the hole cut through the wall into the Red Label Moto space. A test pit and excavated rubble can be observed in the foreground. ( $\leftarrow$  up)

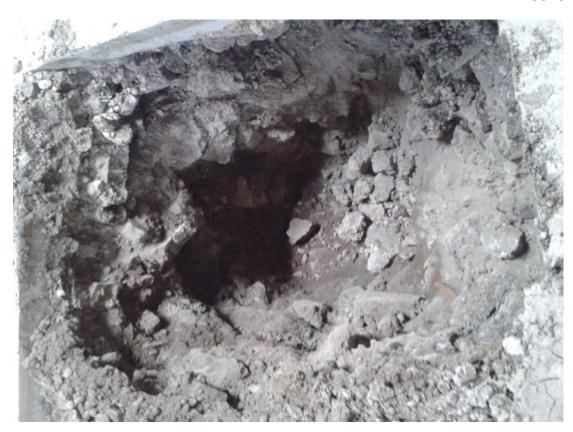
One test pit, at the south end of the building, had been excavated to about eight feet below the floor. The material in the test pit consisted of rubble, including bricks, concrete blocks, soil, and boulders (Photograph 5). The second test pit was located along the west wall, in the northern half of the garage (Photograph 6). This material in this test pit was mainly gravelly soil, with some brick and a large metal bolt. Mr. Cunningham stated that no obvious environmental impacts such as odors or sheens were observed in either hole, and therefore no environmental samples were collected. He also stated that Exxel Pacific, the general contractor for the adjacent Former BMW construction site, had excavated by shovel in the second test pit to locate the base of the wall. This small, deeper hole within the test pit also did not show any signs of environmental impacts.

Photograph 5 – Test pit at south end of 15th Avenue Garage, showing rubble below concrete floor to a depth of approximately 8 feet. (← up)

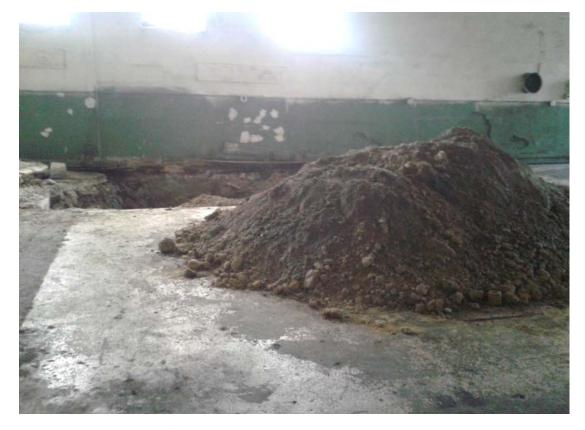
Photograph 6 – Interior of 15th Avenue Garage, showing second test pit along west wall. Excavated material is predominantly soil.

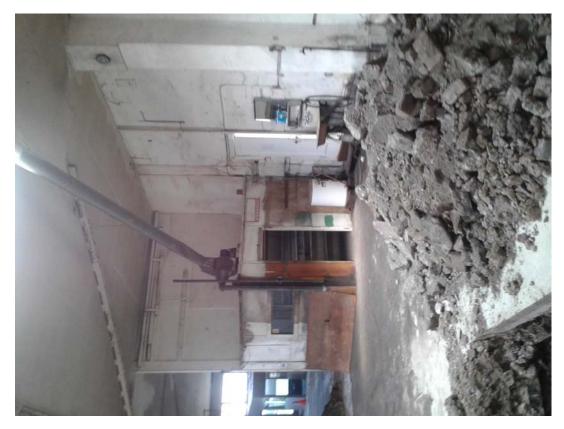
A hole had been cut into the northwest ceiling of the garage for the HBM assessment. Some of the ceiling material had been left on the garage floor, and appeared to be fire-damaged. An exhaust fan and piping remained (Photograph 7) that vented exhaust to the roof. Some pipes were observed entering the ground at the restroom and washup sink area. There were large cracks in the floor of the building. No hydraulic lifts were observed. Shelving in the storage area was empty, and no hazardous materials were observed.

Photograph 7 – Interior of 15th Avenue Garage, showing exhaust fan piping to roof, rubble from south test pit, and empty storage shelves. (← up)

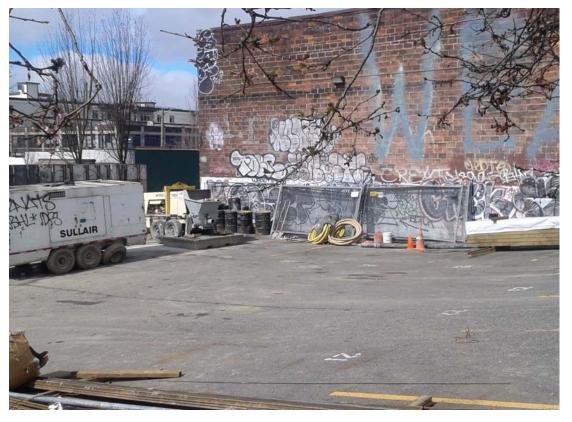
Five 55-gallon drums are stored in the parking lot along the south wall of the building. The drums are labeled as "Non-Hazardous Soils." The drums apparently contain soil cuttings from the geotechnical borings conducted on the parking lot in 2013. The soils are to be disposed of with other soils from the property during redevelopment.

The parking lot was accessed through a gate in the fence. The parking lot is currently being used to store construction materials such as lumber and fencing for Exxel Pacific. A portable generator was stored on the lot along with five 55-gallon steel drums (Photograph 8). The drums are labeled as Non-Hazardous Soils and apparently contain soil cuttings from the geotechnical investigation conducted on the property. The soils are to be disposed of during redevelopment.

Photograph 8 – View of parking lot and south wall of building, looking north. Note five 55-gallon drums containing soil cuttings against building wall.

No recommendations.

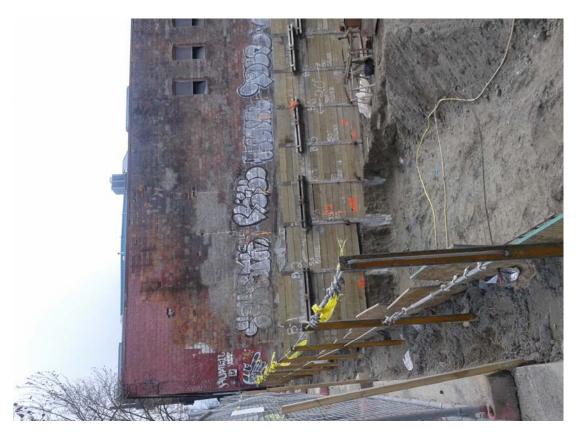
The perimeter of the property was observed. The building was blocked by construction fences, and graffiti was prevalent on the fencing and building façade (Photographs 9 and 10). No vent pipes or fill ports were observed. No transformers were observed, but a portable generator belonging to Exxel Pacific was stored in the parking lot. No monitoring wells were observed on the property, but the patches for the locations of former soil borings could be seen in the parking lot.

To the south and west is the active construction site of the Former BMW Seattle (Photograph 9). The site was observed through the fence. Next to the west side of the property, the excavation extended approximately 16 to 20 feet below grade. Wood lagging was observed below the brick wall of the subject property, and cement or grouting was backfilled behind the lagging. Heavy equipment including excavators, trucks, and graders were observed in the excavation. Soil was being excavated and loaded onto trucks for removal.

Photograph 9 – View of west wall of building, looking east. Former BMW construction site is in foreground. ( $\leftarrow$  up)

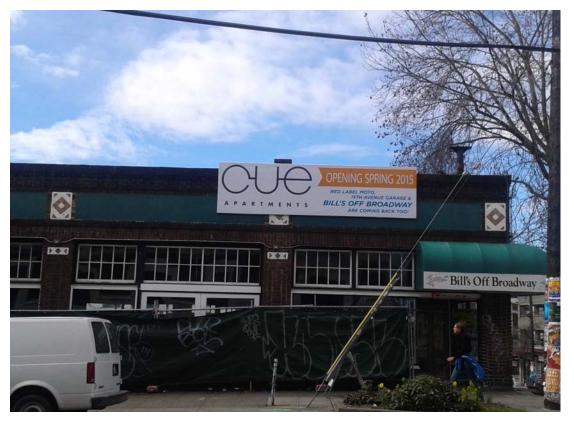
Photograph 10 – View of east wall of building, looking west.
