STATE OF WASHINGTON  
DEPARTMENT OF ECOLOGY

**Re: No Further Action at the Following Site:**

- **Name:** BMW Seattle Pike Street
- **Address:** 714 E. Pike / 715 E. Pine Street, Seattle, WA
- **Facility/Site No.:** 33641566
- **CS ID:** 1055
- **VCP No.:** NW2618

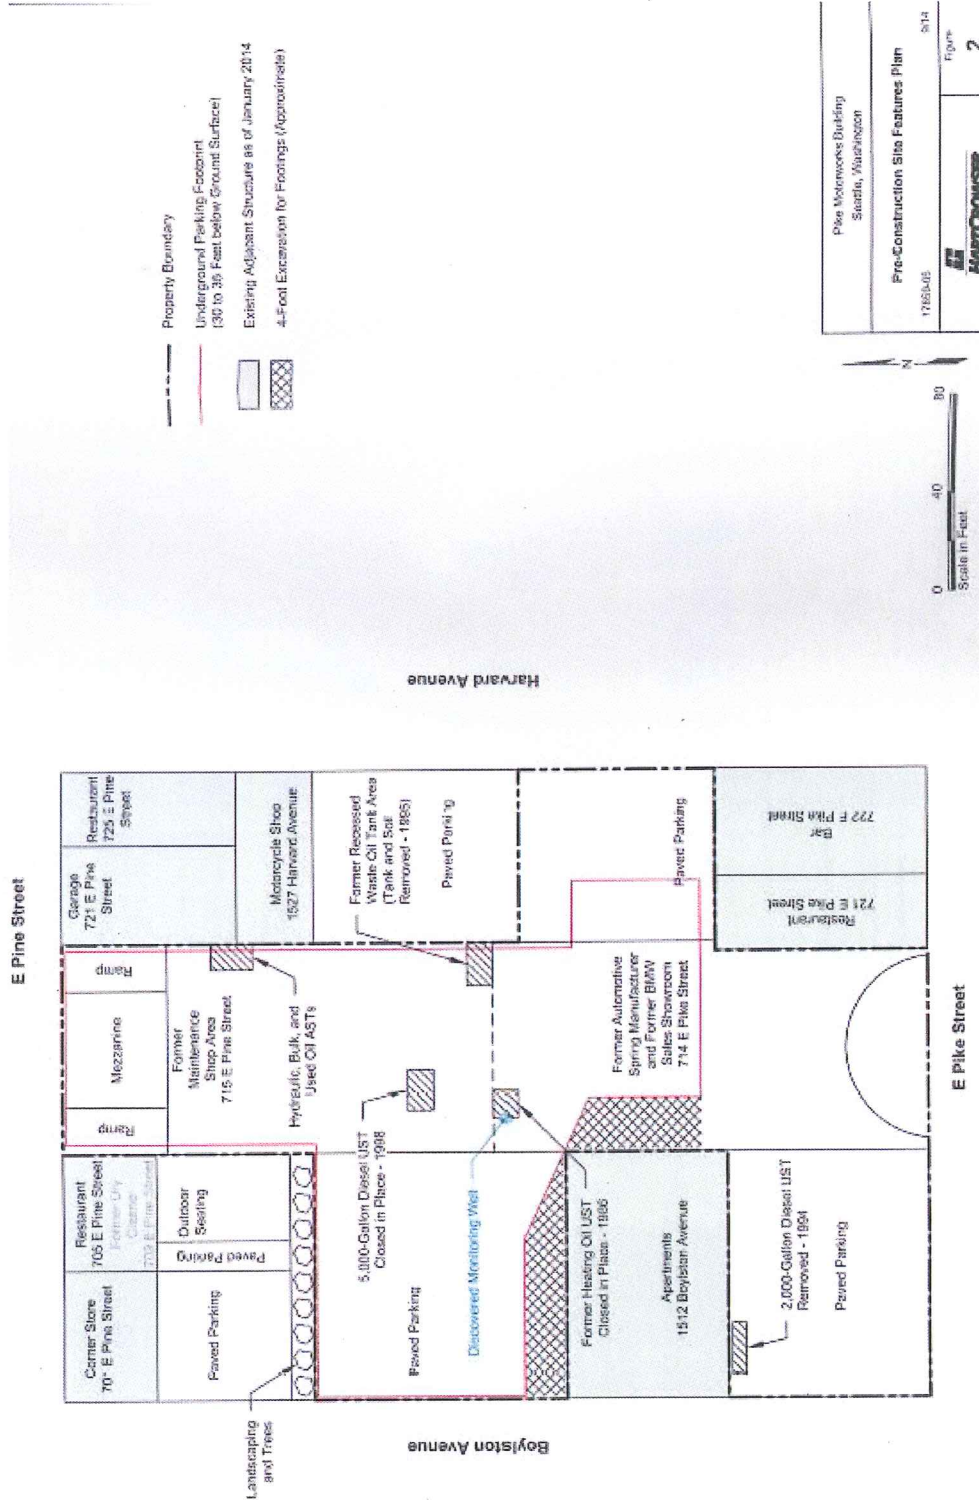
**Figure 2 A Site Plan Showing USTs and Soil Excavation at the Site**

- a. The above-ground hydraulic life and all (four) the gasoline, diesel, waste and heating-oil USTs were removed and appropriately disposed of off-Site.

- b. The petroleum hydrocarbon-, lead- and cadmium-contaminated soils exceeding MTCA Method A cleanup levels were excavated; a total of approximately 20,600 tons was disposed of off-Site. The follow-up soil confirmation sample analysis concluded that completion of soil removal to undetectable, or below MTCA Method A cleanup levels was achieved.

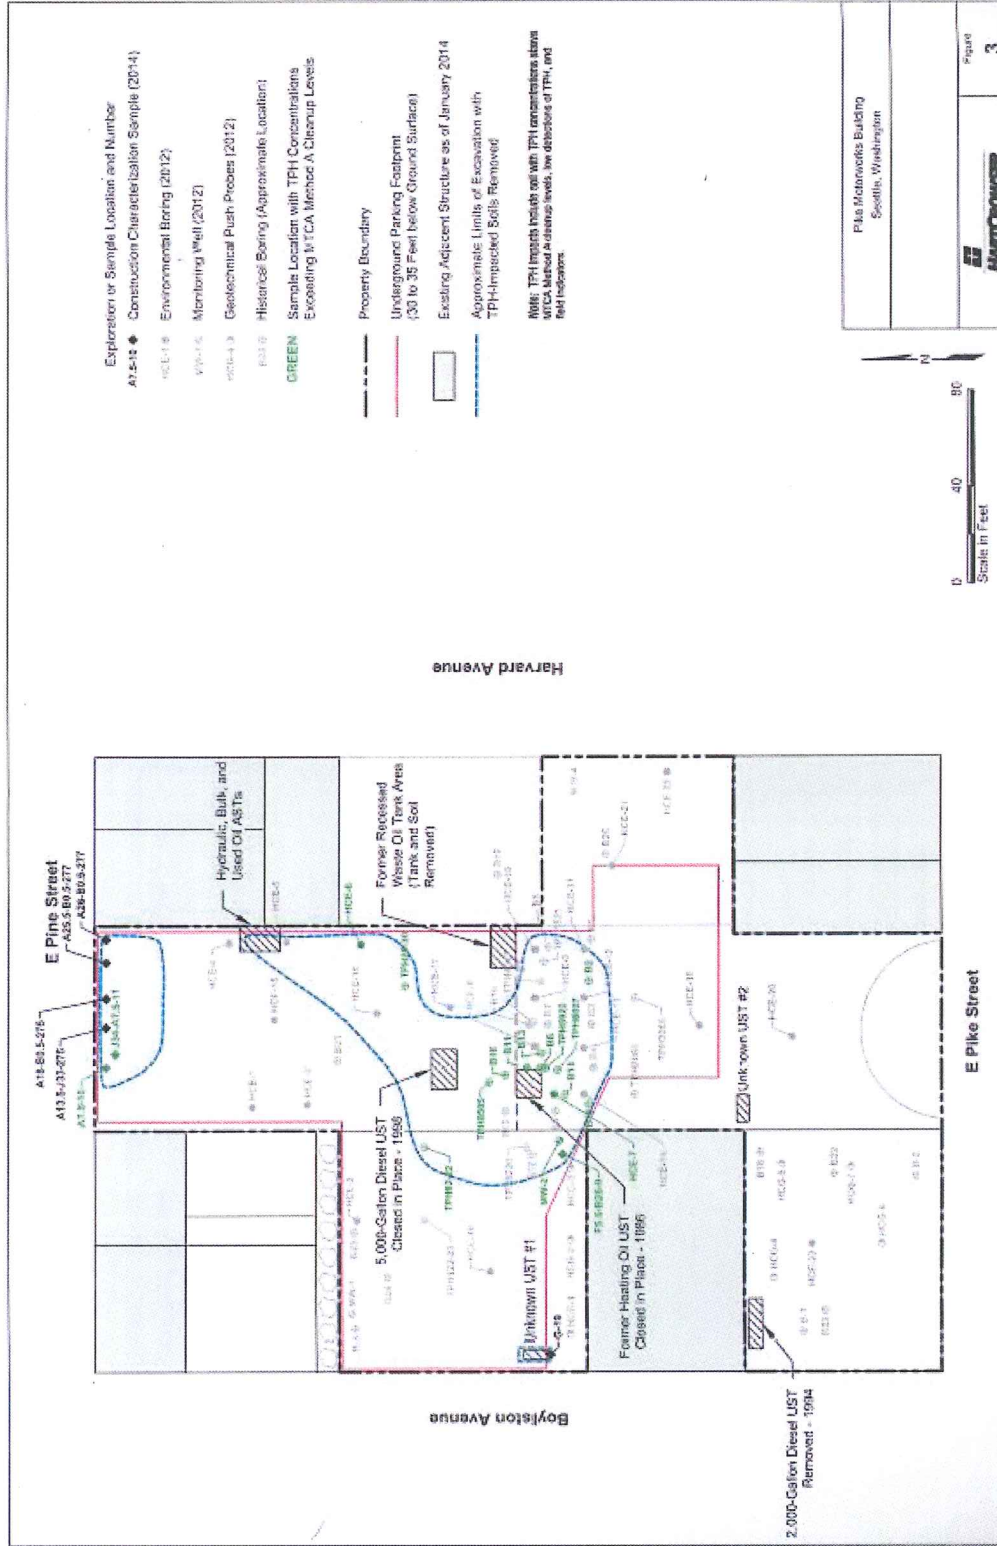
**Figure 3 A Site Plan Showing Soil and Ground Water Sampling Locations at the Site**

- c. The laboratory analysis results of the soil collected from base of the excavation, to a depth of 40 feet bgs, and at the sidewalls confirm that impacted soil at concentrations exceeding MTCA Method A cleanup levels has been cleaned up at this Site.
- d. The laboratory analysis results of ground water samples collected from two monitoring wells confirmed that all the COCs discovered in soil were at non-detectable concentrations at the laboratory reporting limits or below MTCA Method A cleanup levels at this Site.

- c. Laboratory results of samples collected from two Site monitoring wells also demonstrated the ground water was not impacted due to releases of the historical operations at this Site. The monitoring wells were advanced up to approximately 55 feet bgs, one at the central area and another down gradient of the Site. The purpose of the sampling was to determine if the ground water was contaminated due to releases of the facility's operations.
