Subject: As-Built Report
Shoreline Habitat Restoration
Irondale Iron and Steel Plant
Irondale, Washington
File No. 0504-042-02

Irondale Iron and Steel Plant
Shoreline Habitat Restoration
Jefferson County, Washington

File No. 0504-042-02

November 17, 2014

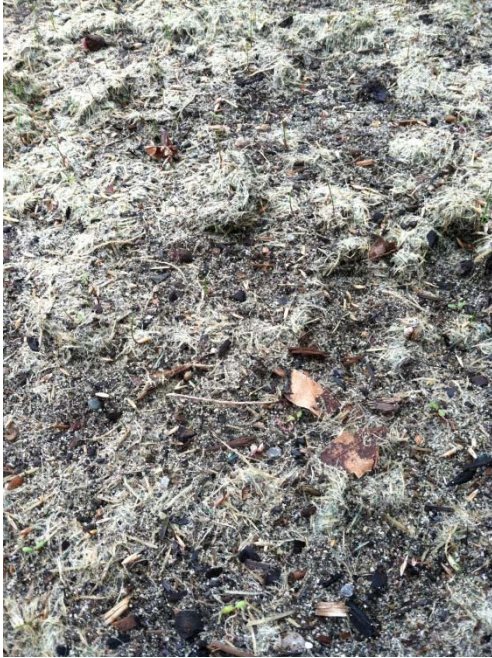
Photograph 1
Hydroseed area of upland soil cap showing new germination.

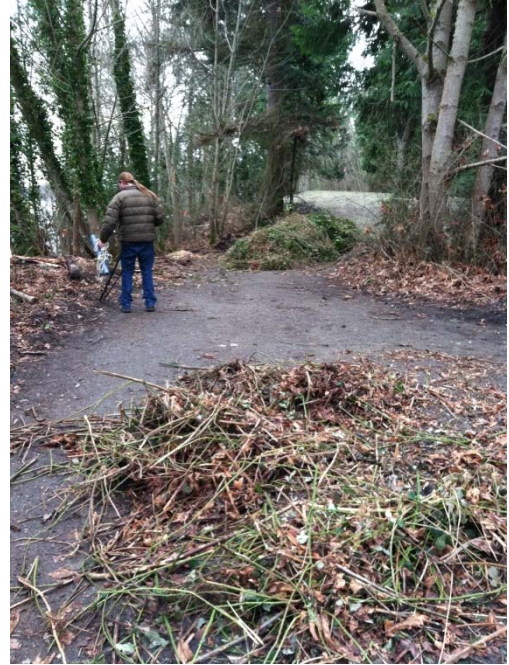
Photograph 2
Volunteer-labor invasive species removal was conducted following environmental remediation.

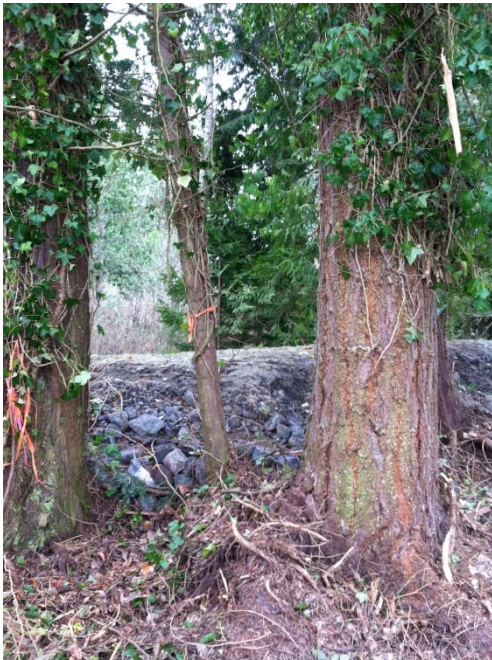
Photograph 3
Invasive species removal included Himalayan blackberry and English ivy.

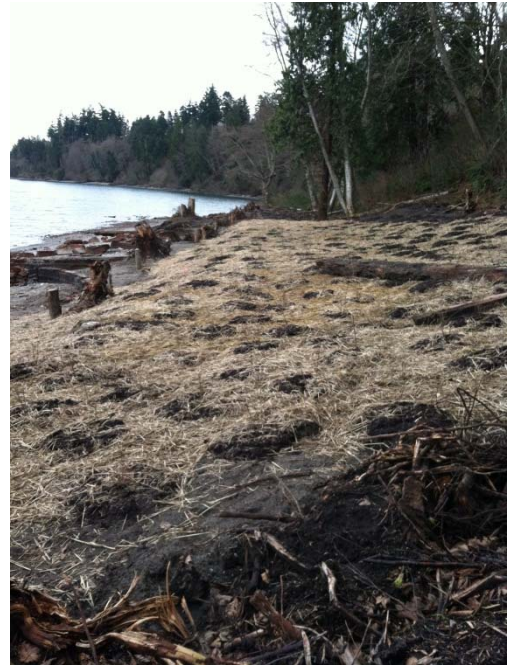
Photograph 4
View south of plantings and LWD root wads around historic kiln site.

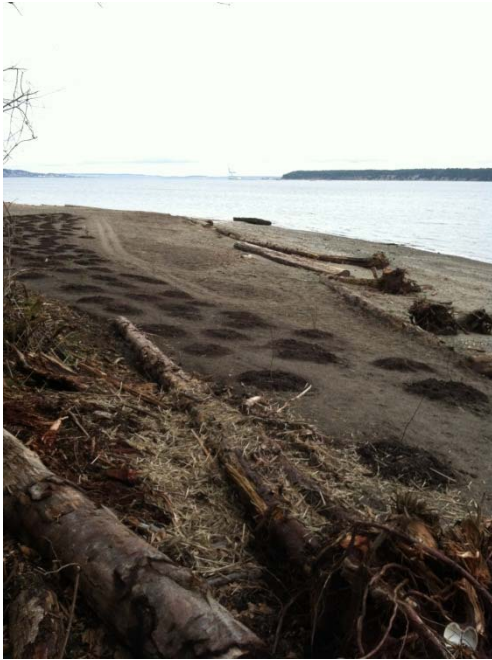
Photograph 5
View north of transition from shoreline tree/shrub plantings to backshore dunegrass. Recent ATV tracks visible in dunegrass area.

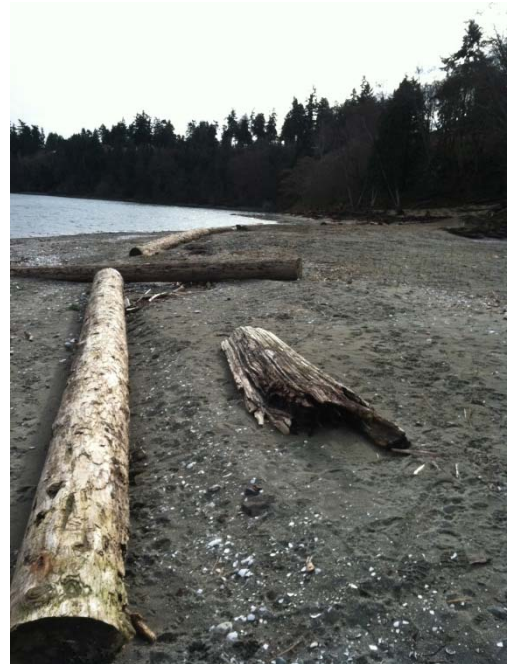
To protect the newly graded shoreline and increase the habitat value of restored areas, LWD was installed along the newly defined OHW. A total of 52 logs were counted along OHW during the February site visit. Overall the wood appeared to be firmly in place and performing as expected. It was noted that several gaps exist along the line of installed logs, probably resulting from recent king tides that occurred following installation. Shoreline LWD can be viewed in pages 2 and 3 of Appendix A and plan diagrams found in Appendix B.

Photograph 6
Shoreline LWD viewed south toward historic kiln area.

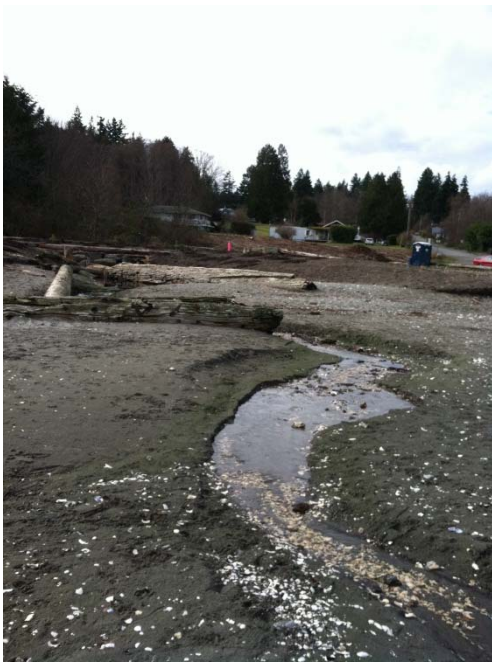
Photograph 7
Lower (restored) section of the southern drainage swale.

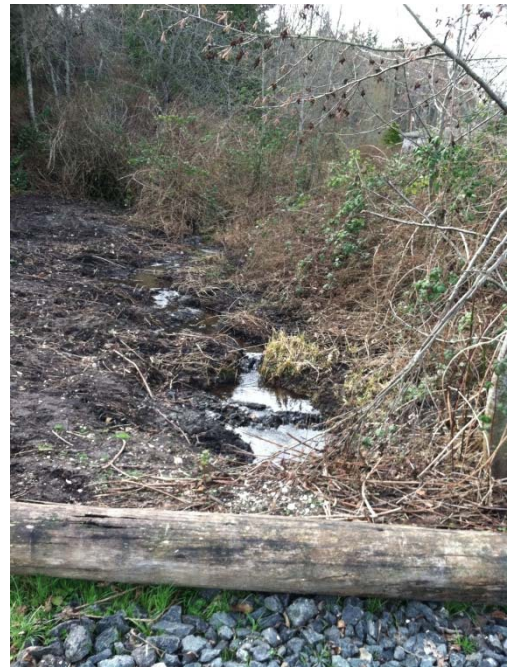
Photograph 8
Upstream of the restored portion of the southern drainage swale. Some invasive species removal evident to the left (southeast).

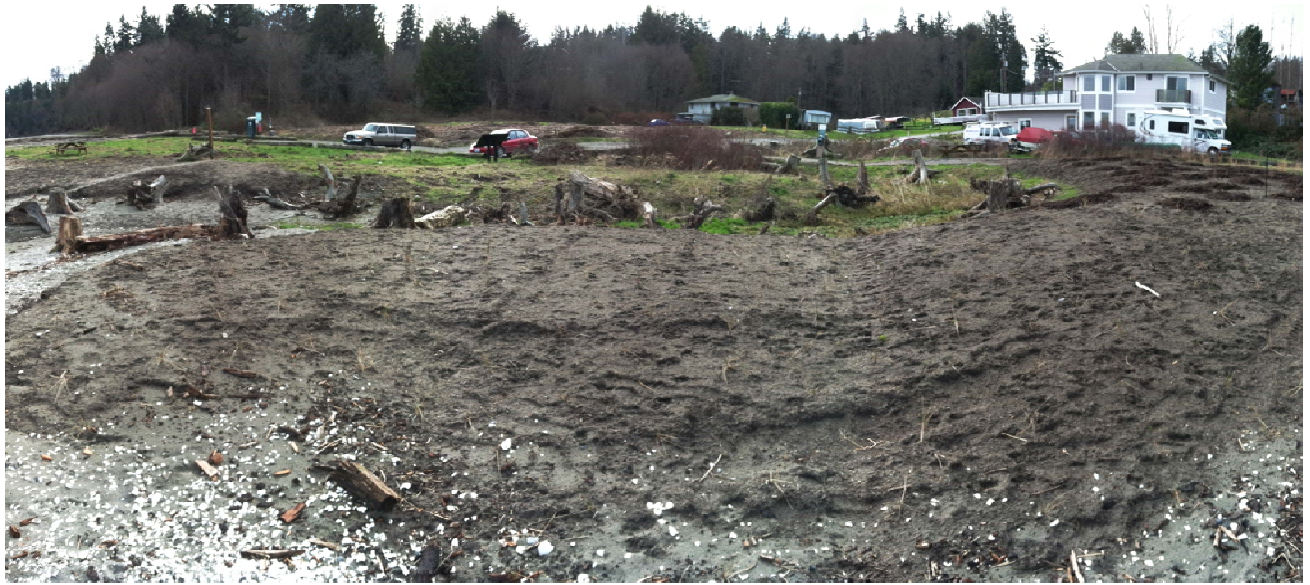
Photograph 9
Restored portion of the northern drainage swale
viewed from the north.

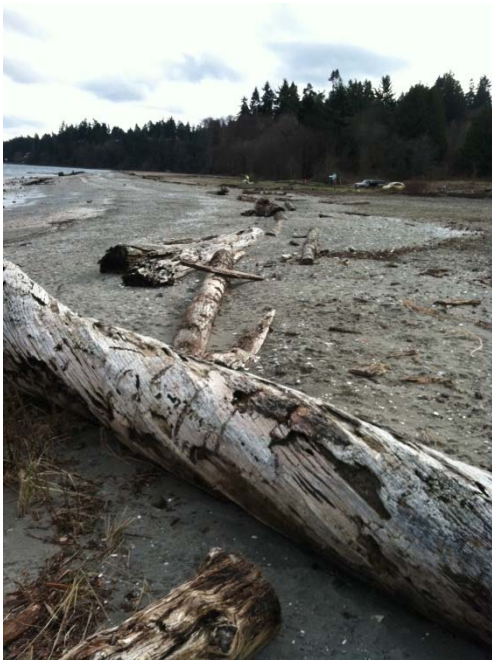
Photograph 10
View south from the northern extent of shoreline
LWD installation.

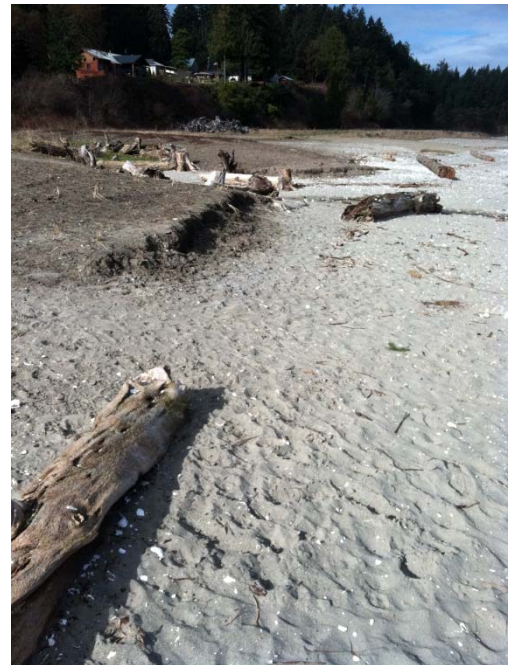
Photograph 11
King tides following shoreline LWD installation
resulted in several logs being relocated.

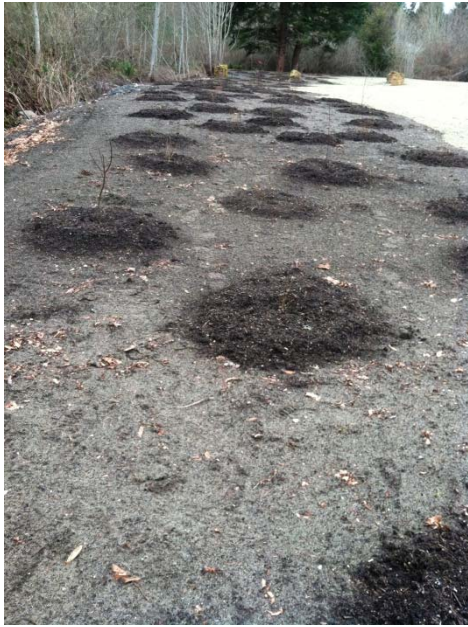
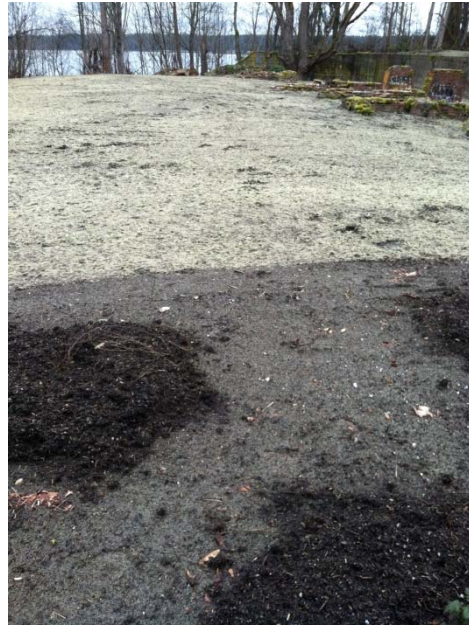
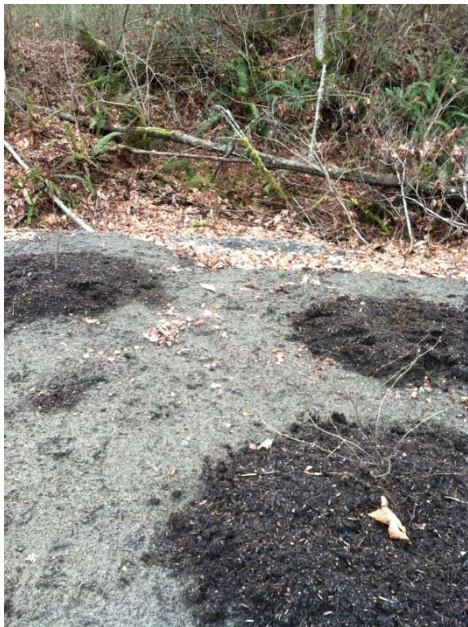
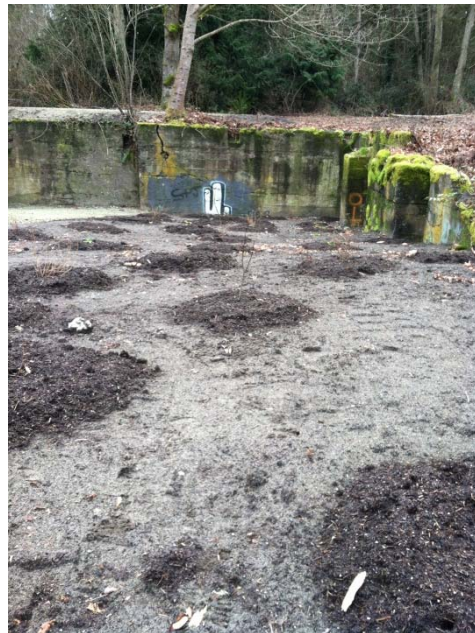
Site Photographs Monitoring Station 1

Monitoring Station 1 is located in the southern portion of the larger upland soil cap within the hydroseed and shrub planting areas (Figure 2). Photographs were taken facing the Northwest, Northeast, Southeast and Southwest to better align with local conditions (Appendix A). Plant species and quantities are presented below in Table 3 and the canopy cover values in Table 4. Overall, shrubs appeared to be in good health following planting. Signs of new buds sprouting were noted on several plants.

No invasive, volunteer, or recruited species have yet colonized this monitoring station. Mole and canine presence were noted in the surrounding area, as were sightings of crows, seagulls and robins.

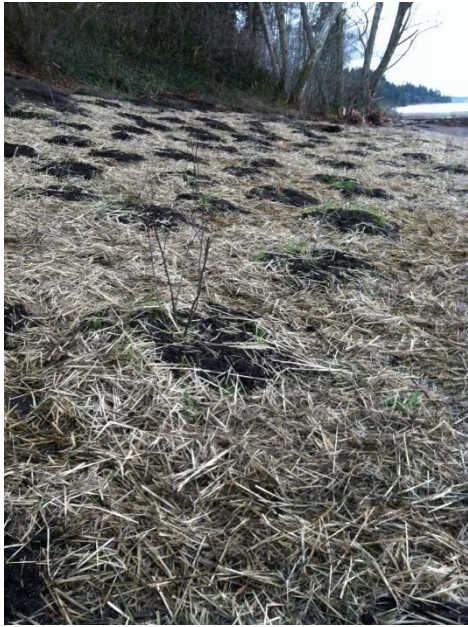
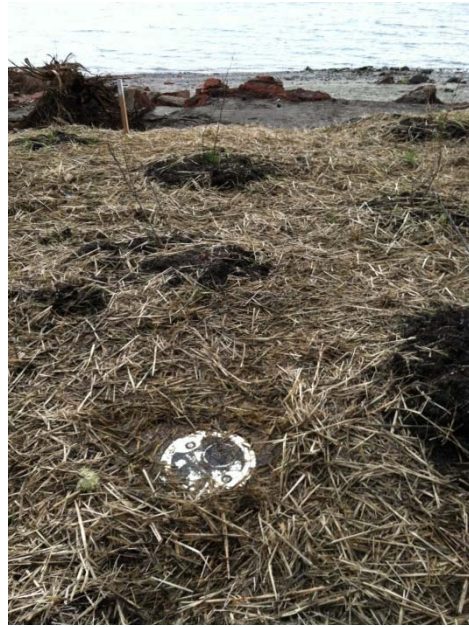
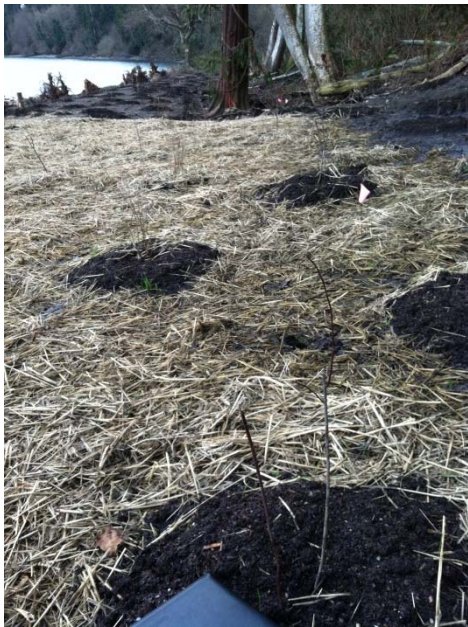
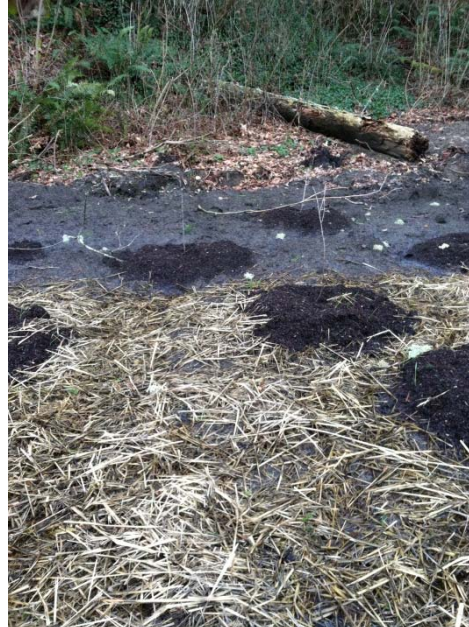
Site Photographs Monitoring Station 2

No invasive or recruited species have yet occurred within this monitoring station. Grass was noted growing through the mulch around some plantings. Seagulls were active in this area.

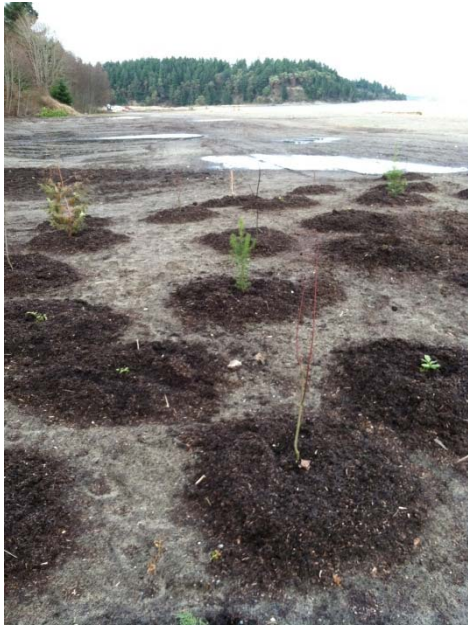
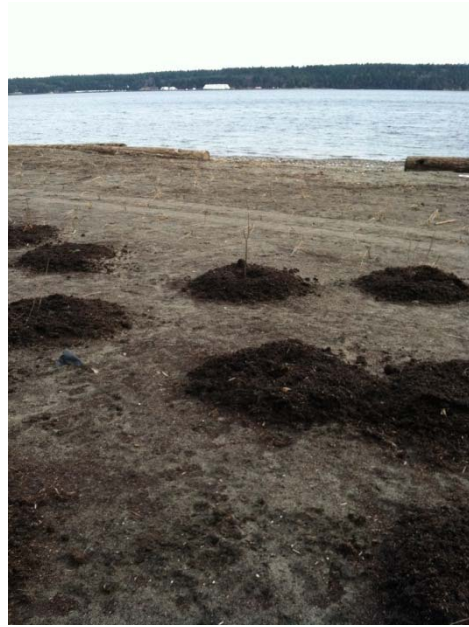
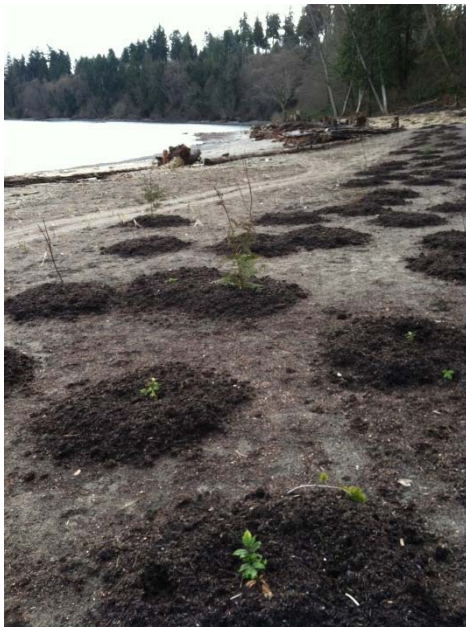
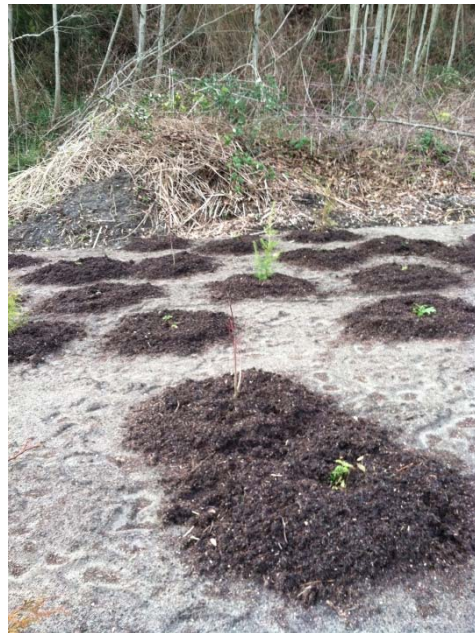
Site Photographs Monitoring Station 3

Monitoring Station 3 is located in the southern portion of the site, where upland tree/shrub plantings transition from to dune grass (Figure 2). Photographs were taken aligned with the shoreline, approximately North, South, East and West (Appendix A). LWD has been placed along OHW near this monitoring station. The plant species and quantities are presented below in Table 7 and the canopy cover values in Table 8. Overall, trees and shrubs appeared to be in good health following planting. Signs of new buds sprouting were noted on several plants.

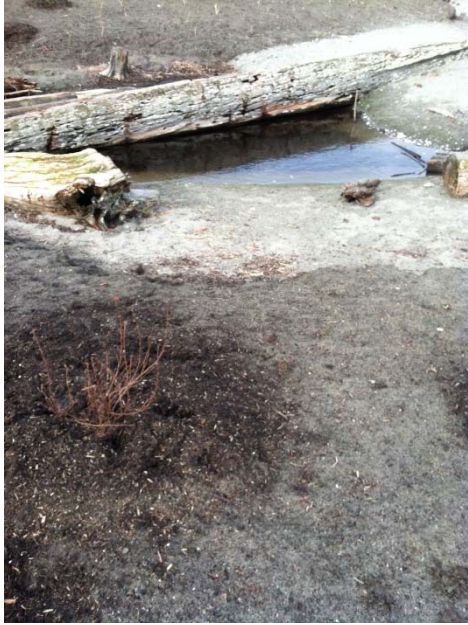
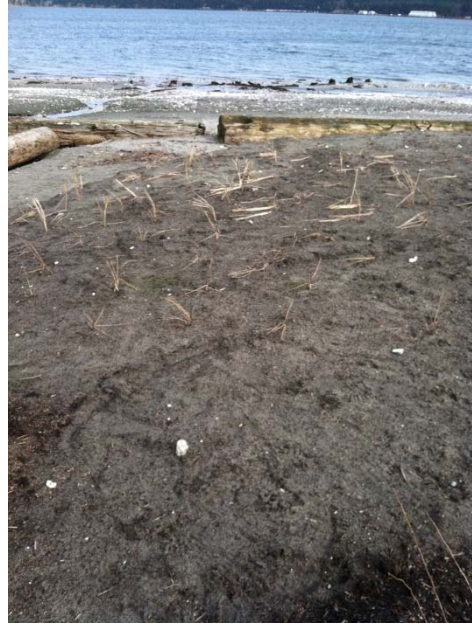
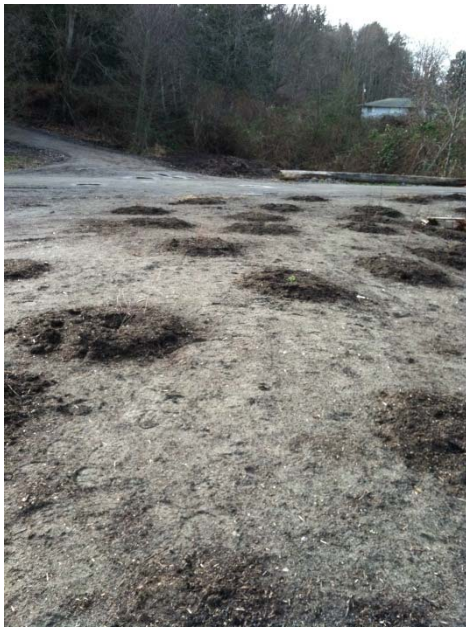
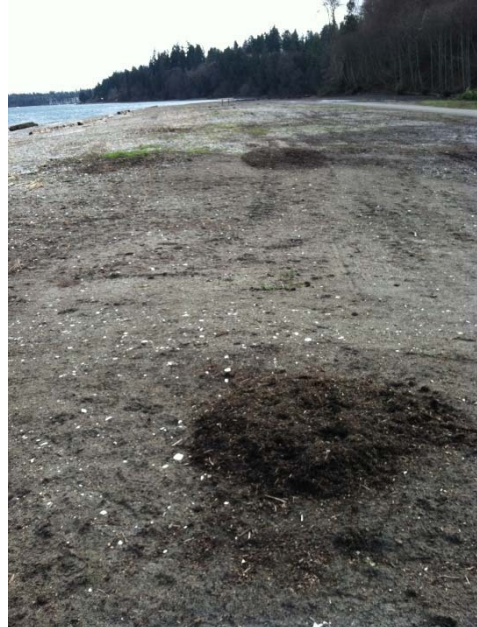
Site Photographs Monitoring Station 4

Monitoring Station 4 is located on the south side of a small drainage swale southeast of the parking area (Figure 2). The plot encompasses both shrub plantings and dune grass areas. Photographs were taken aligned with the shoreline, approximately Northeast, Southeast, Southwest and Northwest (Appendix A). LWD has been placed along OHW near this monitoring station. The plant species and quantities are presented below in Table 9 and the canopy cover values in Table 10. Overall, shrubs appeared to be in good health following planting. Signs of new buds sprouting were noted on several plants.
