Subject: Year-One Post-Construction Monitoring Report  
Shoreline Habitat Restoration  
Irondale Iron and Steel Plant  
Irondale, Washington  
File No. 0504-042-02

**Year-One Post-Construction  
Monitoring Report**

Irondale Iron and Steel Plant  
Shoreline Habitat Restoration  
Jefferson County, Washington

**File No. 0504-042-02**

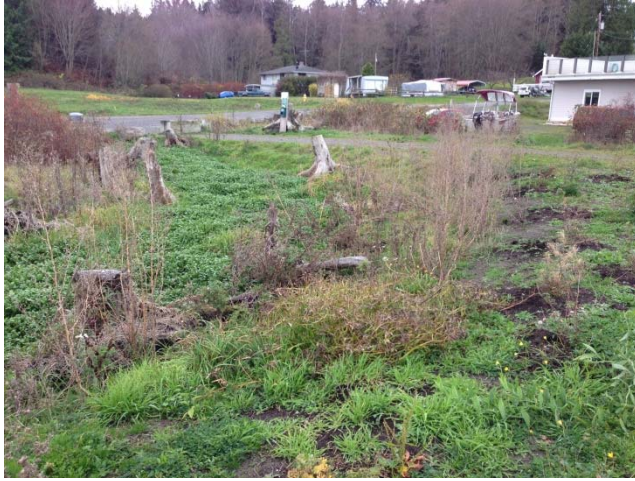
Photograph 1  
Northern drainage swale.

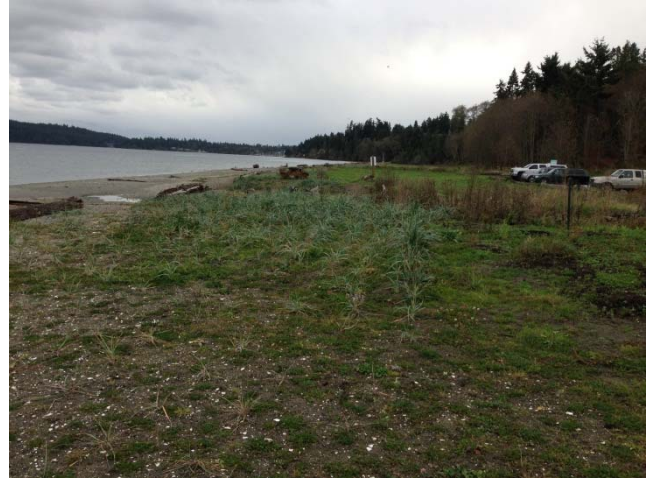
Photograph 2  
Dunegrass plantings in northern portion of restoration area.

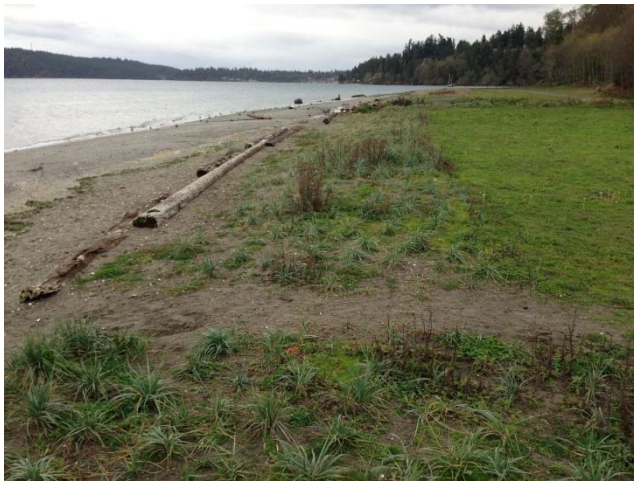
Photograph 3  
Shoreline LWD in northern portion of restoration area looking south.

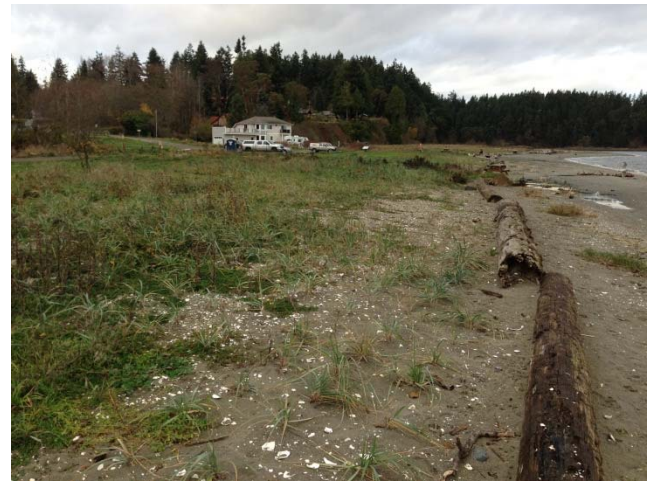
Photograph 4  
Shoreline LWD in northern portion of restoration area looking North.

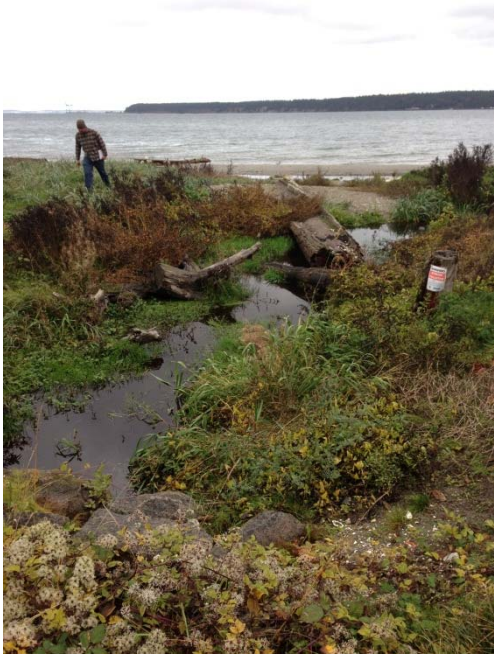
Installed plants appeared healthy and the dunegrass was observed to be actively spreading via rhizomes. This drainage was also previously dominated by Himalayan blackberry, which has been removed, preserving large patches of native rose and emergent vegetation. However, Himalayan blackberry is aggressively reestablishing in this portion of the site and will require frequent removal to allow native plants to become established. Seagulls and a red-tailed hawk were active in this area during the monitoring event.

Photograph 5  
Southern drainage swale.

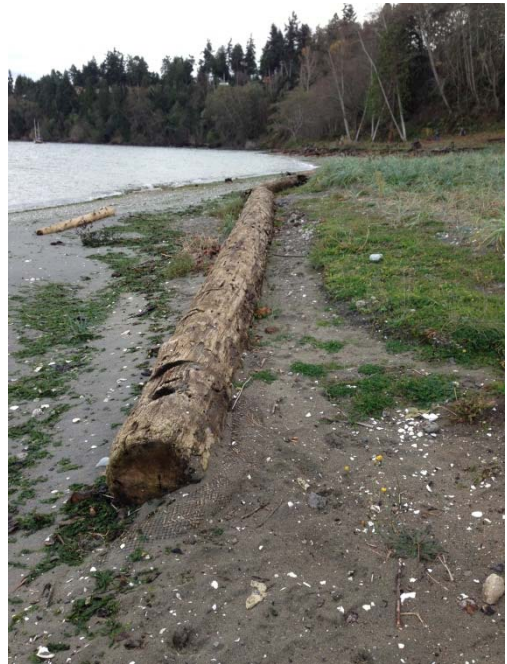
To protect the newly graded shoreline and increase the habitat value of restored areas, LWD was installed along the newly defined OHW. A total of 59 logs were observed along OHW during the year-one monitoring event. Overall the wood appeared to be firmly in place and performing as expected. The increase of nine pieces of LWD during the year-one monitoring event is attributed to recruitment of additional wood during extreme high tide events with easterly winds.

Photograph 6  
Shoreline LWD looking south from central portion of restoration area.

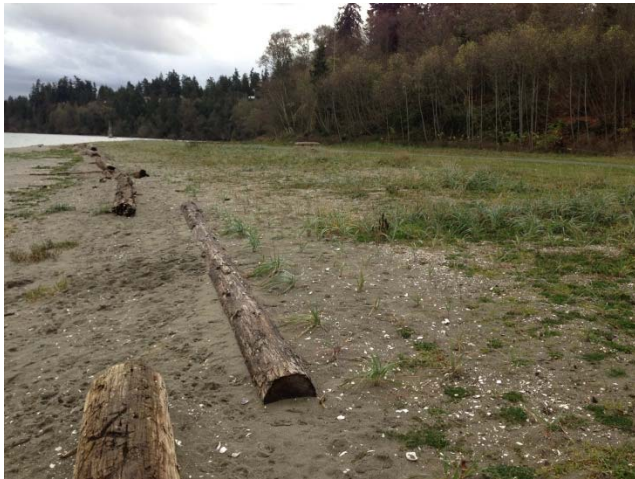
Photograph 7  
Shoreline LWD and backshore dunegrass area looking south.

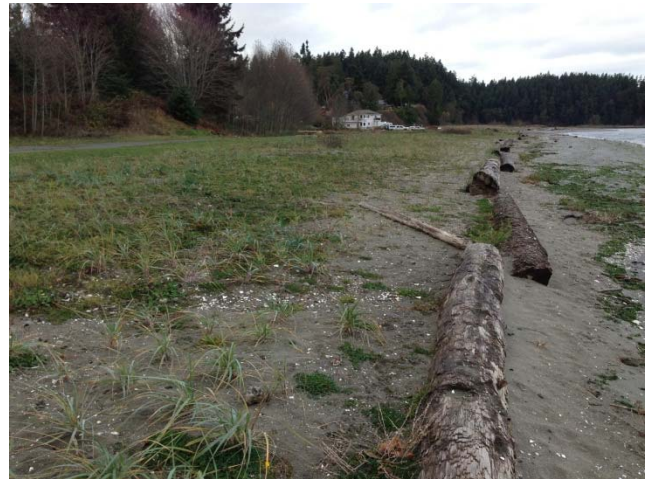
Photograph 8  
Shoreline LWD and backshore dunegrass area looking north.

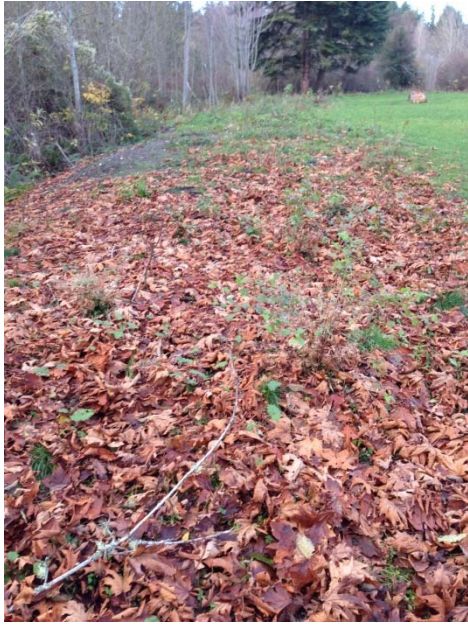
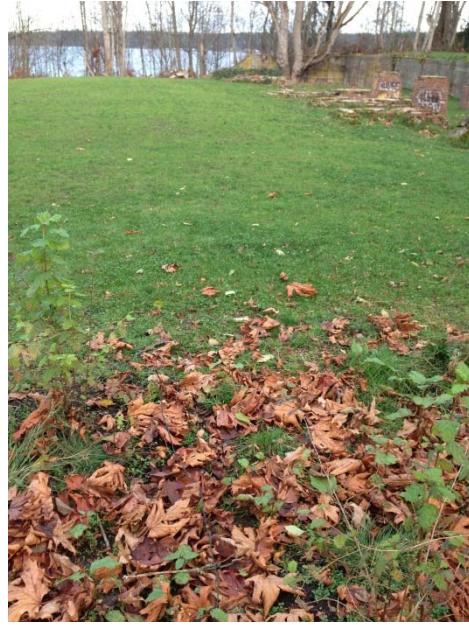
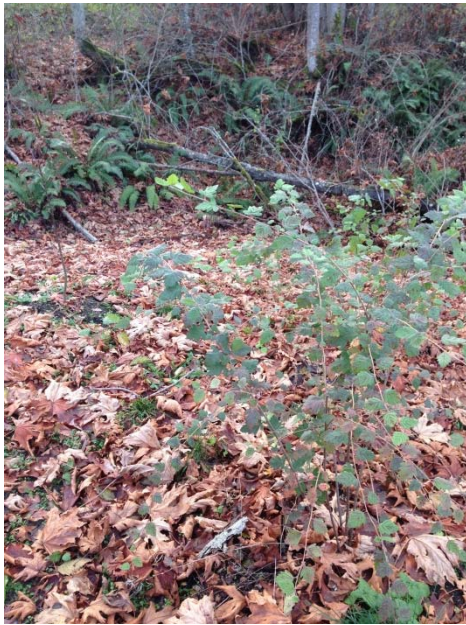
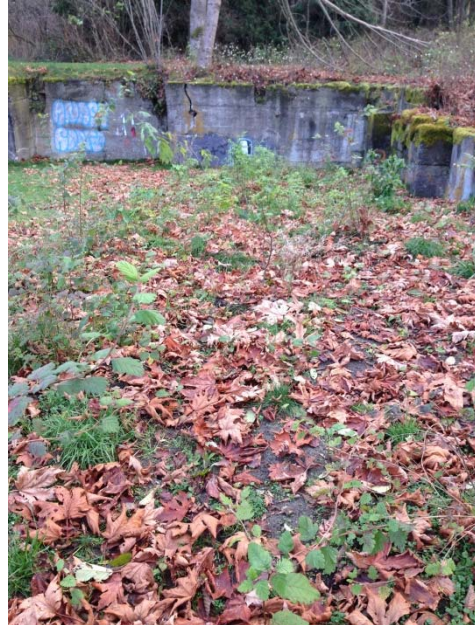
Plant health was observed to be good at Monitoring Station 1 with vigorous growth observed on the oceanspray (*Holodiscus discolor*). Six fewer vine maple (*Acer circinatum*) were observed during the year-one monitoring event as compared to the as-built monitoring event. No indications of these plants were found and appeared to have been intentionally removed. However, the high quantities of new volunteer red alder (*Alnus rubra*) and big leaf maple (*Acer macrophyllum*) will provide adequate vegetation of this portion of the restoration area. No invasive species were observed at this monitoring station.

Photograph 9  
Monitoring Station 1 looking northwest.

Photograph 10  
Monitoring Station 1 looking northeast.

Photograph 11  
Monitoring Station 1 looking southwest.

Photograph 12  
Monitoring Station 1 looking southeast.

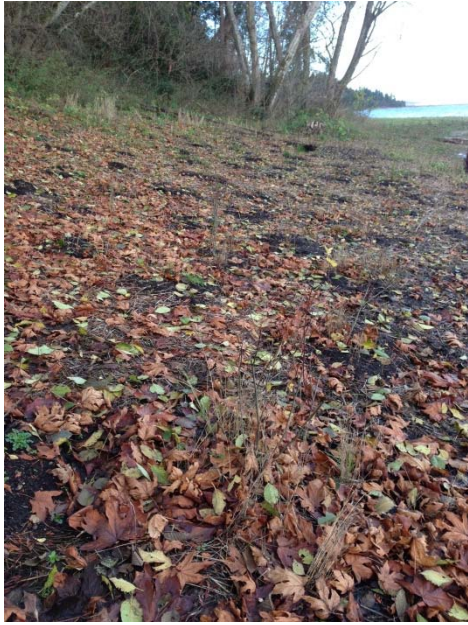
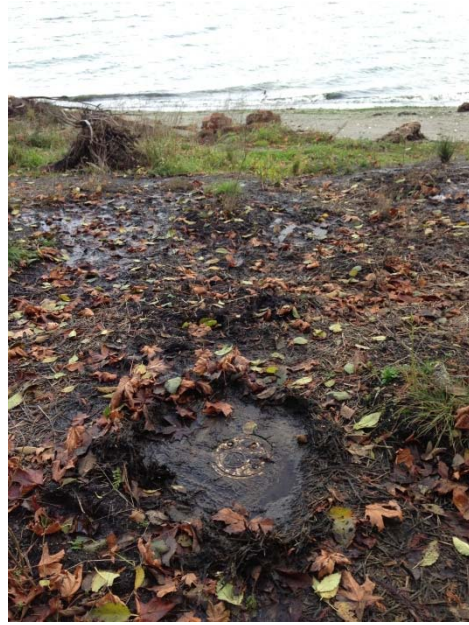
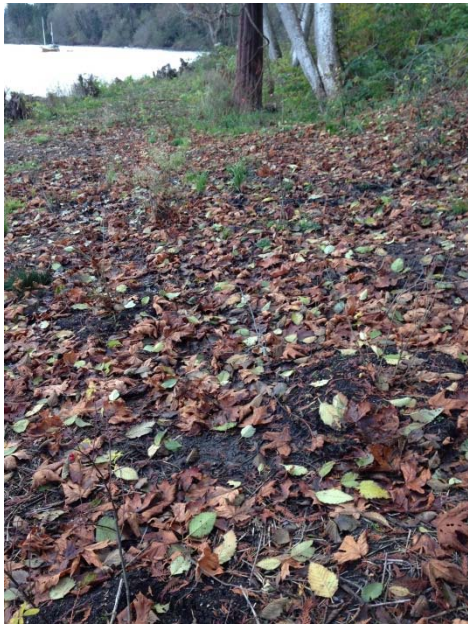
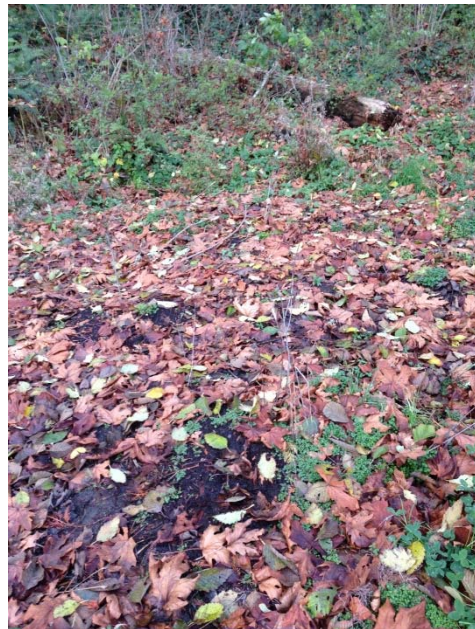
Monitoring Station 2 is located in an area with significant moisture, likely originating from hillside seeps and perched groundwater. The installed plants were observed to be healthy and new growth was visible on several plants. Herbaceous ground cover has become established within the sample plot, consisting primarily of creeping buttercup (*Ranunculus repens*). Few invasive species were observed at Monitoring Station 2; however, Himalayan blackberry and English Ivy were observed outside the sample plot, which will require removal to prevent reestablishment of these species.

Photograph 13  
Monitoring Station 2 looking north.

Photograph 14  
Monitoring Station 2 looking east.

Photograph 15  
Monitoring Station 2 looking south.

Photograph 16  
Monitoring Station 2 looking west.

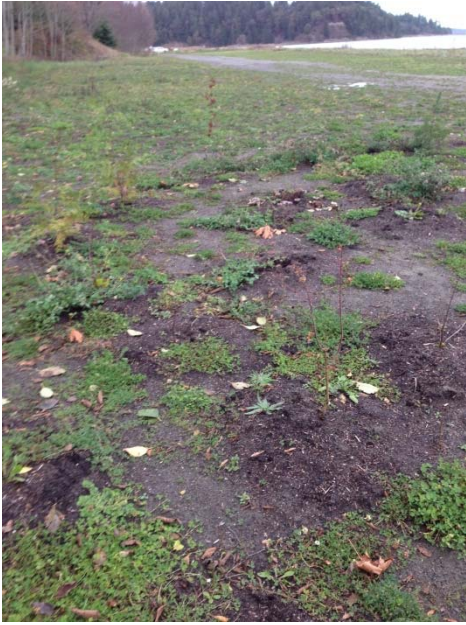
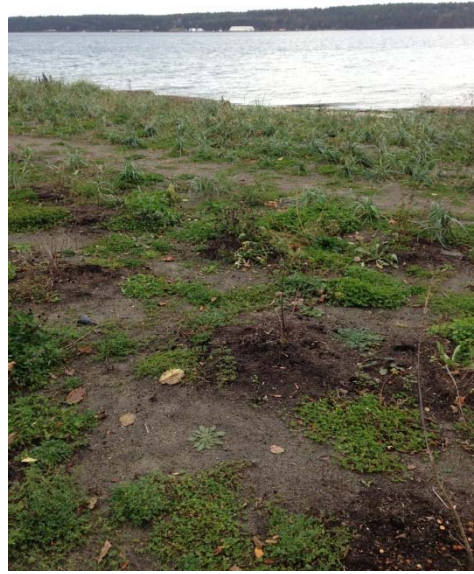
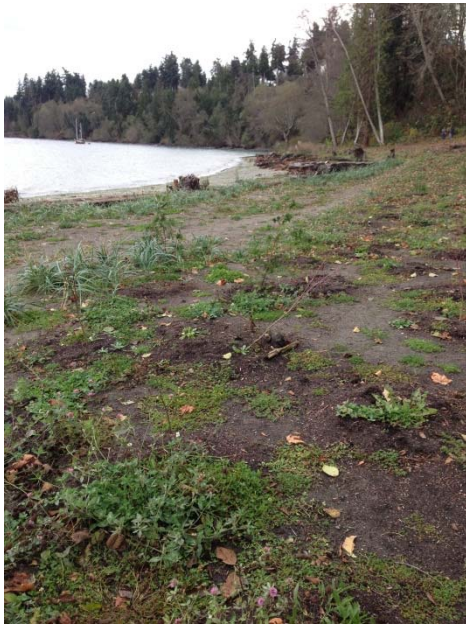
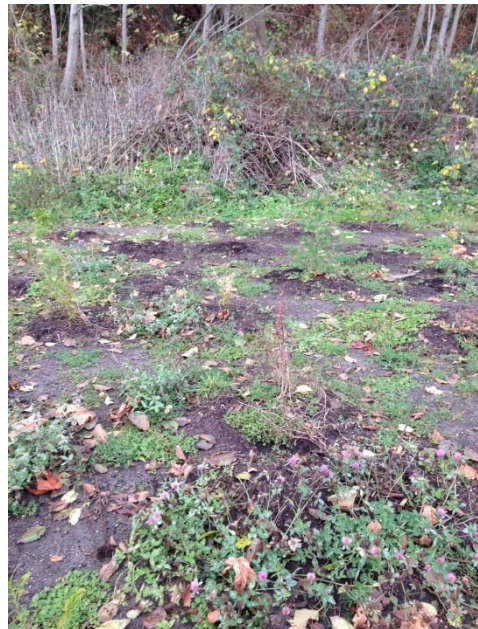
The installed plants were observed to be healthy with new buds visible on several plants. One western red cedar (*Thuja plicata*) and one shore pine (*Pinus contorta*) were missing during the year-one monitoring event and appeared to have been intentionally removed. Herbaceous ground cover increased substantially at Monitoring Station 3 and included native species such as white clover (*Trifolium repens*). Two volunteer red alder have also become established within the sampling plot. Invasive species occupied approximately 5 percent of the sampling plot and included common dandelion (*Taraxacum officinale*) and American vetch (*Vicia americana*). Seagulls were observed in this portion of the site.

Photograph 17  
Monitoring Station 3 looking north.

Photograph 18  
Monitoring Station 3 looking east.

Photograph 19  
Monitoring Station 3 looking south.

Photograph 20  
Monitoring Station 3 looking west.

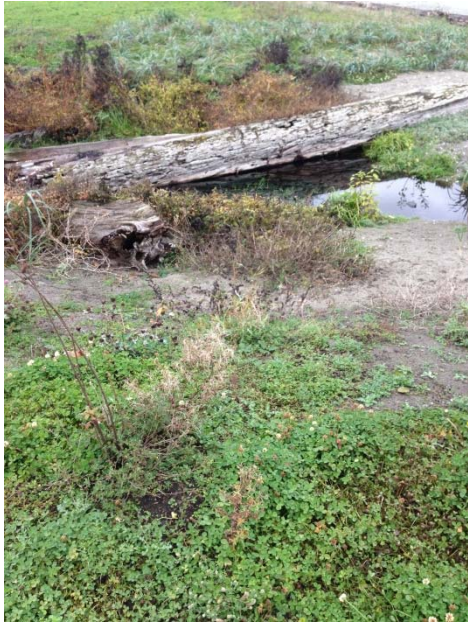
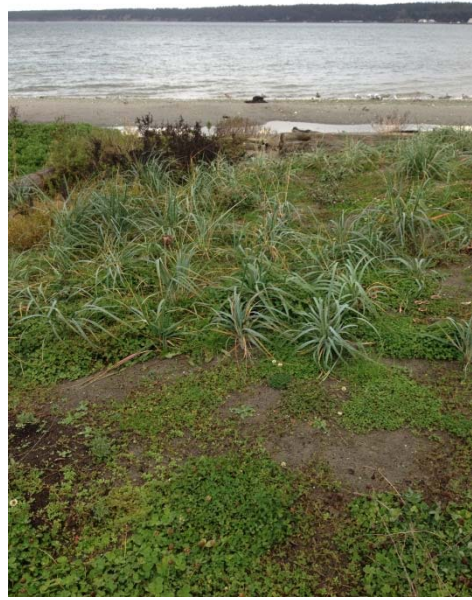
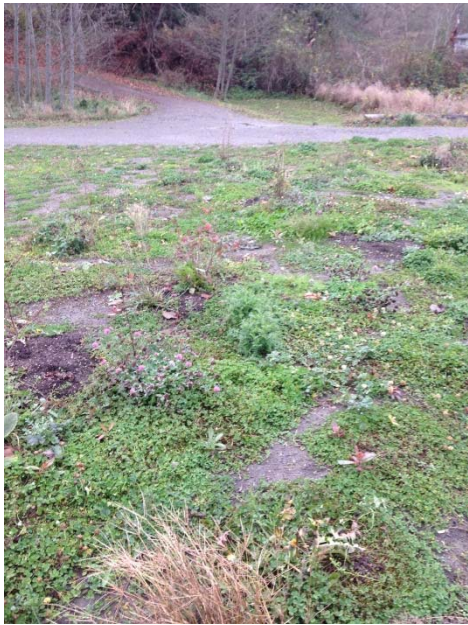
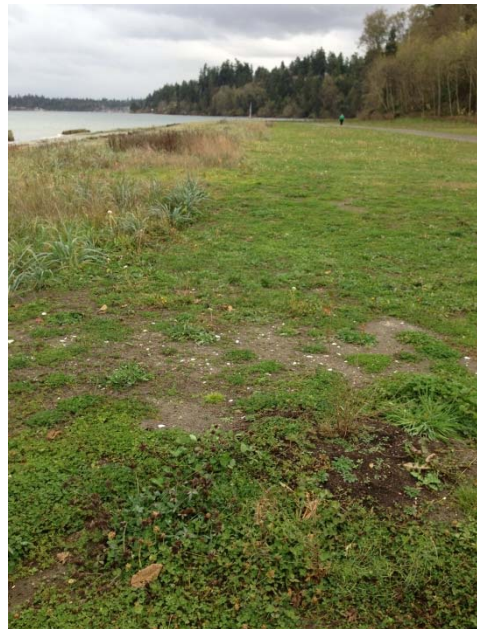
Installed plants were observed to be healthy in appearance and numerous volunteer species have established within the sampling plot, including white and red clover (*Trifolium pretense*). Invasive species are becoming reestablished in this area with species including Scot's broom (*Cytisus scoparius*) and Himalayan blackberry (*Rubus armeniacus*). This drainage was previously dominated by Himalayan blackberry, which was removed prior to planting. Continued removal of invasive species is recommended to allow installed native plants to become established. Seagulls and crows were active in this area.

Photograph 21  
Monitoring Station 4 looking northwest.

Photograph 22  
Monitoring Station 4 looking northeast.

Photograph 23  
Monitoring Station 4 looking southwest.

Photograph 24  
Monitoring Station 4 looking southeast.

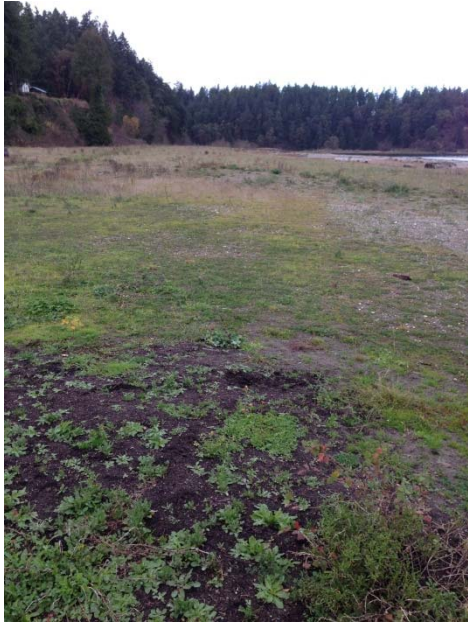
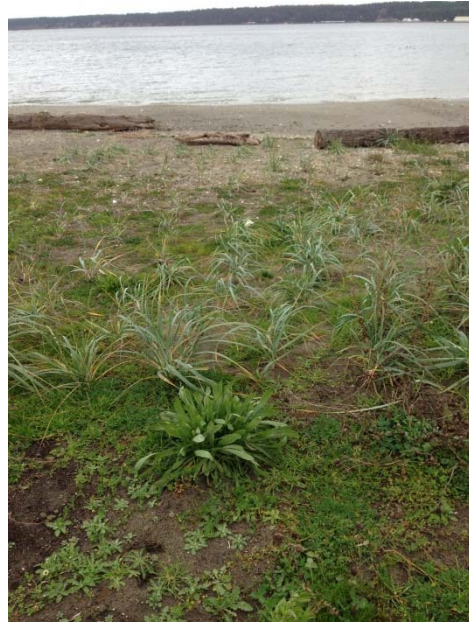
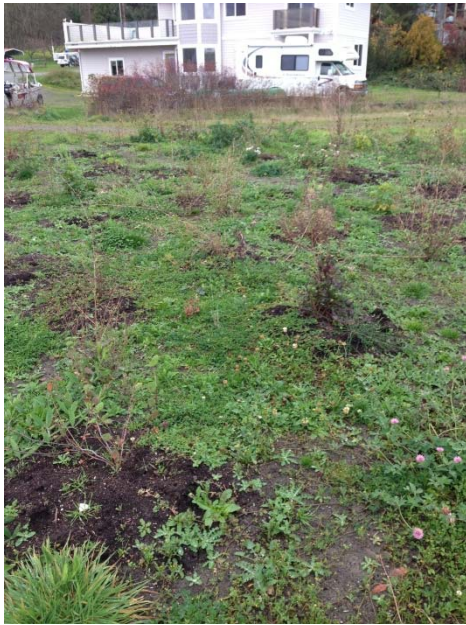
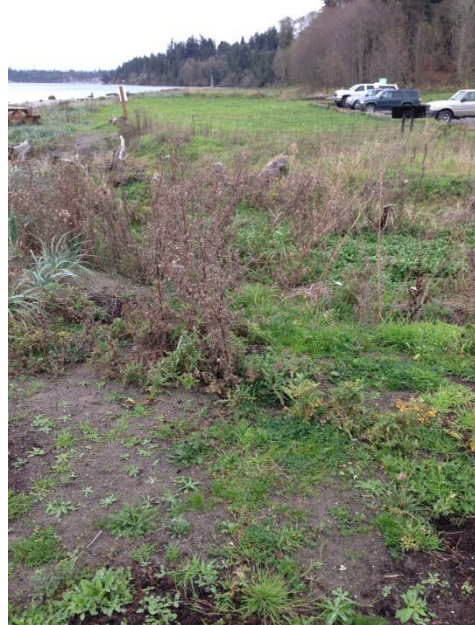
Photograph 25  
Monitoring Station 5 looking northwest.

Photograph 26  
Monitoring Station 5 looking northeast.

Photograph 27  
Monitoring Station 5 looking southwest.

Photograph 28  
Monitoring Station 5 looking southeast.
