**PERIODIC REVIEW REPORT  
FINAL**

**PACE INDUSTRIES PUGET DIV INC  
Facility Site ID#: 86715242**

**2011 & 2101 Mildred Street W  
Tacoma, WA 98466**

**June 2015**

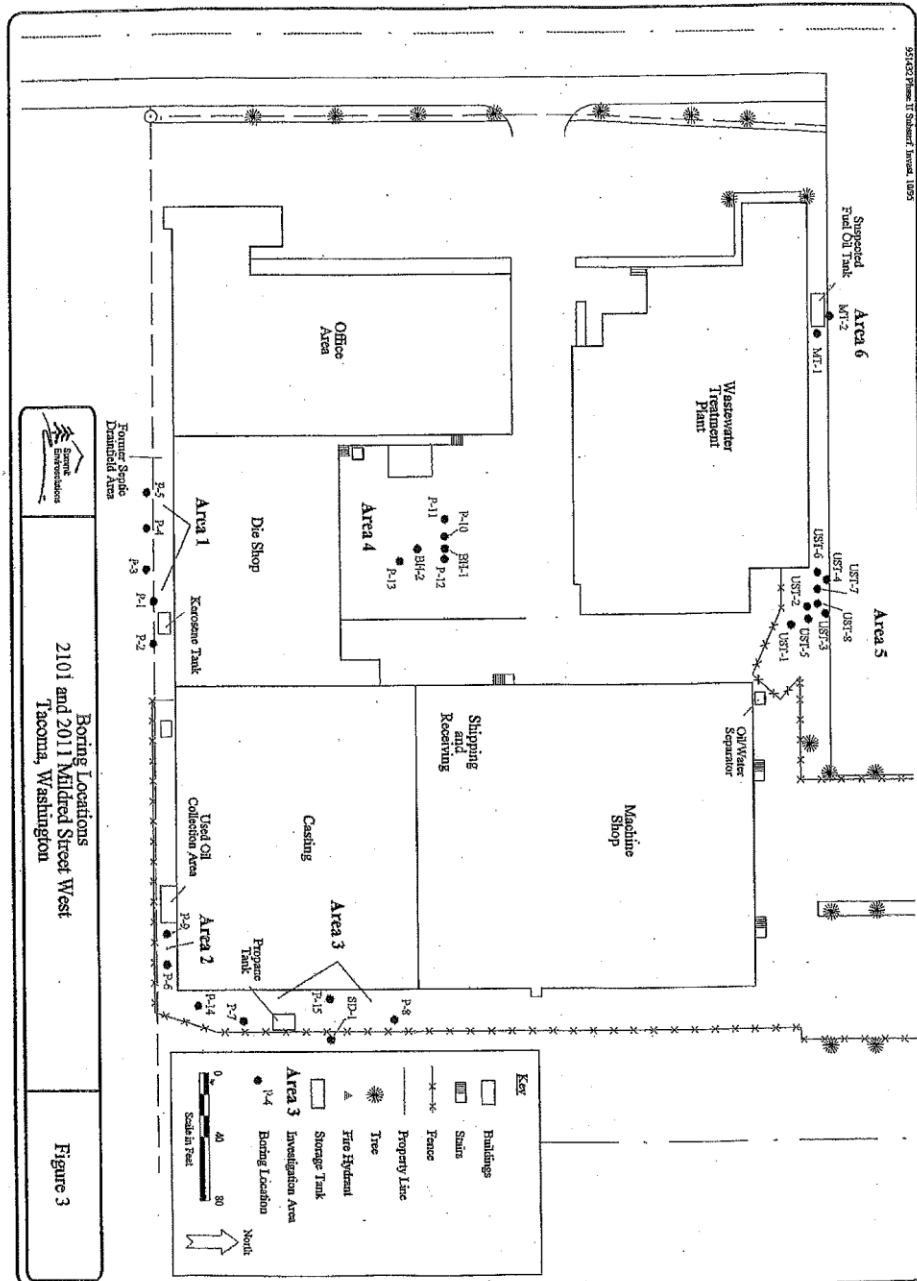
## 6.3 1995 Phase II Investigation Soil Boring Locations and Results

In Area 5, eight GeoProbe soil borings were driven to a depth of three to eight feet in the vicinity of former the USTs. Eight select soil samples were collected based on the field screening results and analyzed for the same above parameters. Only two soil samples collected from UST-3 and UST-6 borings showed TPH-D concentrations of 4,300 mg/Kg, and 3,100 mg/Kg, respectively which exceeds the MTCA Method A cleanup level of 2,000 mg/Kg for diesel in soil. Phase II investigation soil boring locations and sampling results are included as Appendix 6.3.

Locations of USTs, former septic drainfield area, soil sampling locations and results are included as Appendix 6.3.

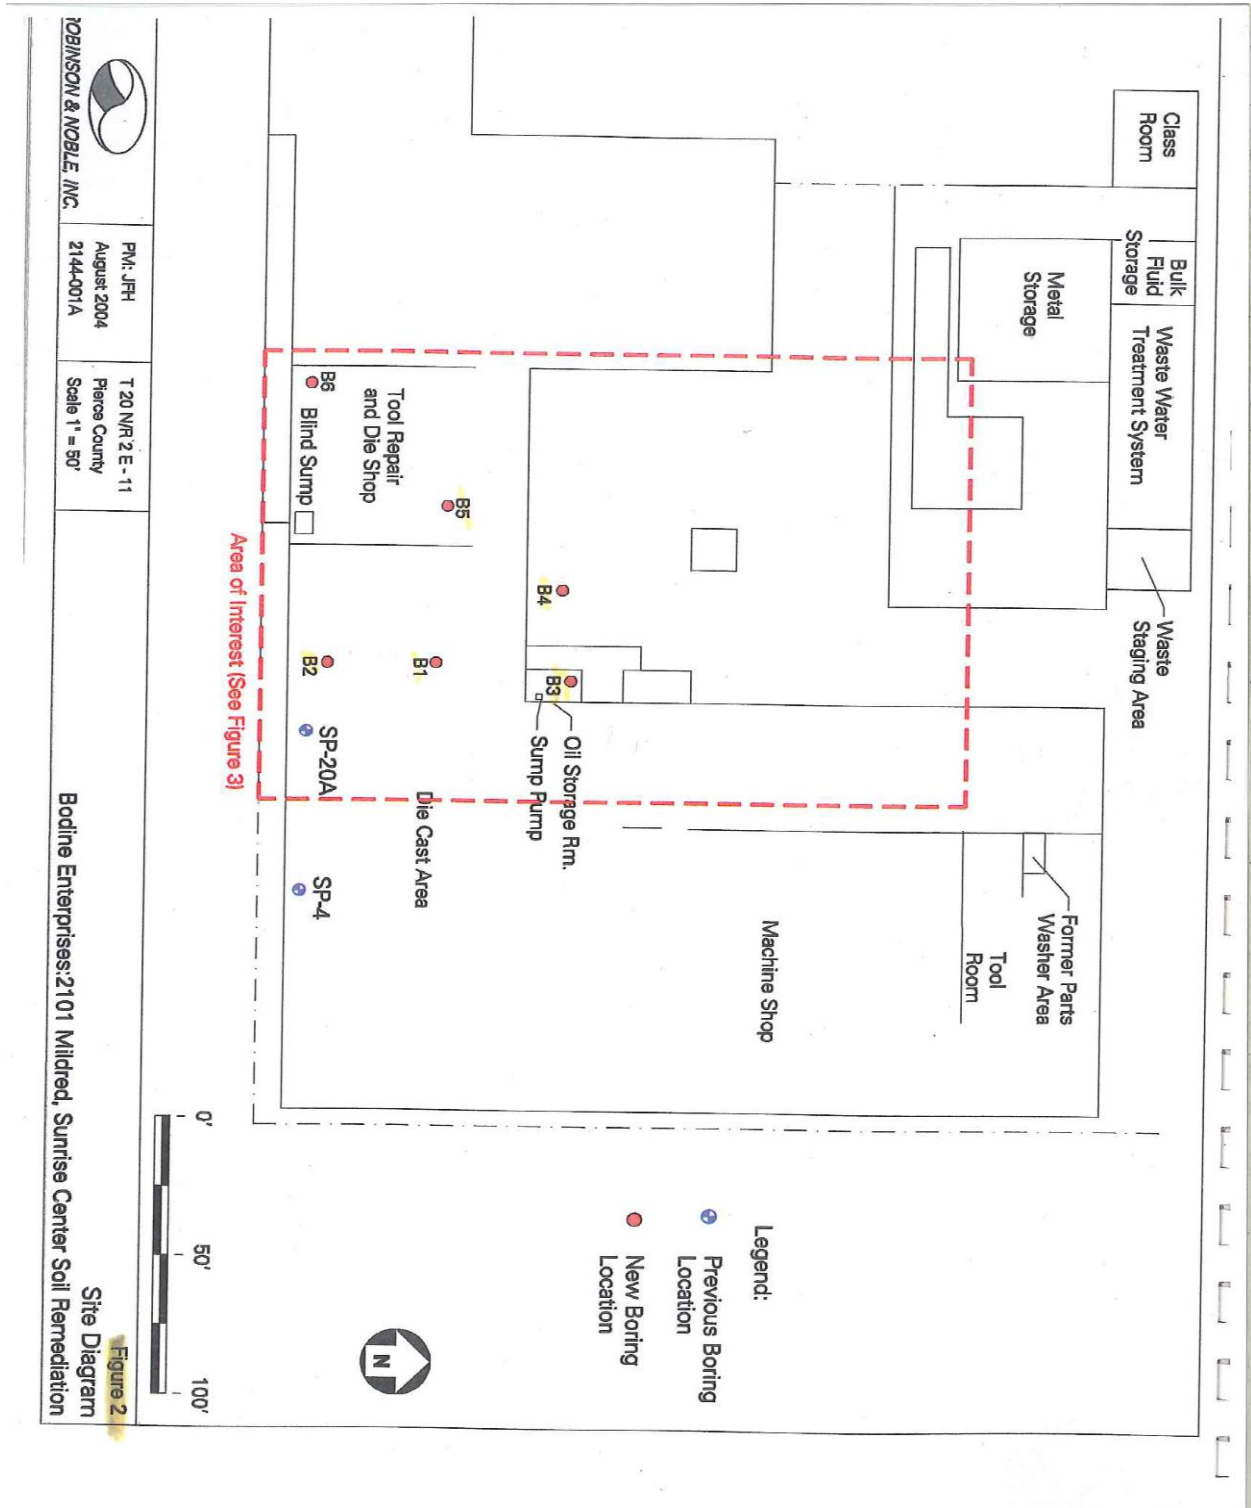
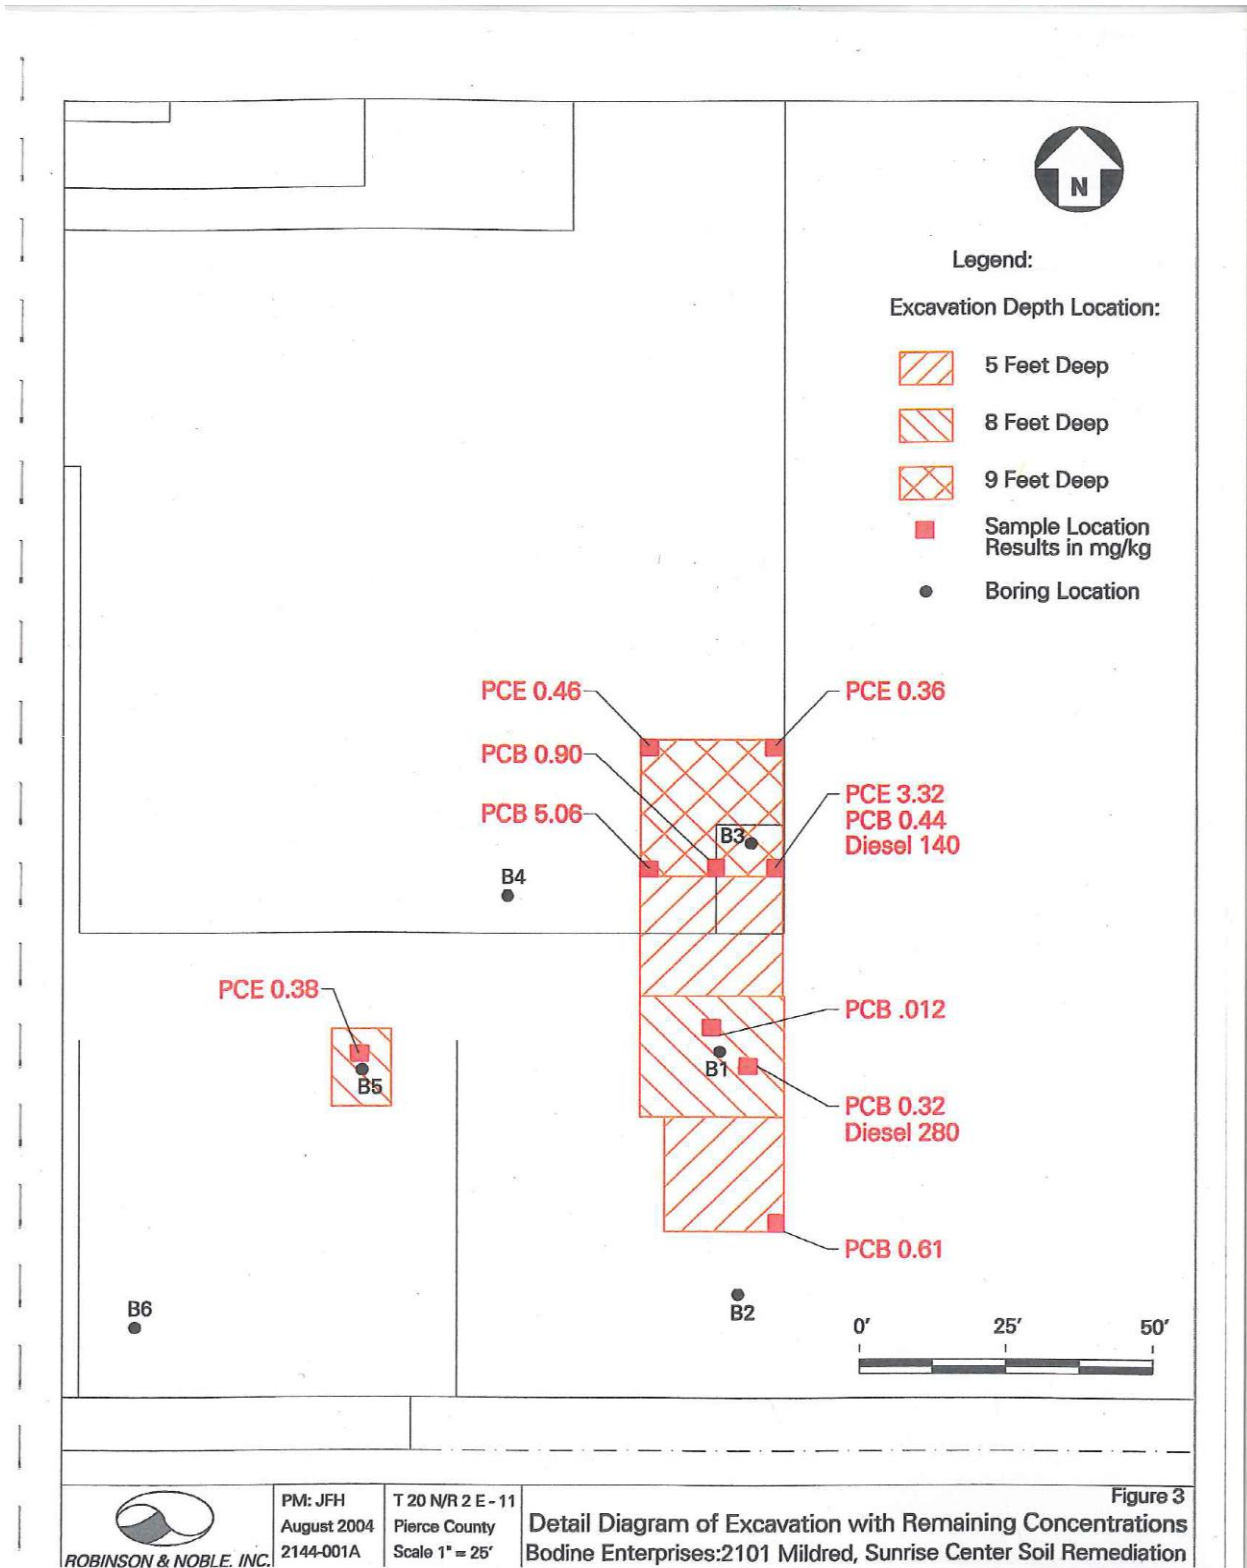
## 6.6 August 2004 Soil Cleanup: New Soil Boring Locations, Extent of Contaminated Soil Excavation and Confirmational Soil Sample Results

Based on the analytical results, approximately 827 tons of contaminated soil was excavated from the area between Buildings B and C, and transported off-Site to TPS Technologies for thermal treatment. Results of confirmational soil samples collected from the excavations indicated that petroleum hydrocarbons and PCBs with concentrations exceeding MTCA Method A cleanup levels remained in the soils near the building foundations and beneath the buildings. The investigation did not successfully locate the suspected former septic tank. There is evidence to suspect there is heavy metals contamination remaining above MTCA cleanup levels beneath the asphalt, along the property line south and southeast of Building B, and is associated with an abandoned septic system. Confirmational soil sampling locations and results are included as Appendix 6.6.

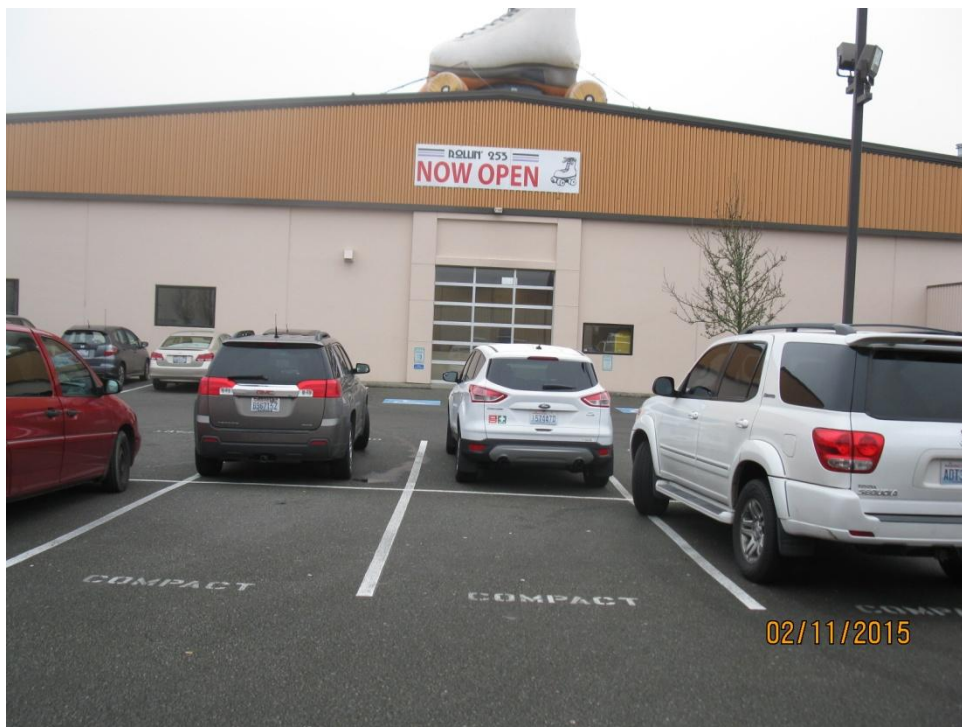
A total of approximately 1300 cubic yards of contaminated soils were excavated as part of the remedial action. However, some petroleum, and PCBs contaminated soils were left in place in close proximity to the building foundation and below the building. This soil contamination was not excavated because of the close proximity to the building. These contaminated soils remain contained beneath an asphalt paved cap. As discussed in section 2.3.4, groundwater does not exist within the upper 65 feet of the subsurface. The PCBs and petroleum hydrocarbons contamination in the soil extends to a maximum depth of 20 feet with a minimum of 45 feet of clean glacial till beneath PCB and TPH contaminated soils. As a result it is highly unlikely that there is any adverse impact to the groundwater by the contaminated soils left in place at the Site.

**Photo 1: Building below which contaminated soils left in place, Looking East**

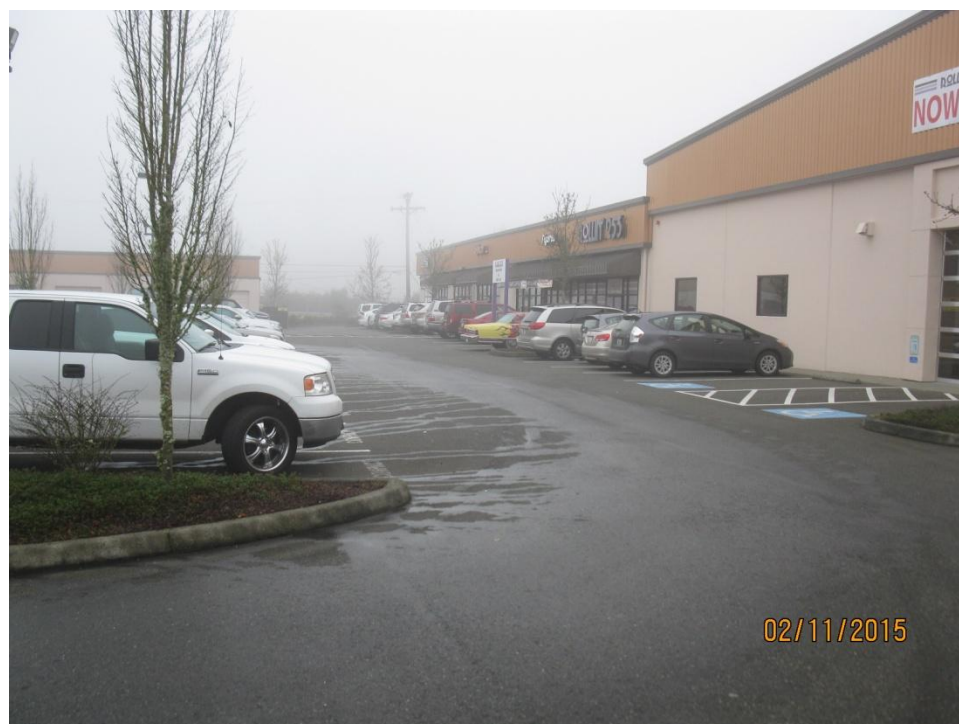
**Photo 2: Previously excavated area, current parking lot-Looking Northeast**

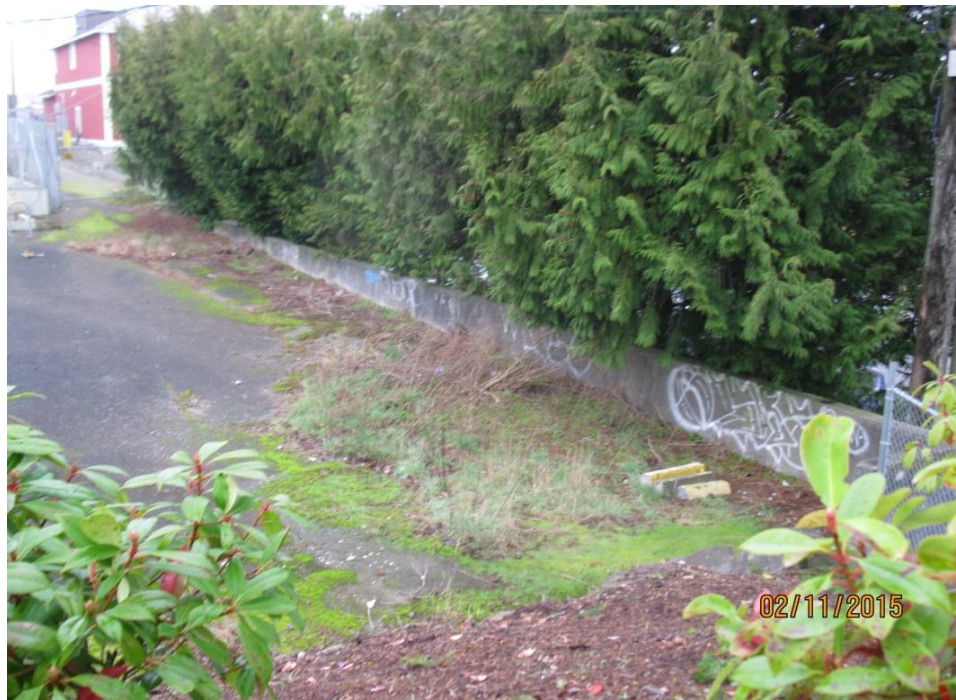
**Photo 3: Retaining wall in Area 5 and Area 6, Looking Northwest**

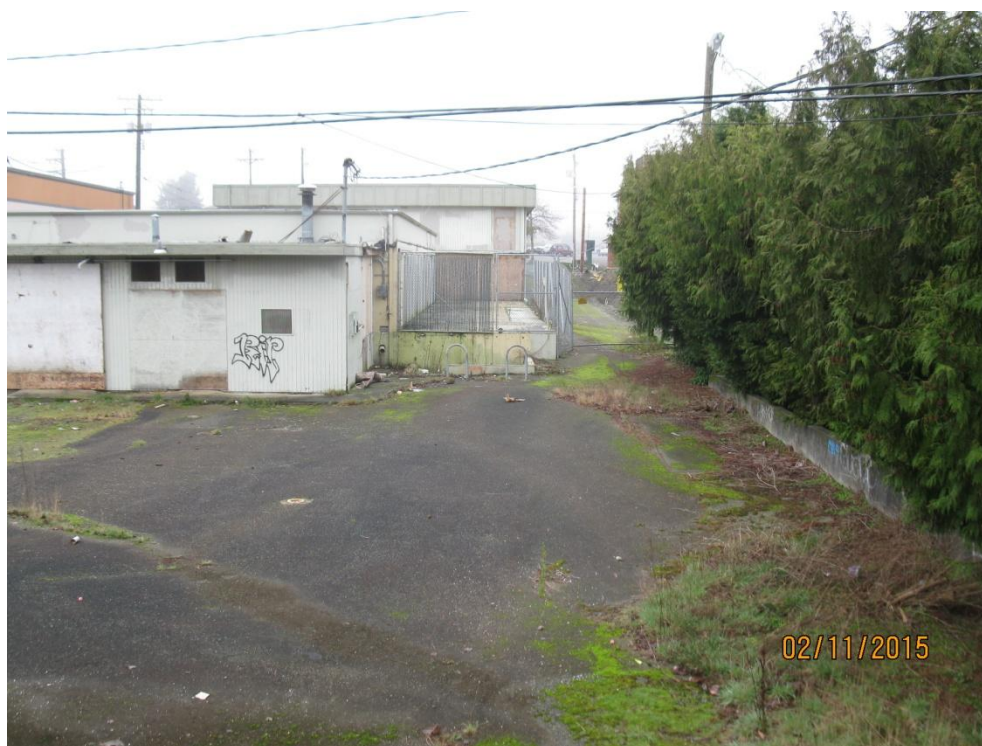
**Photo 4: Former Towne Cleaners in Area 5 some contaminated soils left below the building foundation-Looking West**

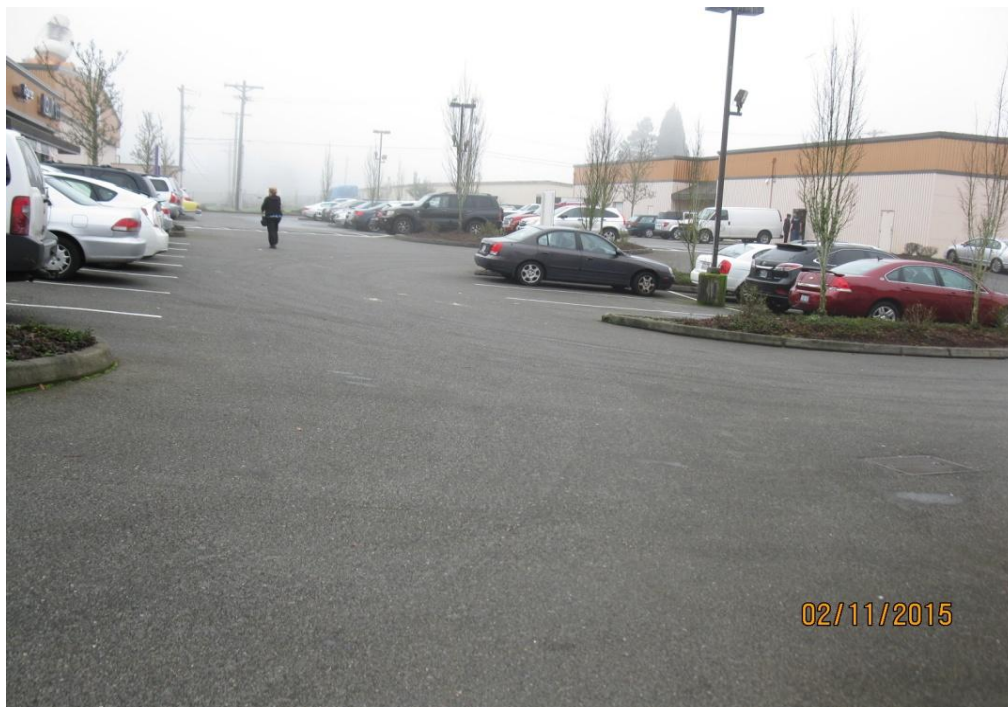
**Photo 5: Previously Excavated Area, Current Parking Lot, Looking North**

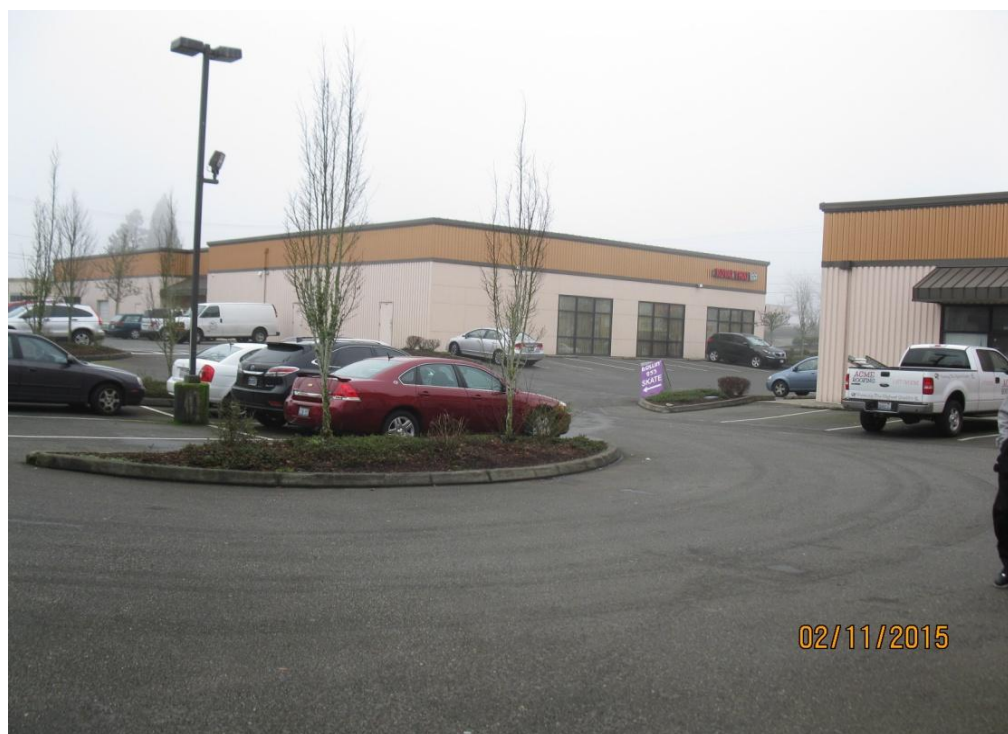
**Photo 6: Previous Area 4, Current Parking Lot, Looking Southwest**

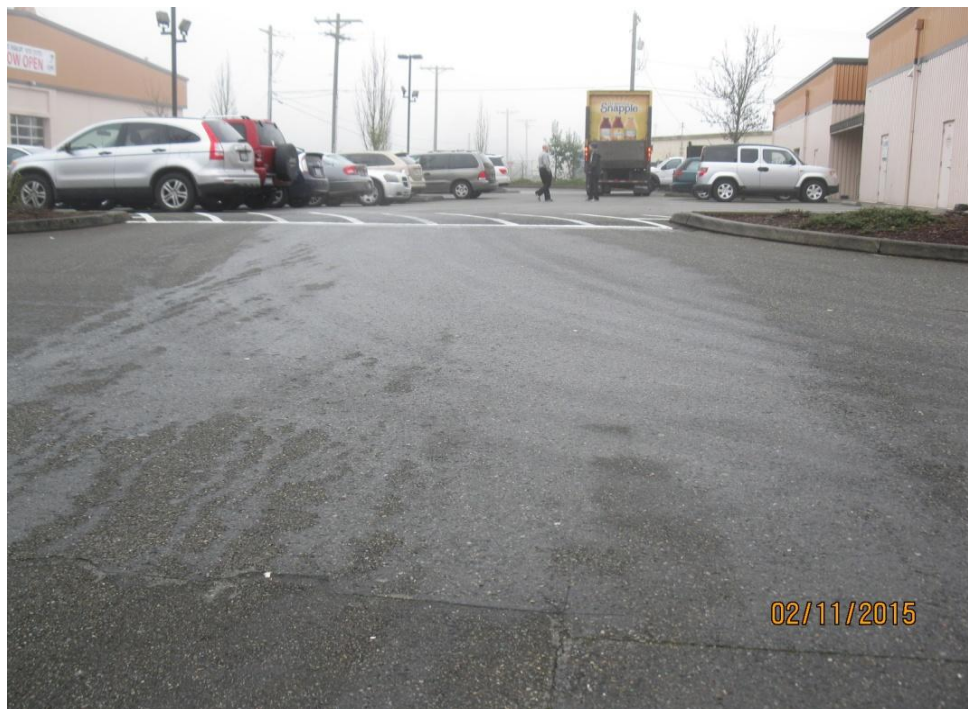
**Photo 7: Previously Excavated Area 4, Current Parking Lot, Looking North**

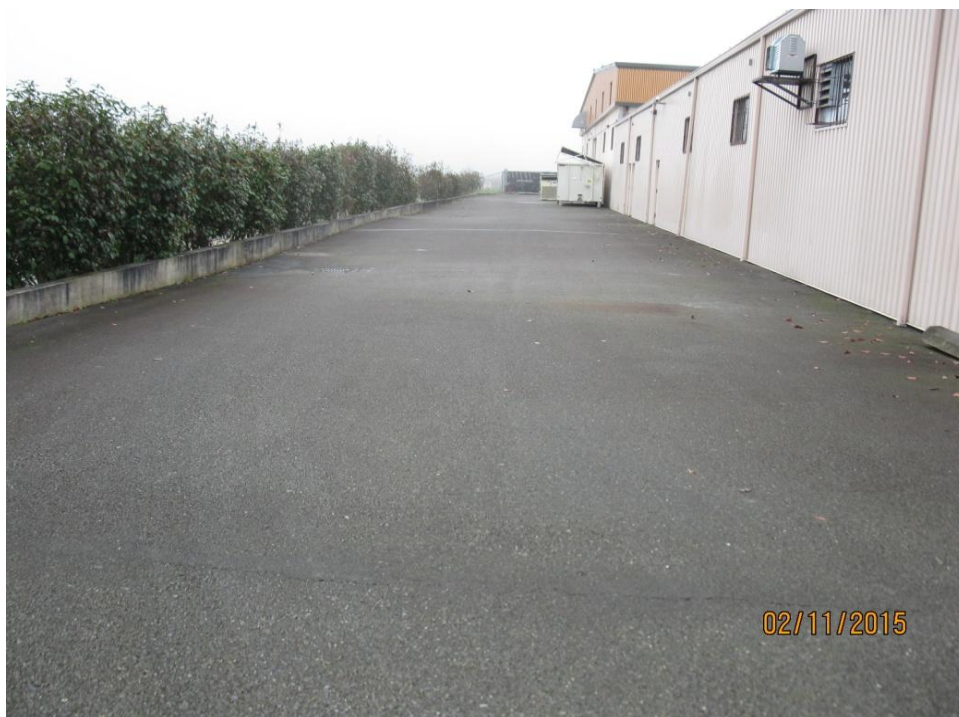
**Photo 8: Previous Area 3, behind the Current Building, Looking South**
