STATE OF WASHINGTON
DEPARTMENT OF ECOLOGY

June 15, 2015

Re: Further Action at the following Site:

- **Site Name:** Alders Chevron
- **Site Address:** 1702 East Yakima Avenue, Yakima
- **Facility/Site No.:** 511
- **VCP Project No.:** CE0391

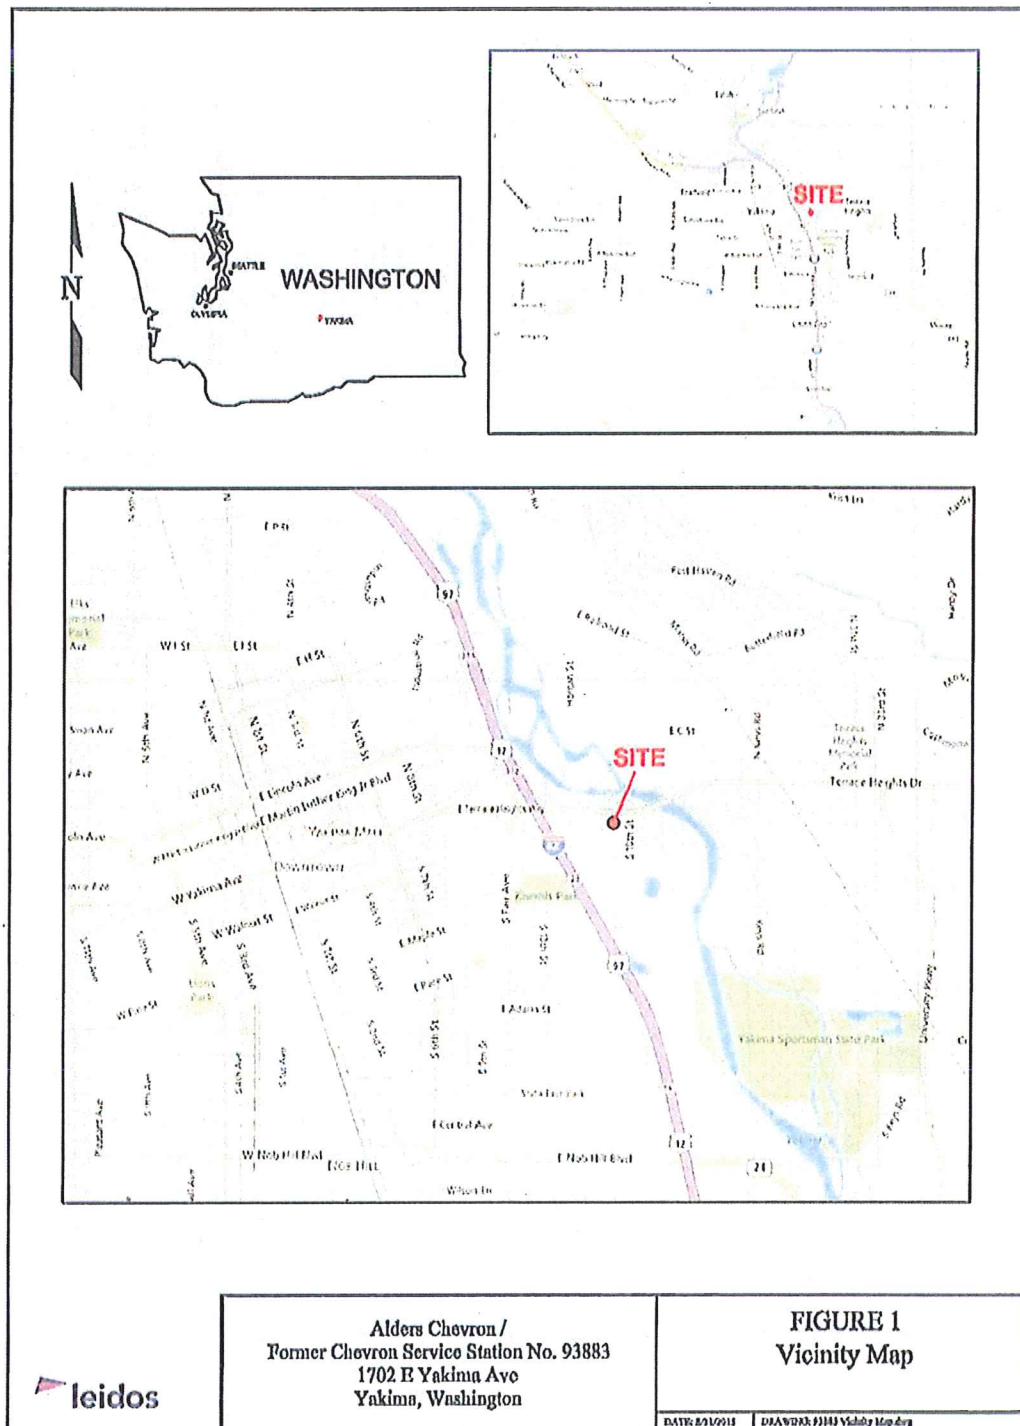
Site Diagrams

- During the cleanup actions, approximately 754 cubic yards of petroleum-contaminated soils were removed from the Site in the affected areas. Residual contamination continues to exist in the vicinity of the former gasoline UST area (northeast portion of Site) and near the waste oil and heating oil UST area (south portion of Site).

Ecology's preferred alternative for a final remedy typically involves active measures to include contaminated soil removal and/or treatment; however, an institutional control enforced by an environmental covenant may be imposed. This mechanism will serve to mitigate direct contact exposure hazard to contaminated soil.
