## **PERIODIC REVIEW**

**Hilton Hotel Parking Garage  
Facility Site ID#: 56642815**

**1305 6<sup>th</sup> Avenue,  
Seattle, Washington**

**May 2015**

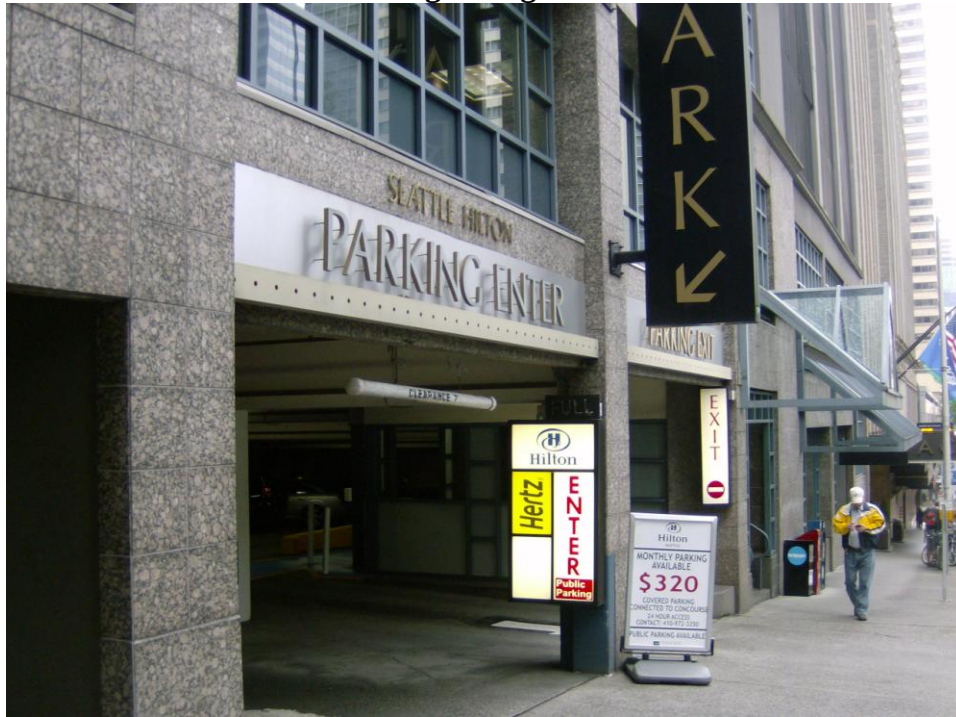
**Photo 1: Entrance to Hilton Hotel Parking Garage – off of 6<sup>th</sup> from the southeast**

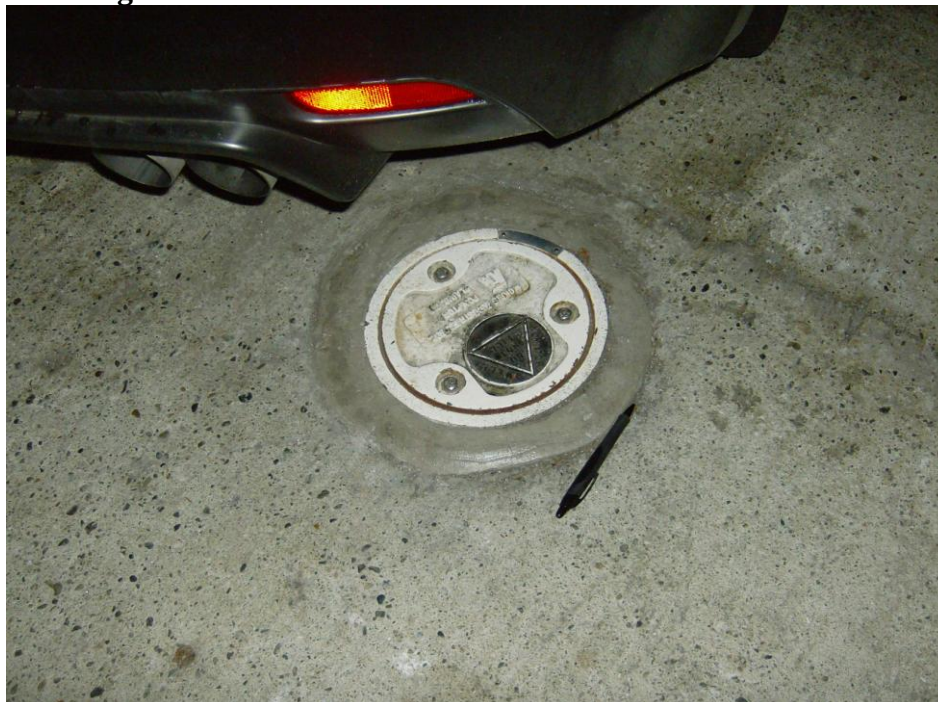
**Photo 2: Monitoring Well MW-4**

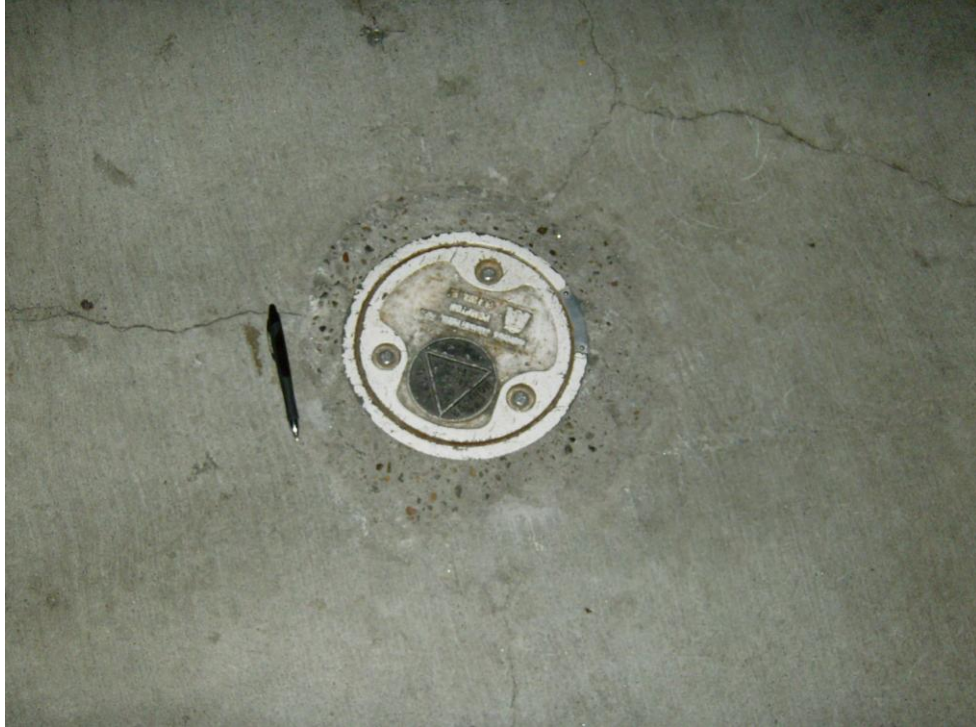
**Photo 3: Monitoring Well MW-3**

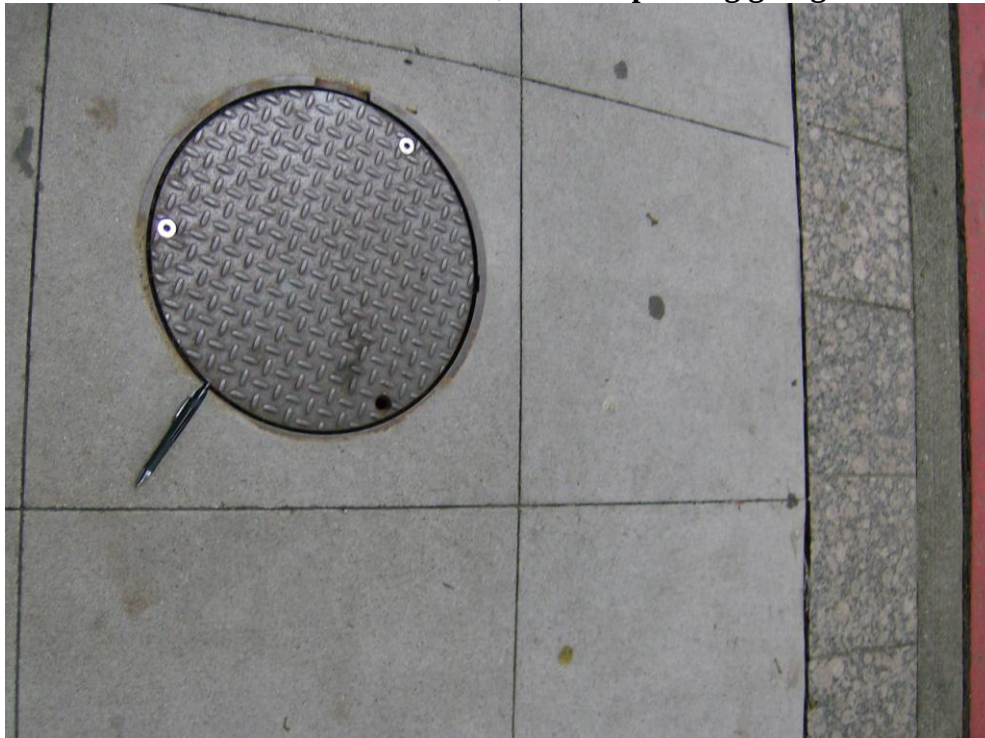
**Photo 4: MW-5 is in the sidewalk – west of 6<sup>th</sup>, south of parking garage entrance**

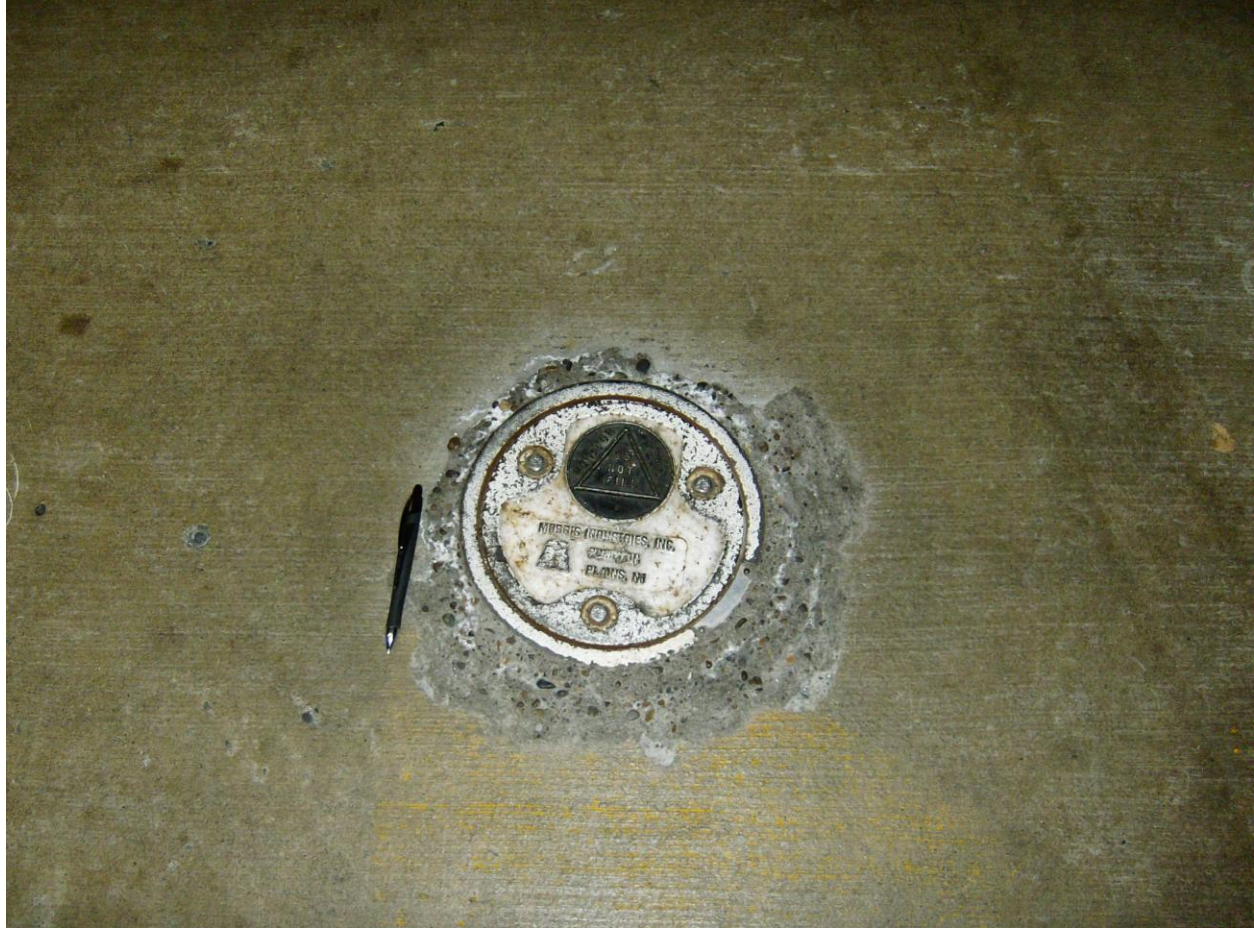
**Photo 5: Monitoring Well MW-2**
