PERIODIC REVIEW

**Georgetown Center
Facility Site ID#: 96679259**

**5959-5963 Corson Avenue South,
829 and 835 S. Fidalgo, 800 South Michigan St. (Co. records),
Seattle, Washington**

June 2015

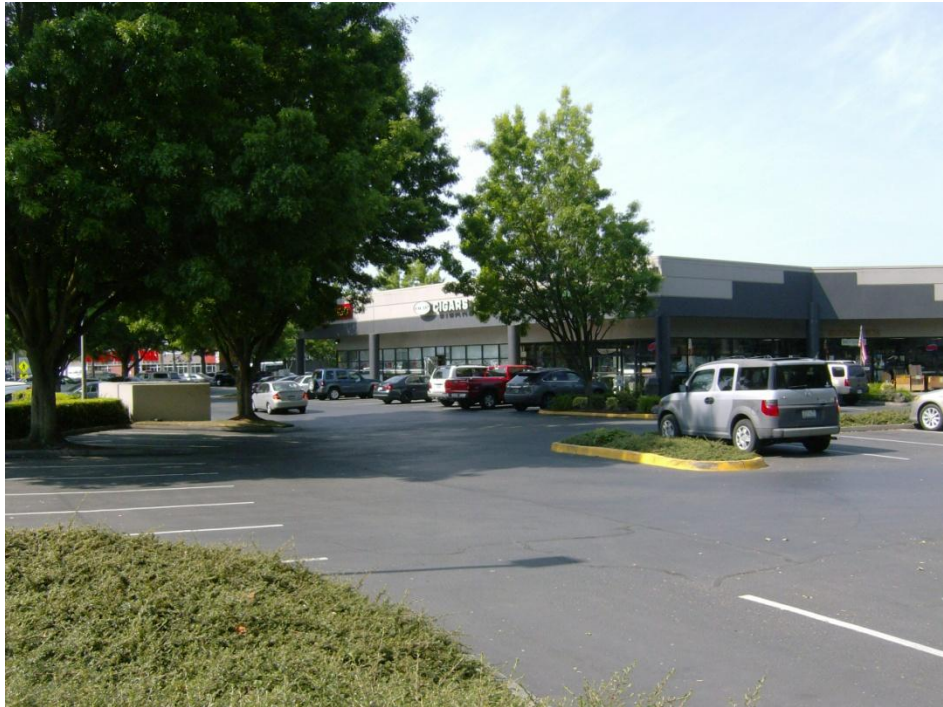
Photo 1: Former Gull gas station location in foreground – looking northwest

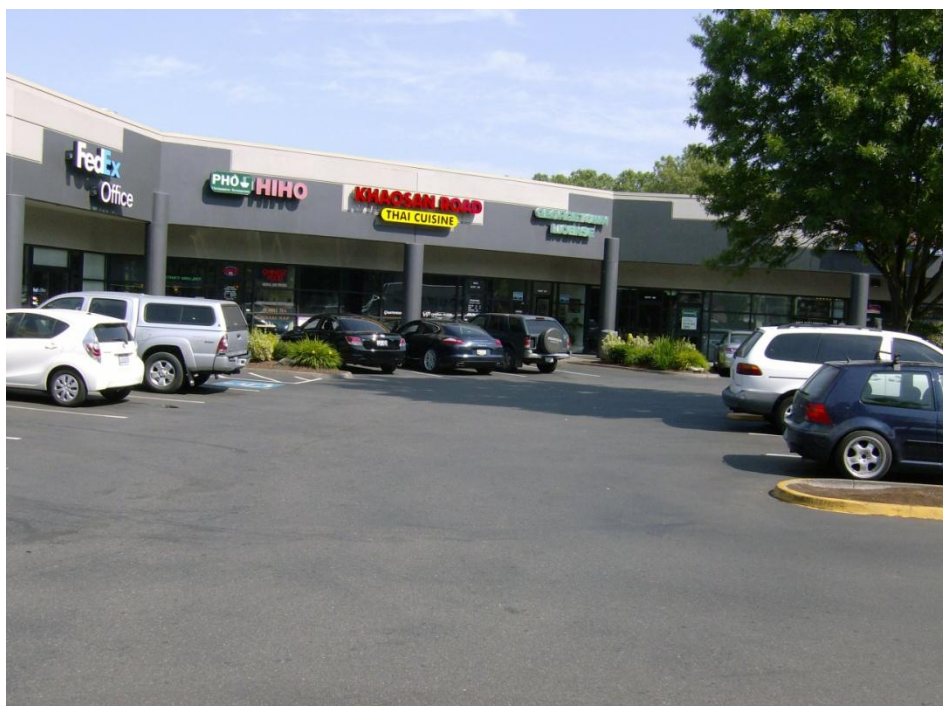
Photo 2: Former Gull gas station location in the left of picture - from the east

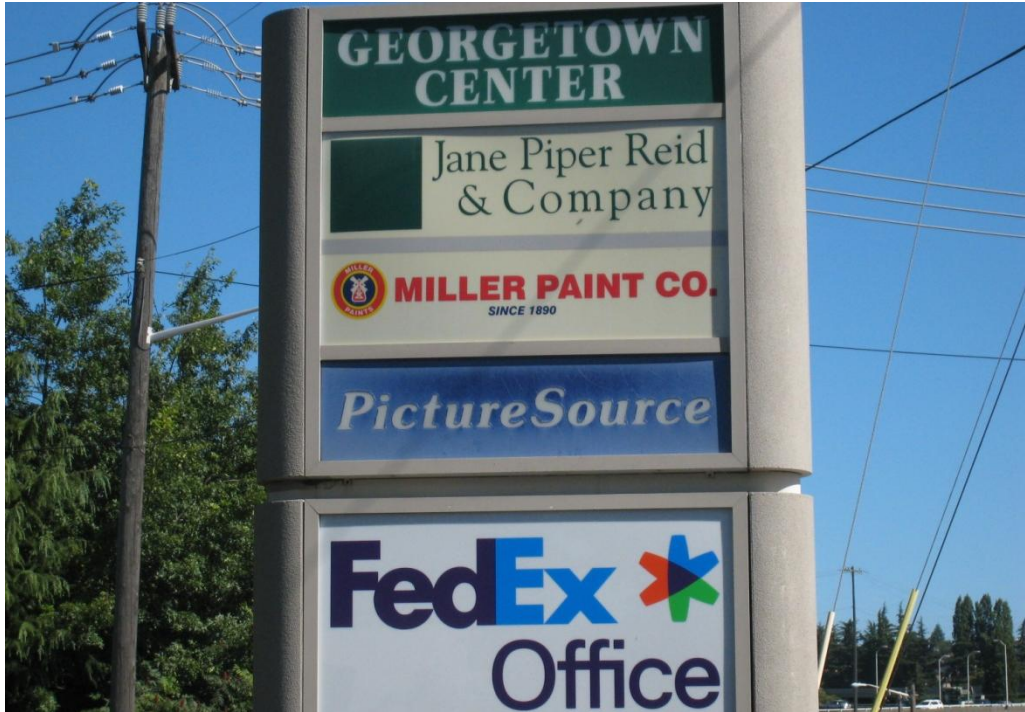
Photo 3: One of the many signs on the property

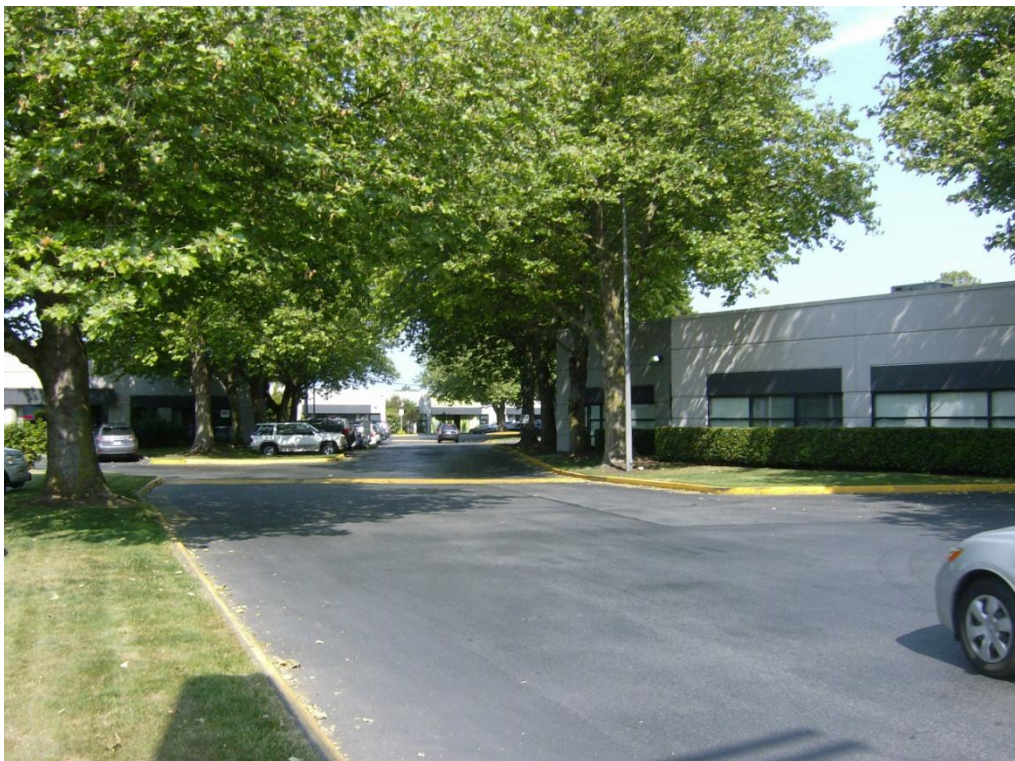
Photo 4: S. Fidalgo addresses, Building 4 in the distance
