STATE OF WASHINGTON  
DEPARTMENT OF ECOLOGY

**Re: No Further Action at the Following Site:**

- **Site Name:** Cue Apartment Property
- **Site Address:** 721 and 725 East Pine Street, Seattle, WA 98122
- **Facility/Site No.:** 19790
- **VCP Project No.:** NW2937
- **Cleanup Site ID No:** 12529

### **Description and Diagrams of the Site**

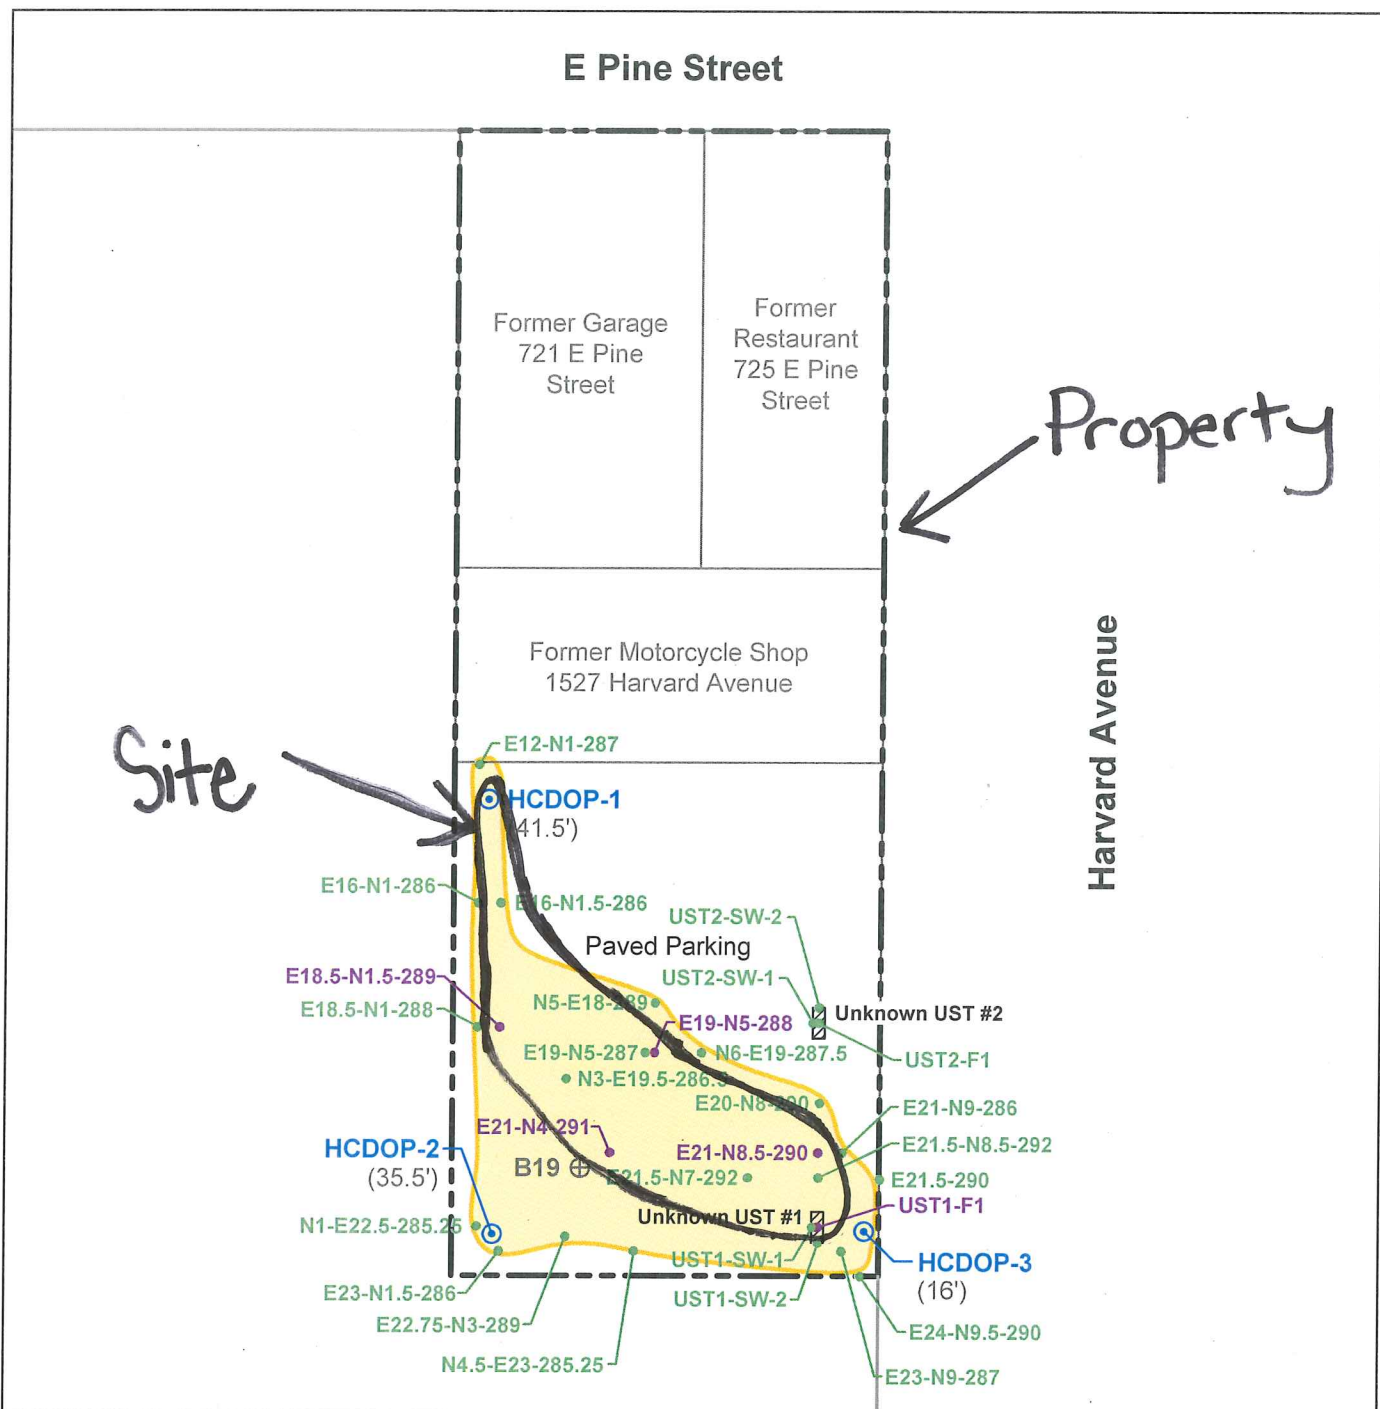
2a

**Release and Extent of Soil Contamination:** Soil contaminated with TPH-g, TPH-d and TPH-o, benzene, ethylbenzene, xylenes and lead above Method A was limited to the southern portion of the Property and within the upper six feet. Ethylbenzene and xylenes were detected but did not exceed the MTCA Method A cleanup levels. The maximum benzene concentration in soil (55 milligrams per kilograms (mg/kg)) was detected in a sample collected at one foot bgs at location HCDOP-1. The maximum TPH-o concentration (6,000 mg/kg) was detected at location E21-N8.5-290 at 5 feet bgs. The maximum TPH-g concentration (32 mg/kg) was detected at location UST-1-F at 6 feet bgs. The maximum lead concentration (1,200 mg/kg) was detected at seven feet bgs at sample location E19-N5-288. Contaminated soil at concentrations exceeding Method A cleanup levels was found at a maximum depth of 7 feet bgs. One of the 33 samples analyzed contained TPH-o, three contained lead and one contained TPH-g and TPH-d at concentrations above the MTCA Method A cleanup levels. These areas were overexcavated and samples were collected confirming all soil above MTCA Method A cleanup

levels had been removed. All contaminated soil was excavated and transported off-Site for disposal at a permitted facility. Additional redevelopment excavation occurred beyond the remedial action limits to depths of 10 to 15 feet bgs.
