STATE OF WASHINGTON
DEPARTMENT OF ECOLOGY

July 29, 2015

Re: No Further Action at the following Site:

- **Site Name:** Wyman's Marina and Wholesale Supply Area-Parcel Numbers: In-water Parcel Area (P32868), Upland Parcel Area (P56526, P56511, P56510)
- **Site Address:** 202 U Avenue, Anacortes
- **Facility/Site No.:** 2821735

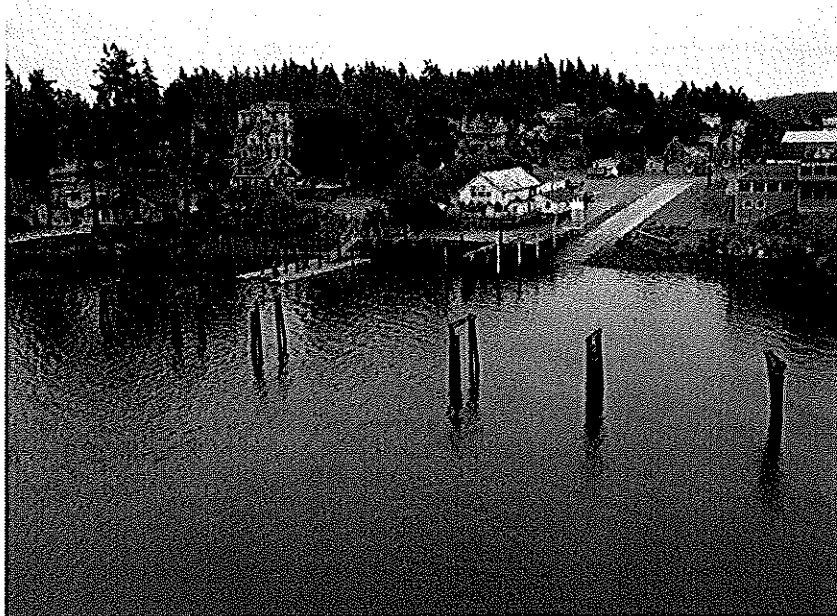
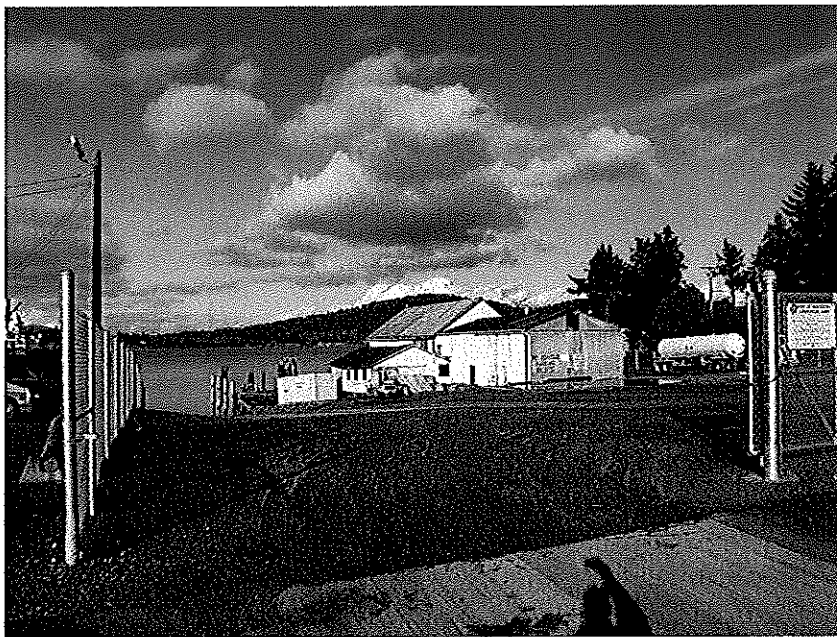
Figure 2. Site prior to excavation activities.

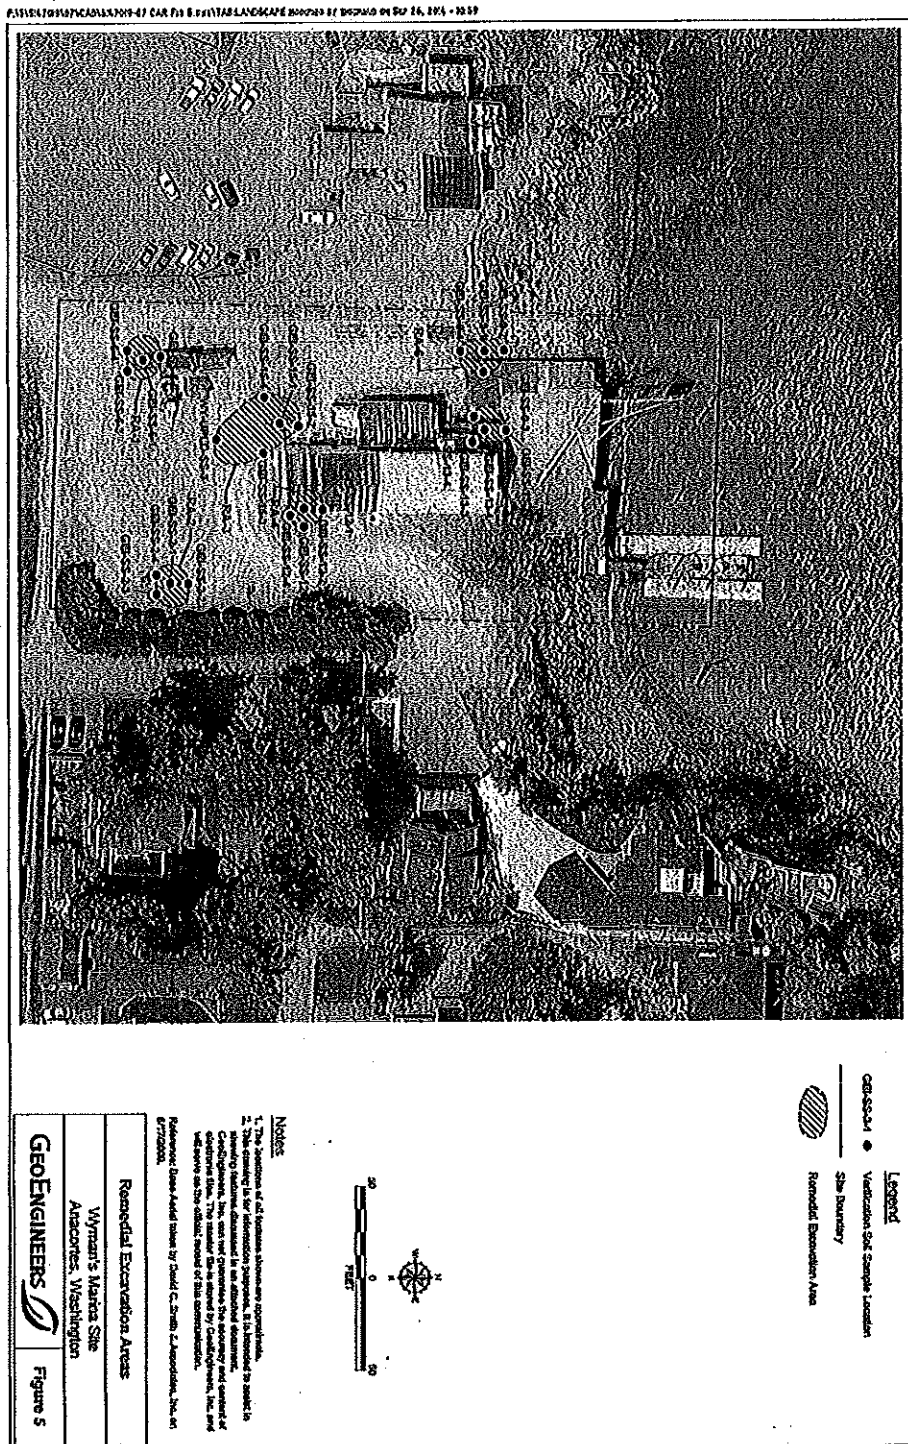
Figure 3. 2012 contaminated soils excavation areas.

In 1998, during the decommission and removal of four USTs, contractors excavated approximately 300 cubic yards of soil from the Upland Area parcels and transported off-site for thermal treatment and landfill disposal. Final cleanup activities included removal of 417 tons of contaminated soil off-site for permitted landfill disposal from the Upland Area. An additional 27,670 tons of soil was removed to between +10 feet and approximately +16 feet MLLW as part of the CORPS habitat requirement.

In order to meet the criteria for a replacement of aquatic habitat affected by the Port of Anacortes' Pier 1 Redevelopment Project, full removal of contaminated soil was completed in 2014 and transported off-site to a permitted landfill (Permit No. 200501451). Sampling of soil was conducted at the final excavation levels and met the sediment management standards. Because the CORPS required final habitat for the site to meet intertidal and salt marsh/riparian habitat, sediment management standards were considered appropriate.

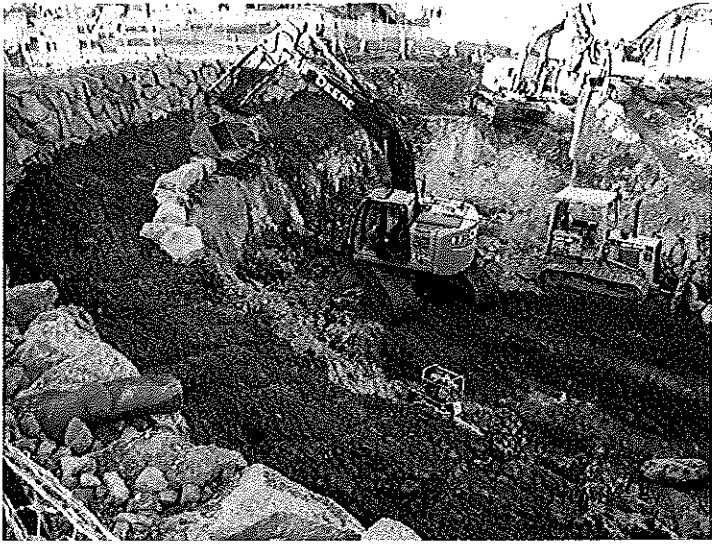
Figure 5. Additional excavation activities after contaminated soil removal.

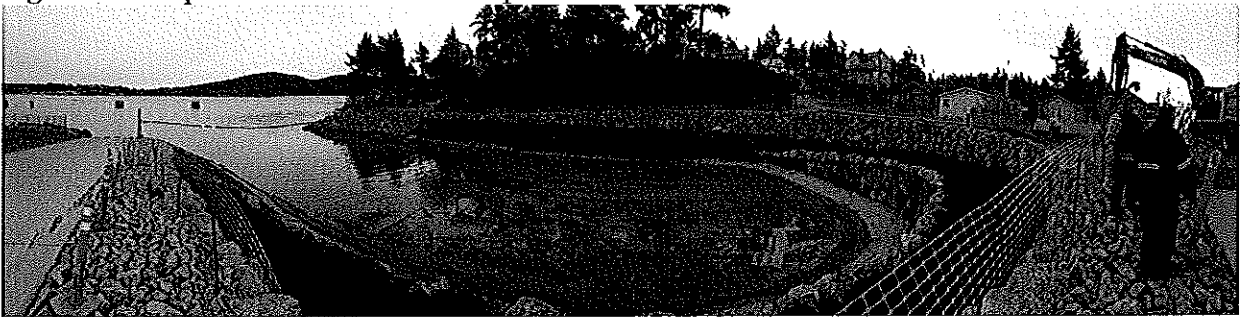
Figure 6. Site photo of habitat redevelopment construction.
