TECHNICAL MEMORANDUM

RE: Completion Documentation for Vapor Mitigation System
Former Clean-M-Rite Property
3308/3310 Third Avenue West, Seattle, Washington

EPI Project Number 53403.1

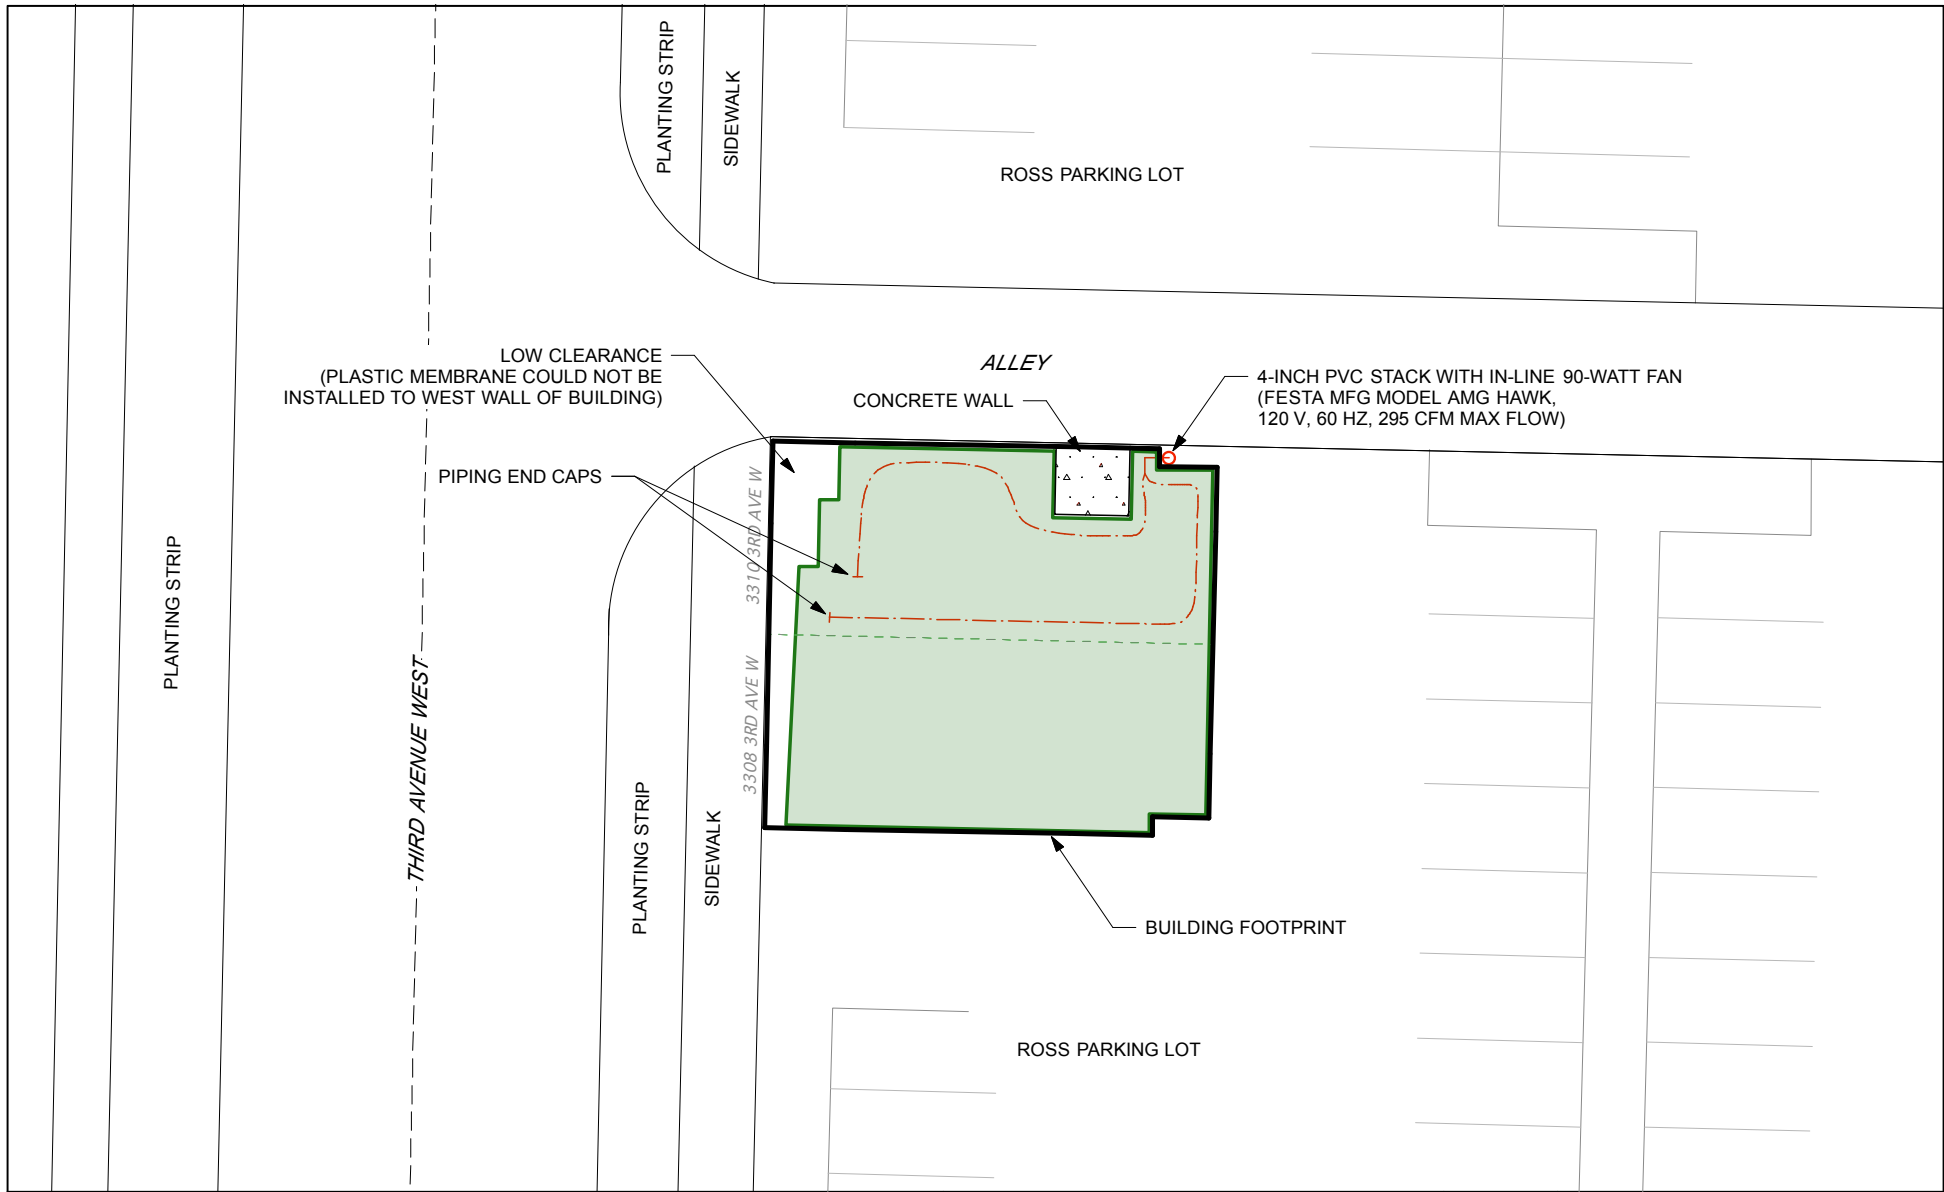
FIGURE 1
CRAWL SPACE VAPOR MITIGATION SYSTEM LAYOUT

Approximately 105 linear feet of 4-inch-diameter, flexible corrugated HDPE piping was installed beneath the northern half of the building (see Figure 1) in the area where PCE impacts were identified in shallow subsurface soils. This area generally corresponds with the area of former dry cleaning operations and overlies the area of highest PCE concentrations in ground water. Prior to installation, ART perforated the piping by drilling three to four small (i.e., 1/8-inch or slightly larger) holes in the piping approximately every 2 to 3 feet (Photo 2).

APPROXIMATE LOCATION OF 4-INCH HDPE PERFORATED PIPING; CAPPED AT THE ENDS

AREA COVERED WITH 6 MIL POLYETHYLENE PLASTIC SHEETING; SEAMS OVERLAP 4 TO 5 FEET AND SEALED WITH MULTI-PURPOSE CONSTRUCTION ADHESIVE

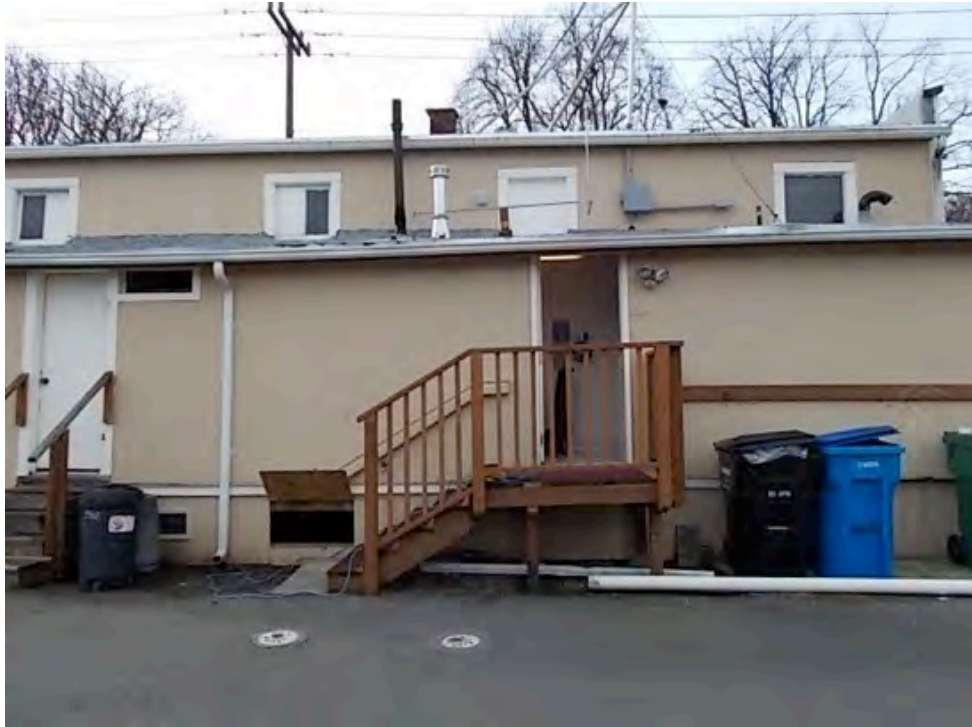
PHOTO 1

On February 6, 2013, Eric Caddey of EPI met with Dave Gerard of ART at the Property to review and implement the planned scope of work. ART installed the system on February 6 and 7, 2013, and subcontracted with Balkan Electric, LLC for the electrical connections associated with the vent stack fan. Figure 1 shows the approximate layout of the system. Photographs of the system and installation are included as Attachment A to this Technical Memorandum. ART used the access hatch on the east side of the building to access the crawl space (Photo 1).

Back of building (east side) with crawl space access hatch next to stairs.

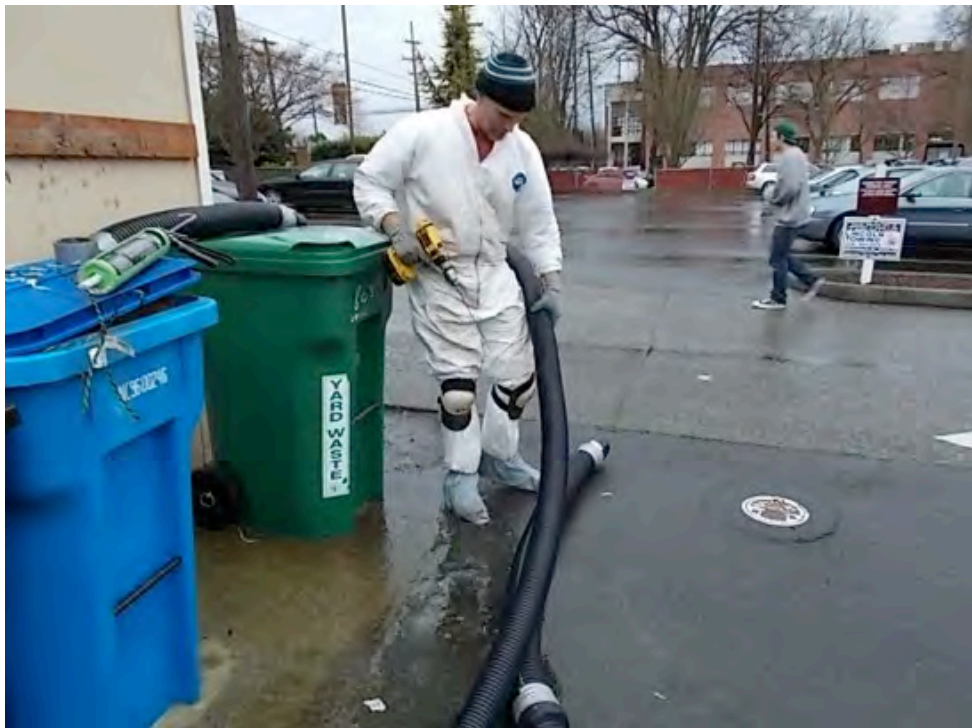
PHOTO 2

Mr. Dave Gerard of Advanced Radon Technologies drills holes in vapor collection piping.

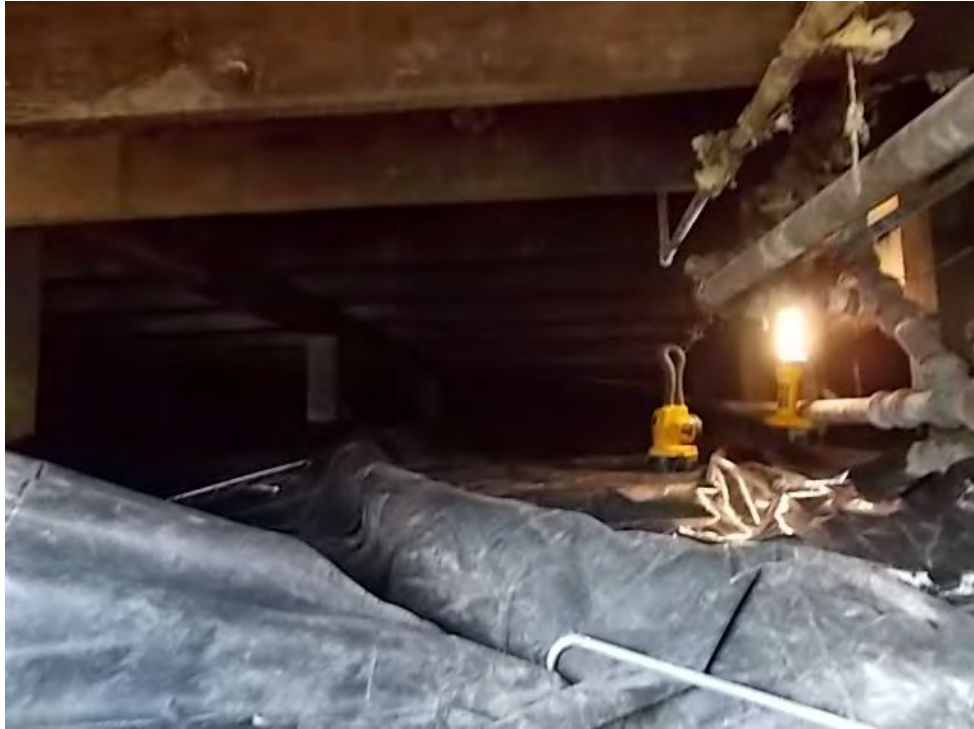
PHOTO 3

ART installed a plastic membrane over the perforated piping (Photo 3). Approximately 1,800 square feet of 6-millimeter (6-mil) polyethylene plastic sheeting was used to construct the membrane. The seams overlapped approximately 4 to 5 feet and were sealed with OSI® QB-300 multi-purpose construction adhesive. The membrane was also sealed at each of the building's structural support posts and around vertical pipes beneath the building (Photo 4), and at the north, east, and south walls using the construction adhesive. Due to very low overhead clearance (i.e., approximately 4 to 6 inches) beneath the westernmost portion of the building, that area was physically inaccessible for ART to install the membrane. Therefore, the membrane does not fully extend to the west wall of the building, as shown on Figure 1. Where the western edge of the membrane could not be sealed, ART secured the plastic sheeting to the dirt floor with brick weights. Mr. Howard was informed of the final layout of the membrane and acknowledged that the west portion of the crawlspace could not be fully covered.

Inside crawl space, membrane installed over vapor collection piping.

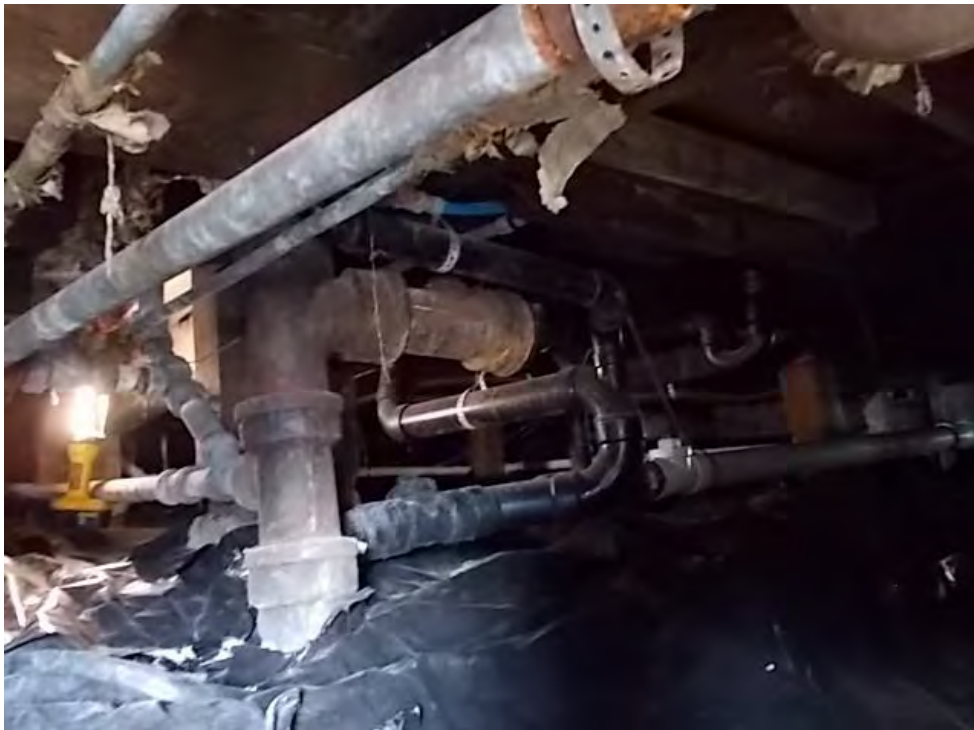
PHOTO 4

Inside crawl space, membrane sealed around piping under building.

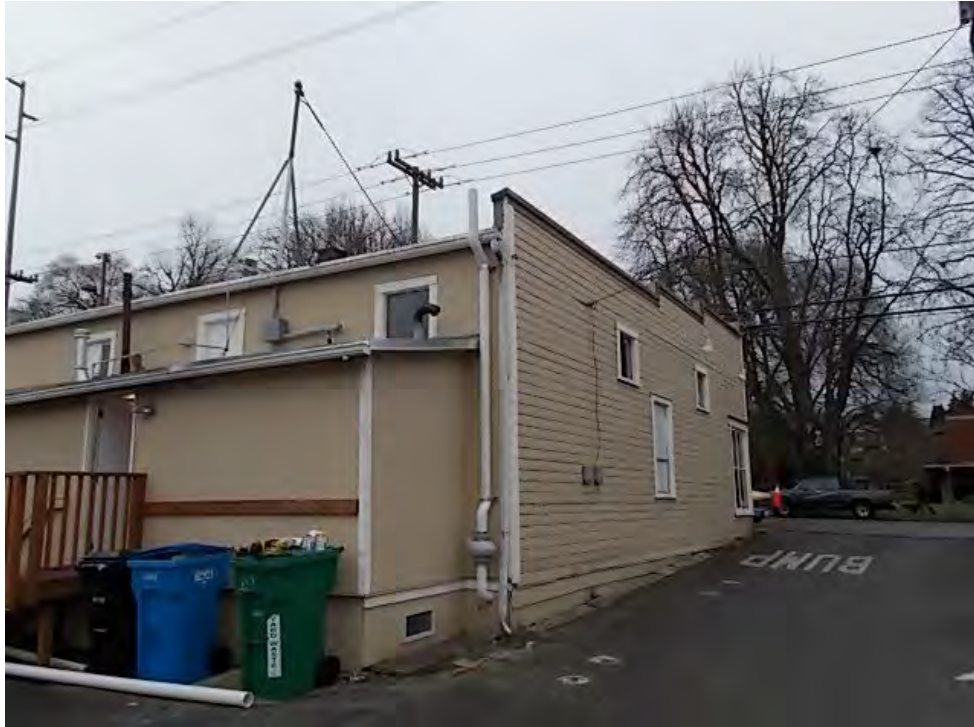
The vent stack was constructed of 4-inch-diameter, Schedule 40 polyvinyl chloride (PVC) piping, and was installed at the northeast corner of the building exterior in the location shown on Figure 1 and in Photo 5. The bottom of the stack transitions through the building wall into the interior crawl space with an elbow fitting, and connects to the header of the perforated HDPE piping. The top of the stack is fitted around the eave and gutter at the roof of the building and extends approximately 2 feet above the roof line. Aluminum brackets were used to secure the stack piping to the exterior building wall.

ART installed the in-line ventilation fan near the bottom of the stack on the exterior of the building (Photo 5). The fan is a 90-watt AMG Hawk manufactured by Festa Manufacturing Enterprises, LLC. The AMG Hawk operates on 120 volt 60 Hz power and can achieve a maximum rated flow of up to 295 cubic feet per minute (CFM) at a static pressure of 0 inches of water column (w.c.). Performance specifications for the fan indicate that it can achieve 122 CFM at a static pressure of 1.0 inch w.c., which is the approximate operating flow rate expected for the system based on communications with ART. A copy of the fan specifications sheet from the manufacturer is included as Attachment B.

PHOTO 5
Northeast corner of building, location of vent stack and in-line fan.

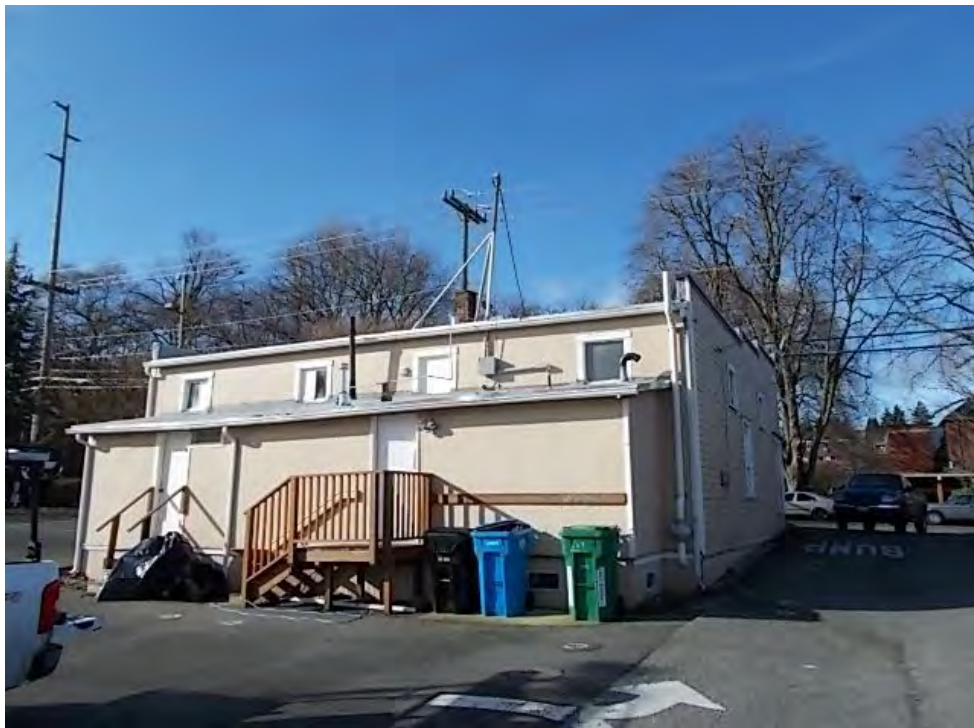
After ART completed installation of the system components, a representative from Balkan Electric, LLC completed the electrical connections to the fan in a manner consistent with local electrical codes. The electrical installation was completed on February 7, 2013, at which time ART started up the system. Upon final inspection of the system and its operation, ART left the Property with the system operating (Photo 6).

PHOTO 6
Building with vapor mitigation system installed and operating.
