Independent Cleanup Action Report Eastmont Junior High Site

**Eastmont School District
East Wenatchee, WA**

October 20, 2005

INDEPENDENT CLEANUP ACTION REPORT
Eastmont Junior High School Site
East Wenatchee, Washington

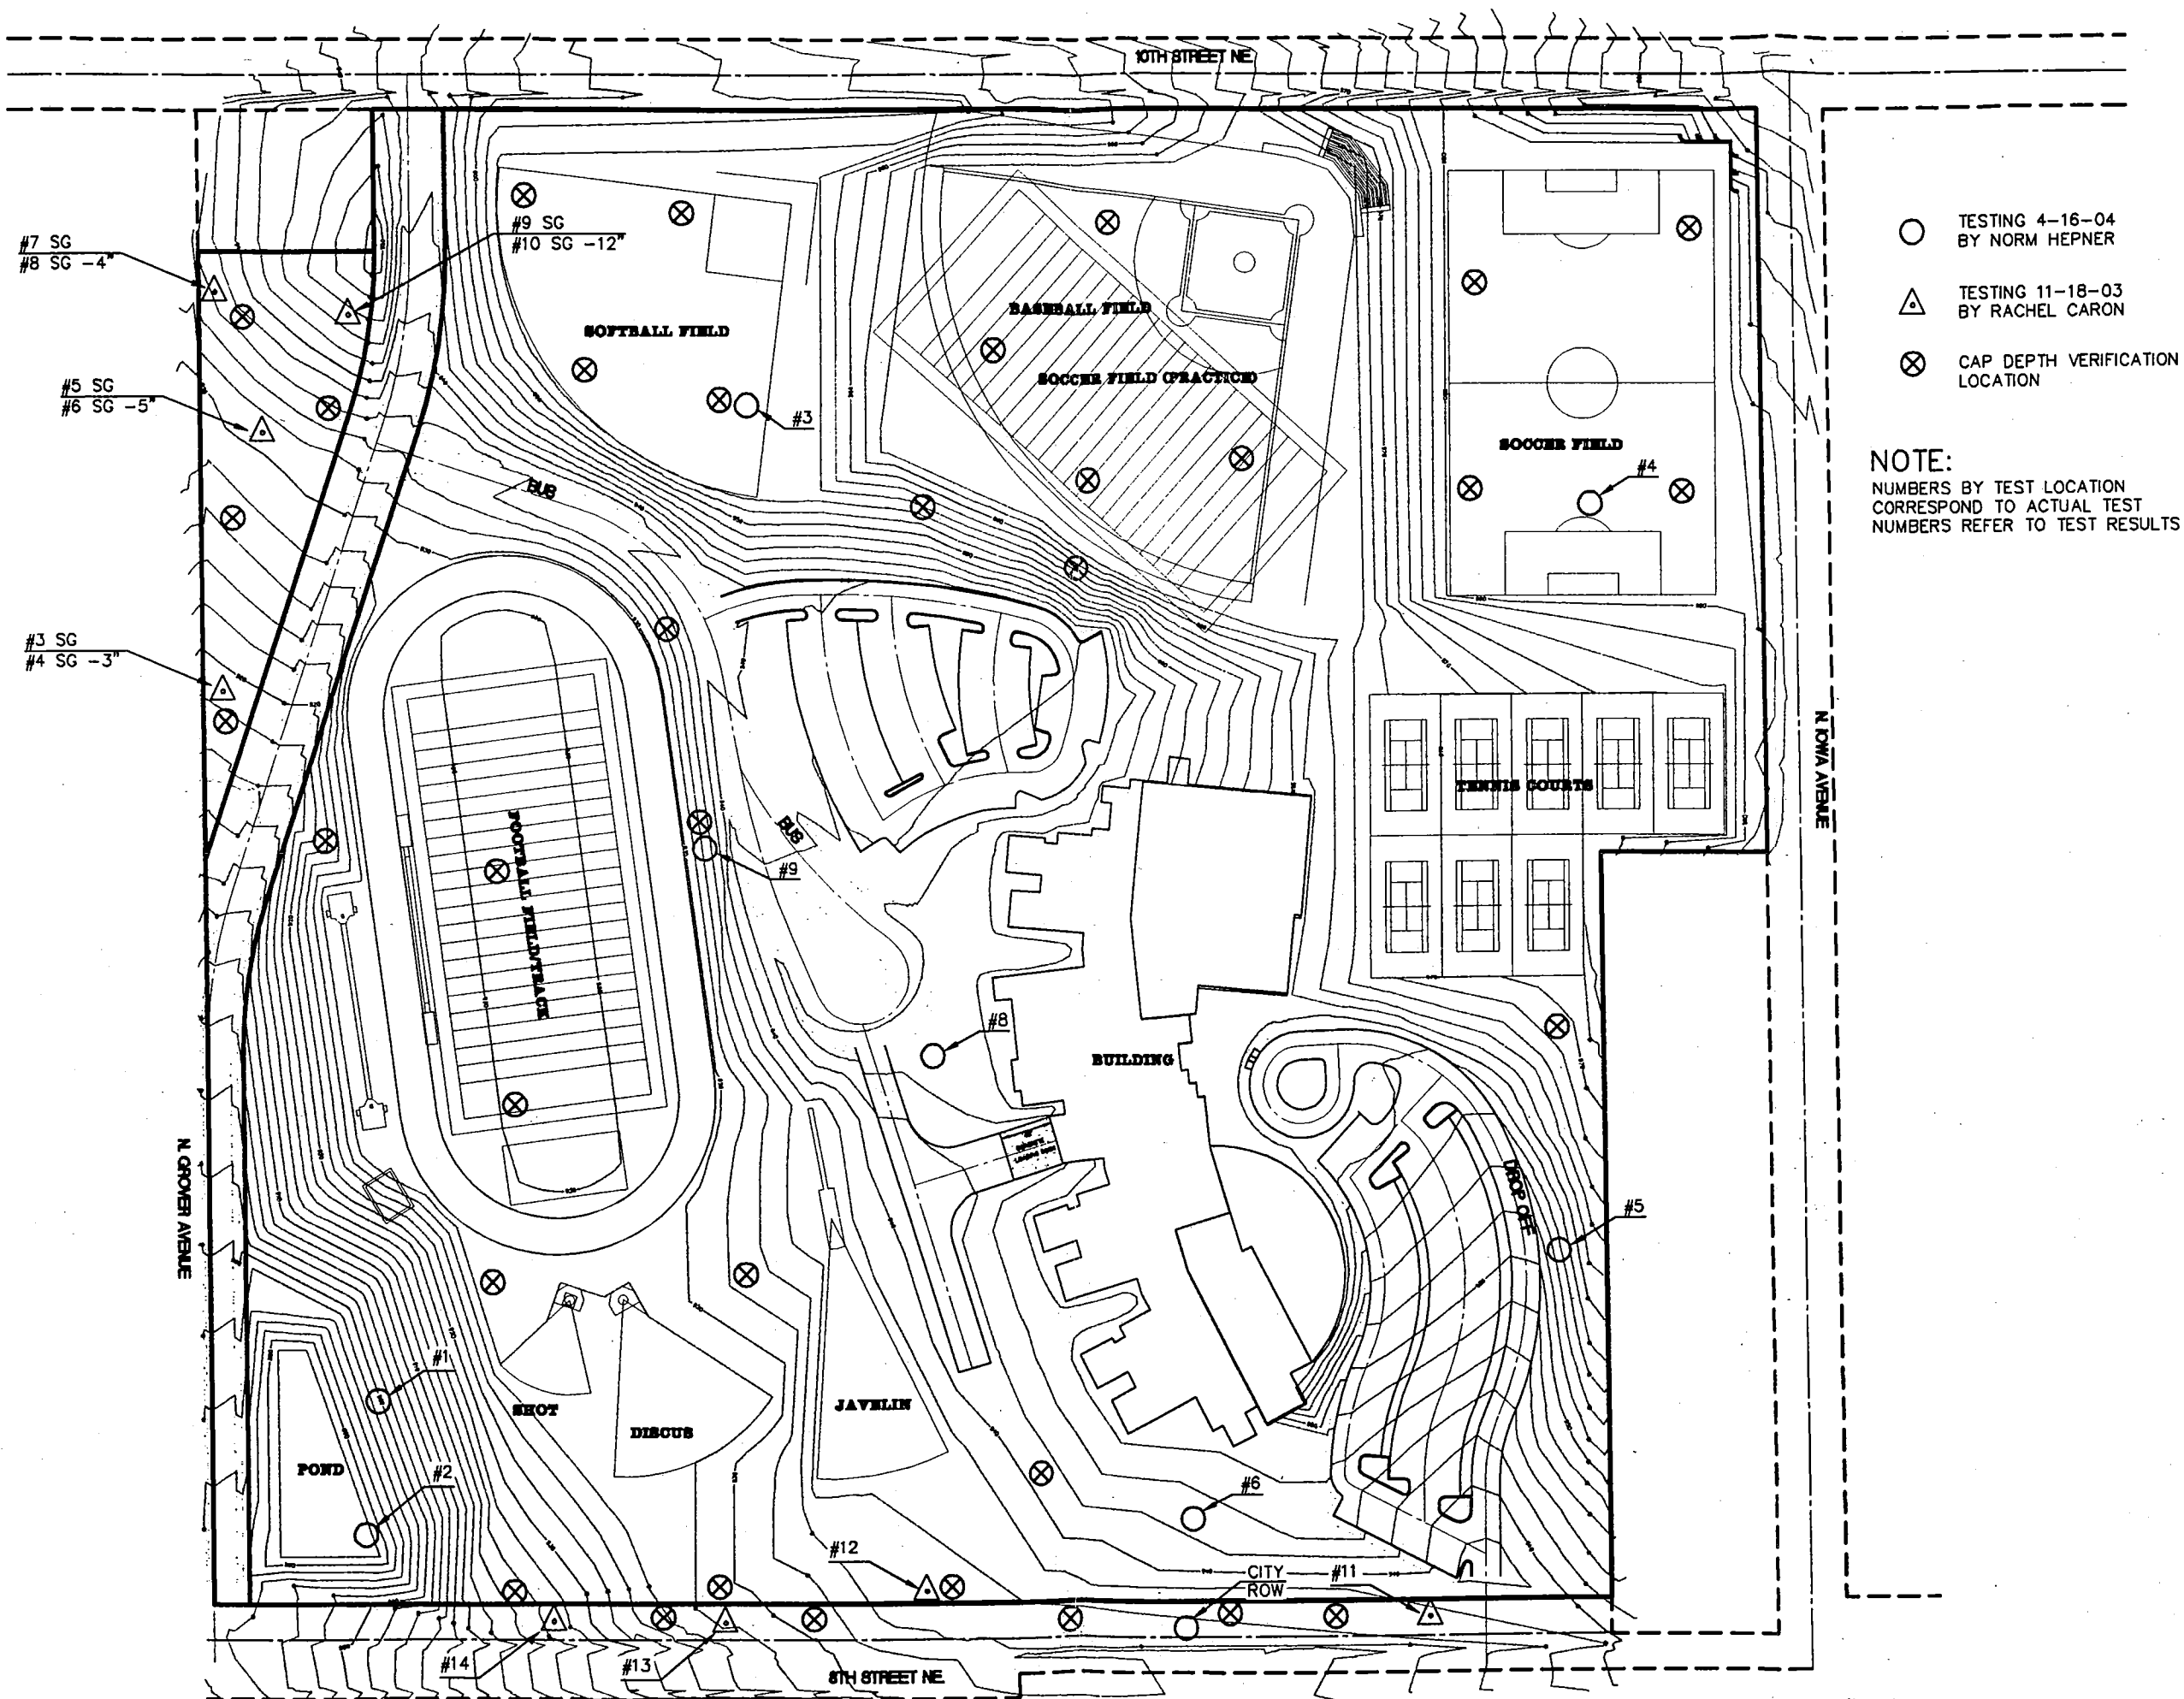
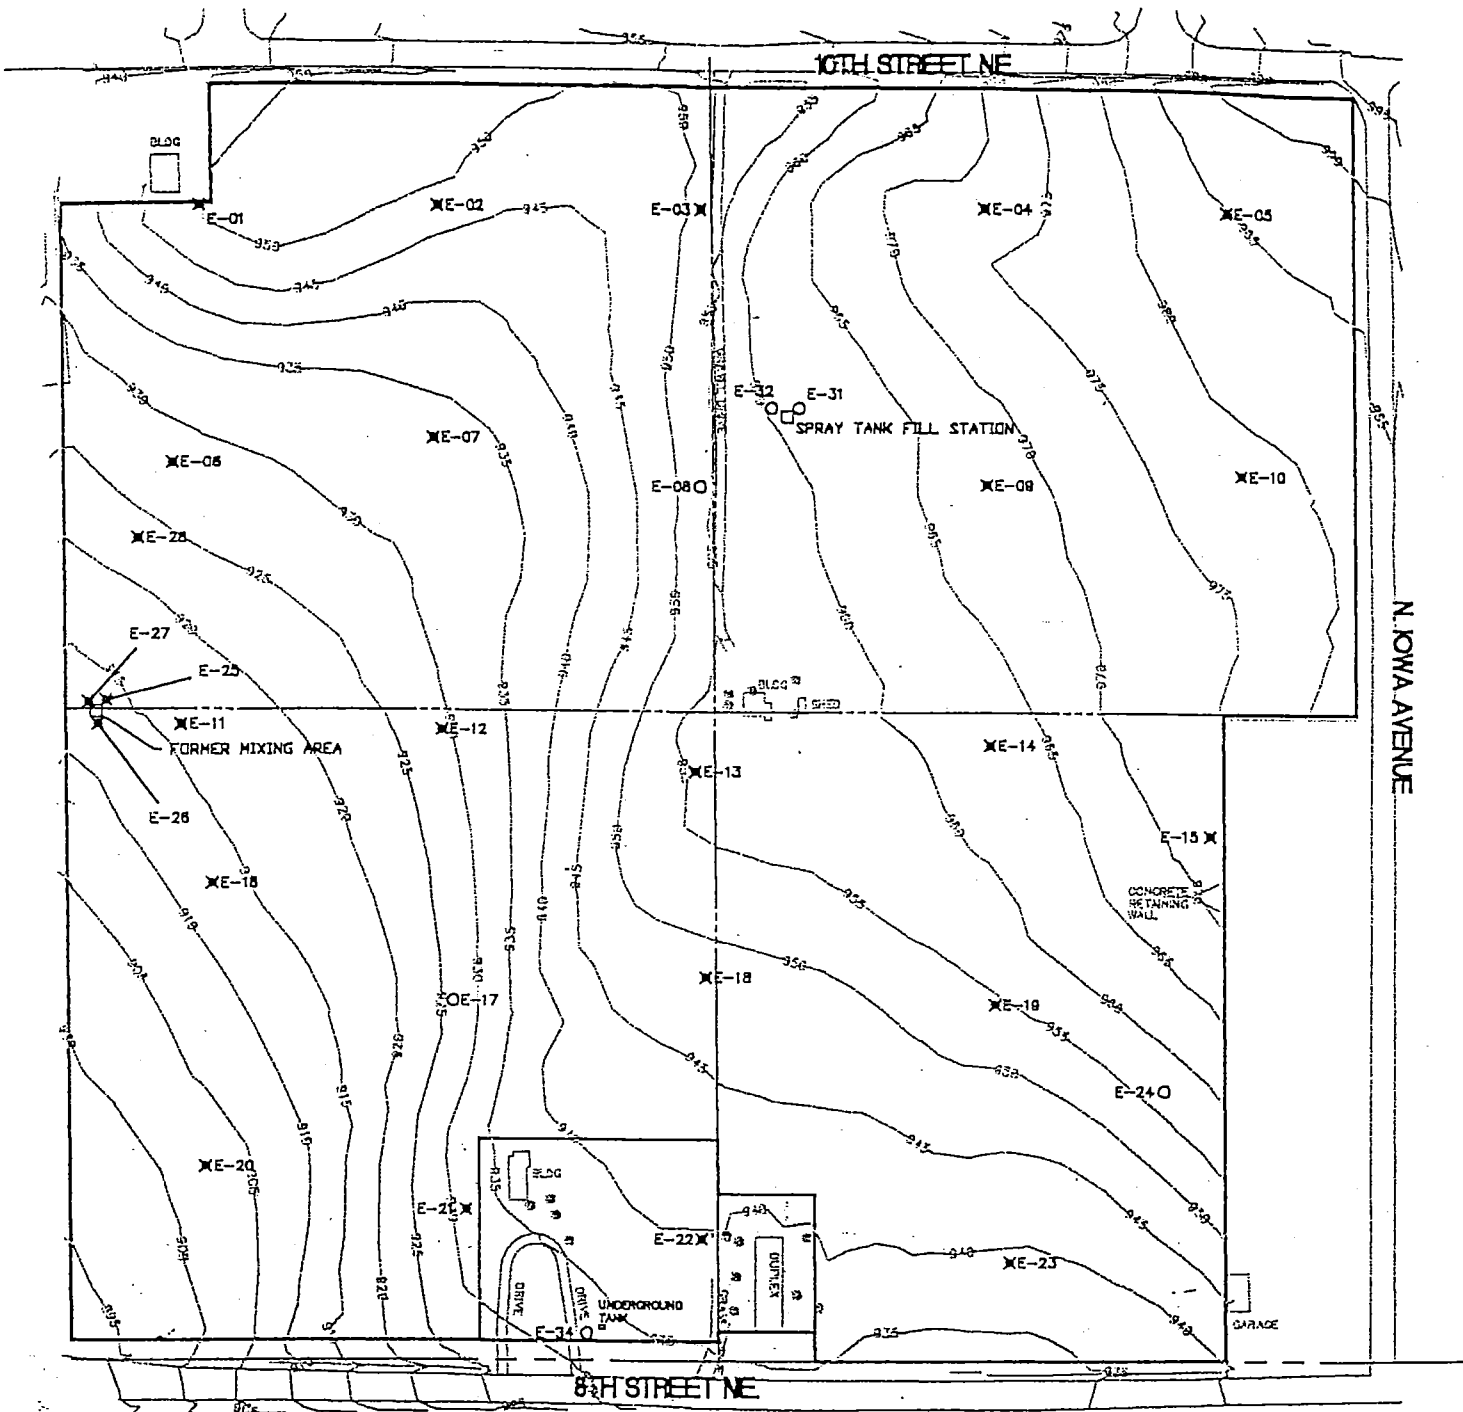
FIGURE 1
EASTMONT JR. HIGH SCHOOL
SOIL CAP LEAD AND
ARSNIC LEVEL VERIFICATION

In an effort to confirm the effectiveness of the remediation program at the Eastmont School Site, Forsgren Associates and Department of Ecology representatives visited the site on April 16, 2003 to sample selected areas for metals analysis. Ecology provided and operated a hand-held field x-ray fluorescence (XRF) instrument for on-site analysis of lead and arsenic. The instrument was a Niton XL700 Series detector. Ten tests were completed using the XRF instrument at locations shown on Figure 1. Test results are shown in Table 5-1.

All arsenic tests indicated concentrations below the detection limits for the XRF instrument. One half of the lead tests showed concentrations below instrument detection limits. Four samples showed concentrations above the detection limit but below the Washington State Method A cleanup level for lead of 250 mg/kg. The remaining sample was analyzed in the City of East Wenatchee right-of-way south of the Eastmont School property boundary. That sample showed a concentration of lead in the soil above the Method A cleanup level. The arsenic concentration in this sample was below the instrument detection limit. This area was addressed as part of the City of East Wenatchee 8th Street Improvements.

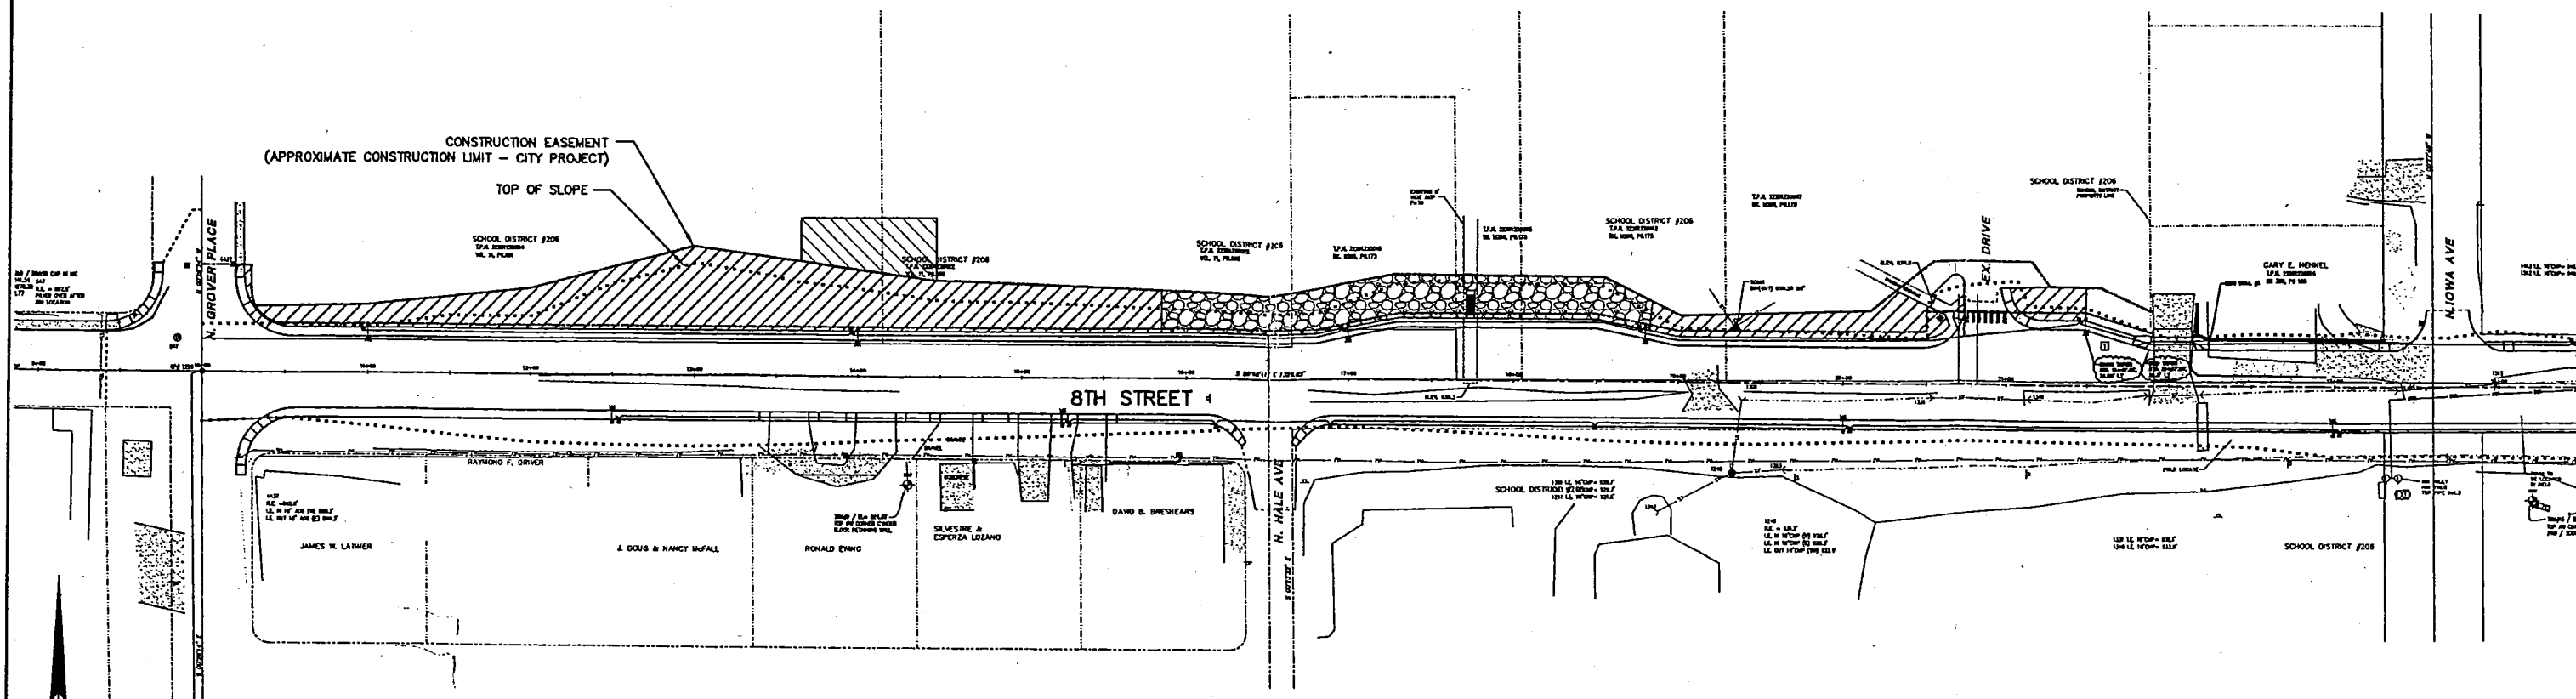
The 8th Street project originally called for 6" of topsoil to be placed over 6" of common borrow along the ESD sloped frontage of 8th Street. This was changed to either placing 12" of topsoil with 6 oz. geotextile fabric placed between the two 6" minimum layers or placing 12" minimum quarry spalls. Quarry spalls were to be used where the slope was steeper than 3:1 and the fabric option was used for the remainder of the sloped area in question.

The enclosed map details the locations where the various approaches were constructed.

The Eastmont School District triangular parcel, near the southwest corner of Grover and 10th Street, was covered with 6 oz. geotextile fabric and 6" minimum depth of topsoil.

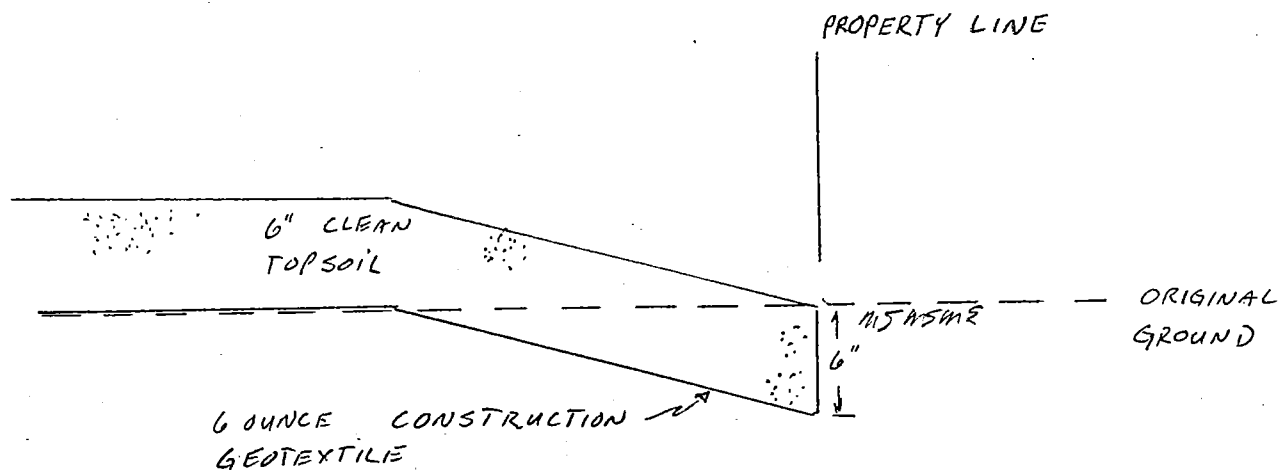
OWNER-PROJECT	BY	DATE	PROJECT NO.
1ST MONT JR HIGH SCHOOL	J. CALDWELL	10-7-03	900-106.008
FEATURE	CHK'D BY	DATE	SHEET 1 OF 1
GROVER ST TRIANGLE CAP DETAIL

I am writing at your request to clarify the cover requirement for the fill area on the west side of Grover Avenue. As per my discussion with Norm Hepner of the Washington State Dept of Ecology, a 6 oz. Geotextile fabric overlaid with 6 inches or clean topsoil will satisfy the capping requirement. The issue at hand is the capping on the edges of the site. The intent of the requirement is that the entire site must contain the stated cap. The property line shall not be allowed to unravel or erode and end up with exposed geofabric or a substandard cover. There are many methods which will meet this requirement. I have attached a detail that will work and shows my intent.
