# Five-Year Review Briefing

## Harbor Island Superfund Site, Seattle, WA

*Presented by USACE  
Seattle District*

*1 July 2015*

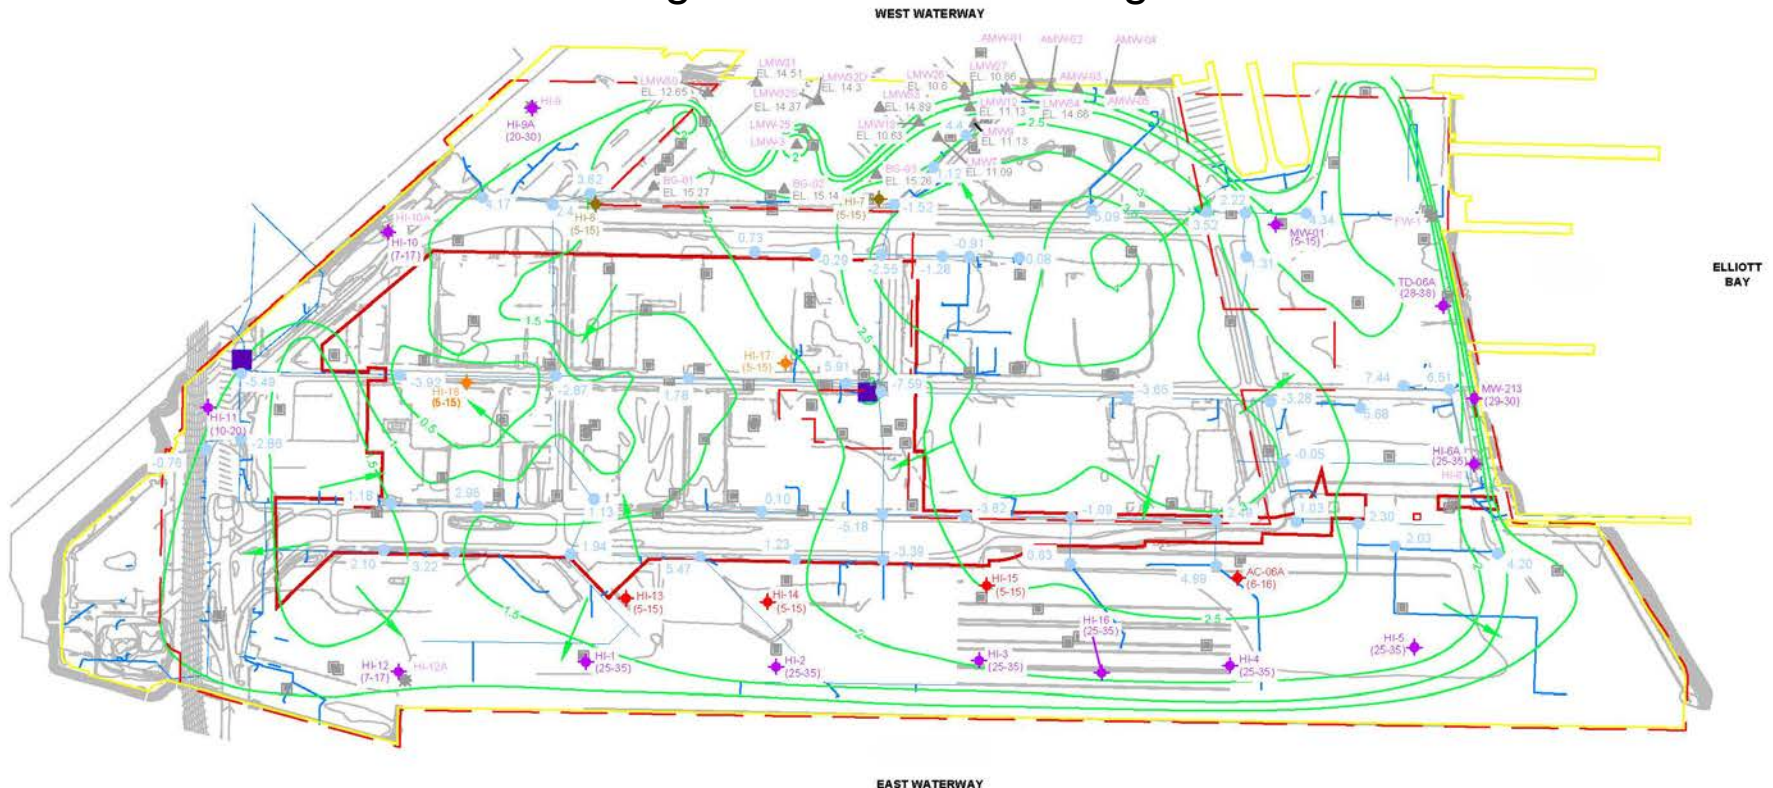
- Submitted cap inspections indicate cap is appropriately maintained
- Exceedences of ROD cleanup levels in last 5 years of arsenic, cadmium, copper, lead, mercury, nickel, zinc and cyanide.
- Highest concentrations observed at inland well HI-17
- No spatial or temporal data trends
- Data indicate that active migration is not occurring.

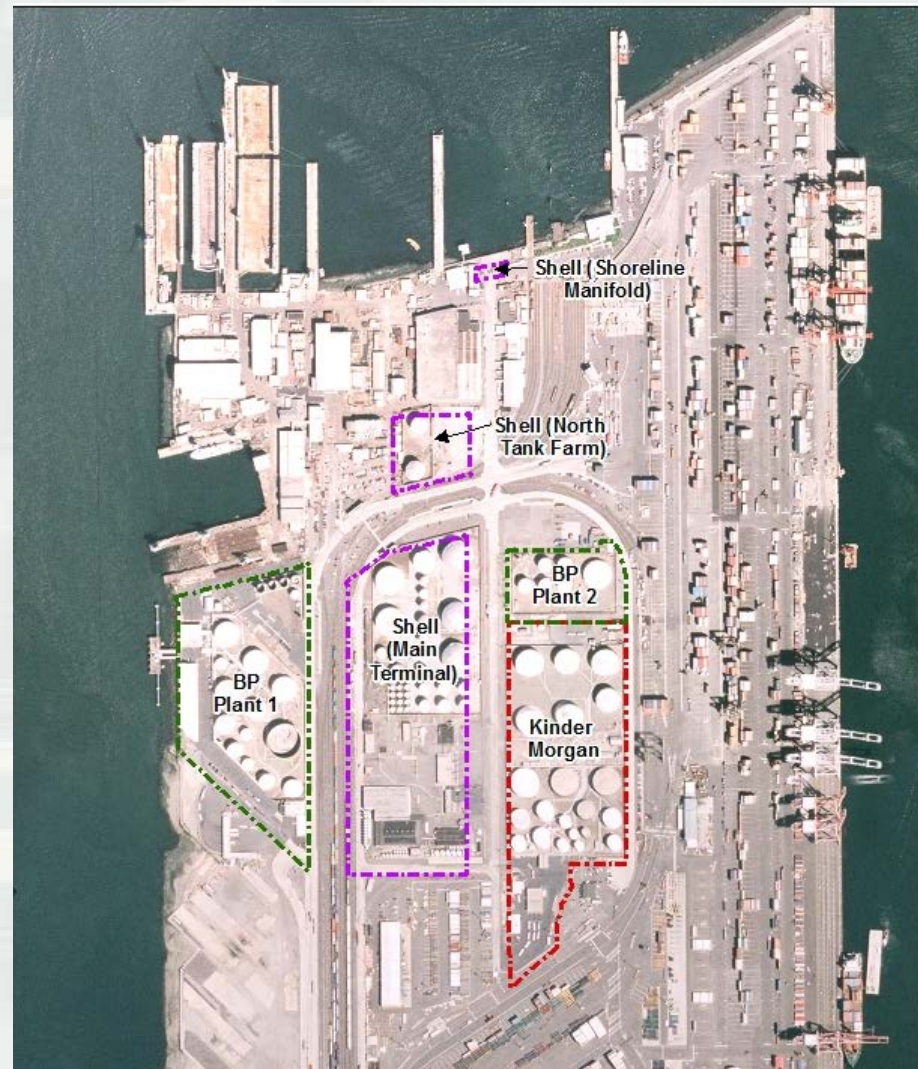
- **BP Plant 1:**
  - ▶ Active recovery system along shoreline
  - ▶ COCs along shoreline below cleanup levels
  - ▶ Installing new seawall in 2015, design calls for sheet piles driven to 70 feet
- **Kinder Morgan:**
  - ▶ Using sulfate land applications to treat remaining contaminants
  - ▶ Area along 13<sup>th</sup> Ave W investigated and shows contamination is contained and concentrations are decreasing
- **Shell:**
  - ▶ Elevated COCs at north end of Main Terminal
  - ▶ Pilot testing completed and full-scale remediation is being evaluated.

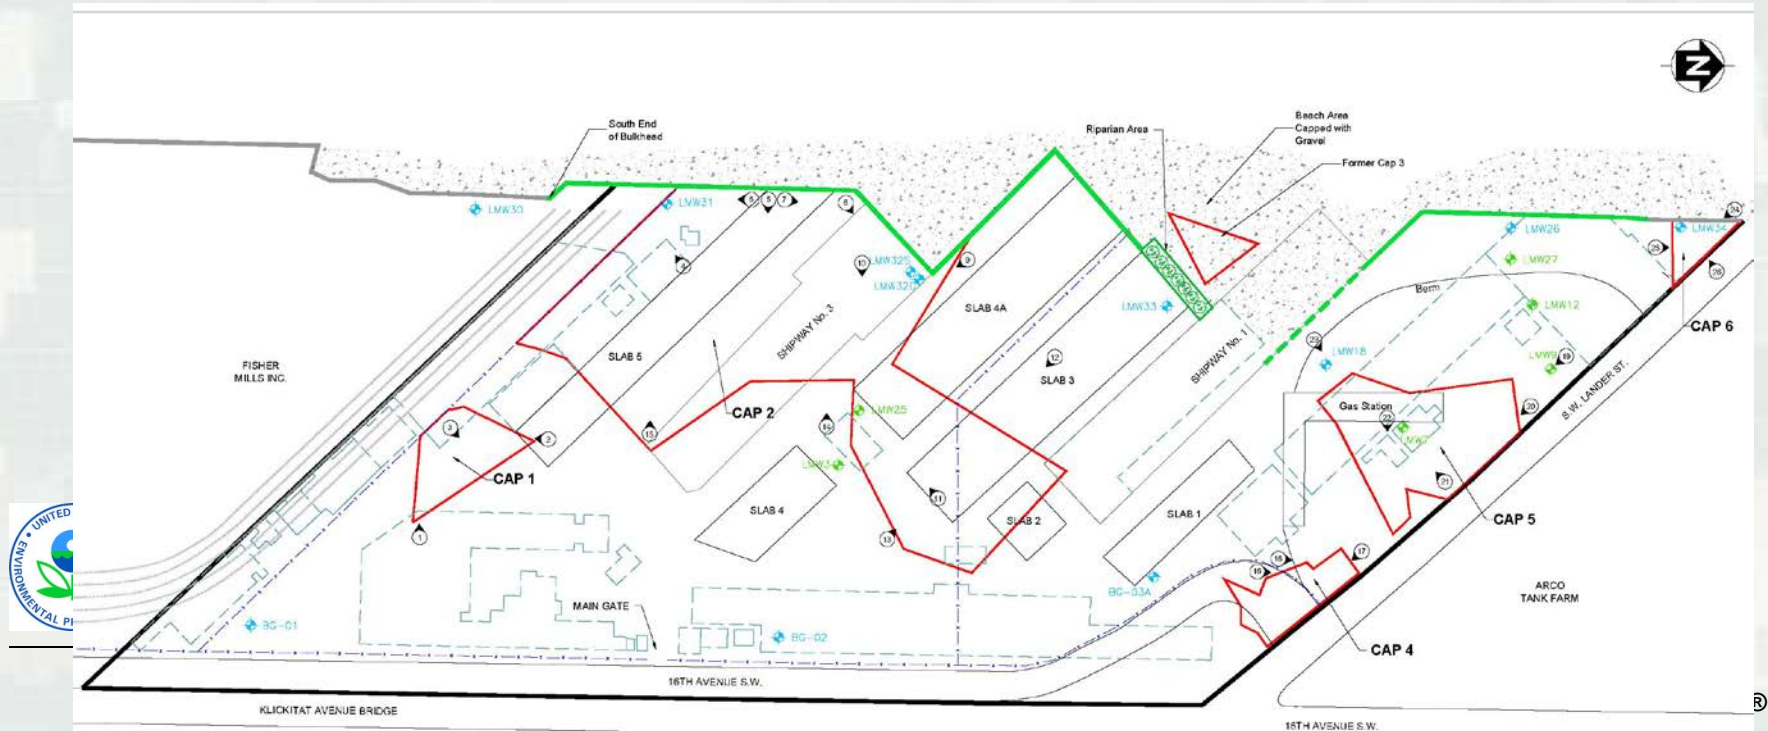
- Port of Seattle redeveloped site in 2011, re-grading removed ponding issues on the cap
- Exceedences of ROD cleanup levels in last 5 years of PCE, copper, zinc
- PCE concentrations show increasing trends
- Copper and zinc detections are sporadic or localized occurrences

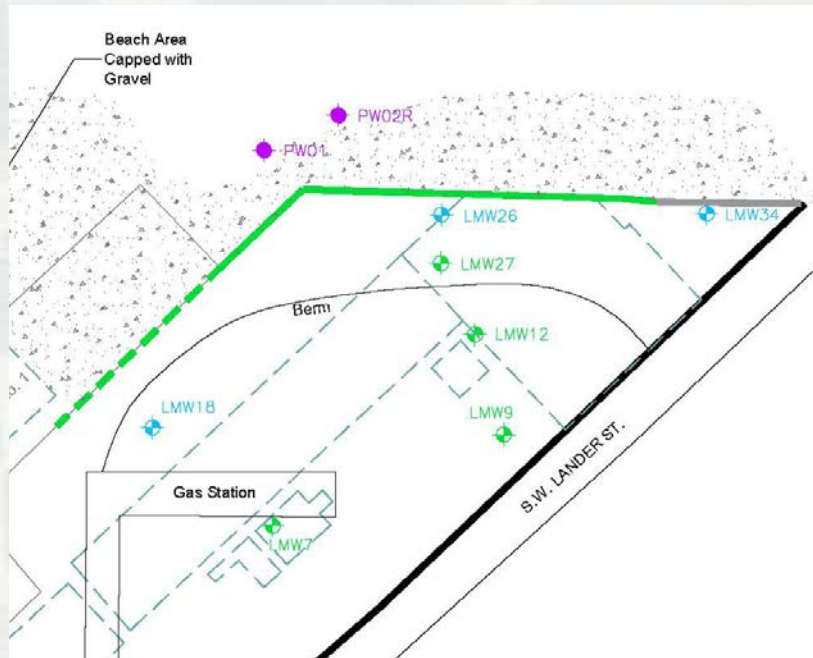
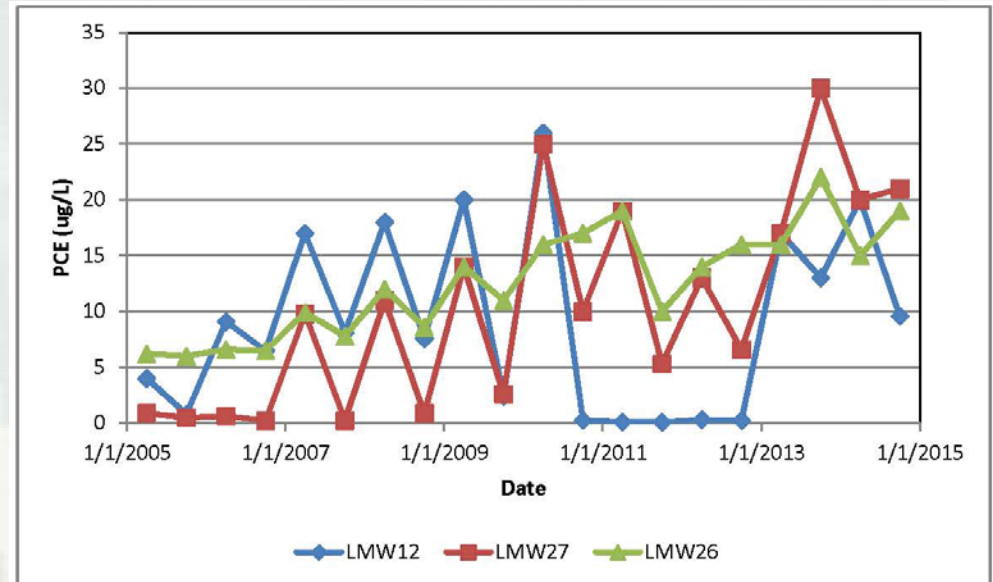
- Tidal study in 2011 showed groundwater flow directions varied from northerly to westerly (inland)
- Pore water samples collected in 2014 did not detect PCE
- PCE does not appear to be impacting the waterway

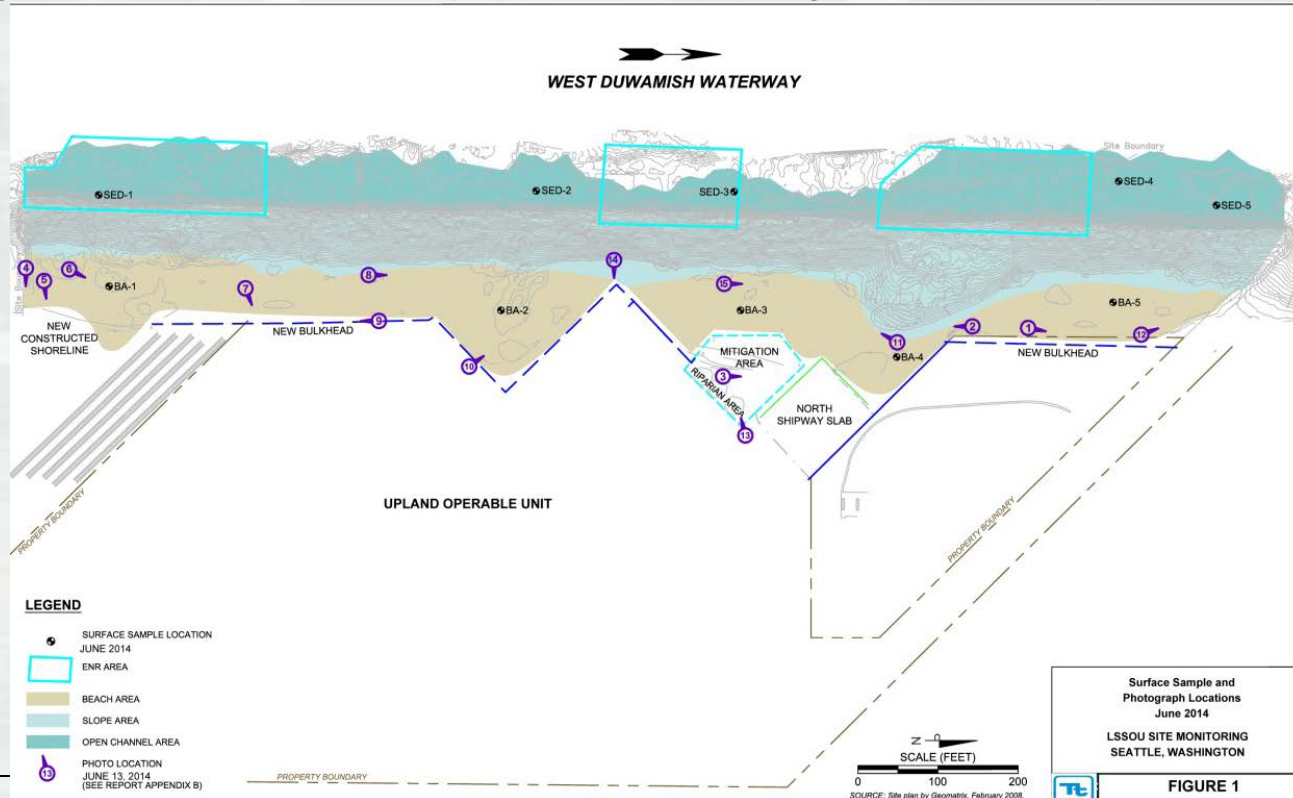
FIGURE 1

- In 2013 and 2014, mercury and zinc in stormwater solids > SCOs
- In 2014, mercury in SED-2 and SED-3 and total PCBs in SED-3 > SCOs; increase in fine-grained sediments; possible top-down contamination
- Hydrographic survey: localized erosion near BP pier in open channel (not part of cap)
- Topographic and visual surveys: little to no change since remedy implementation

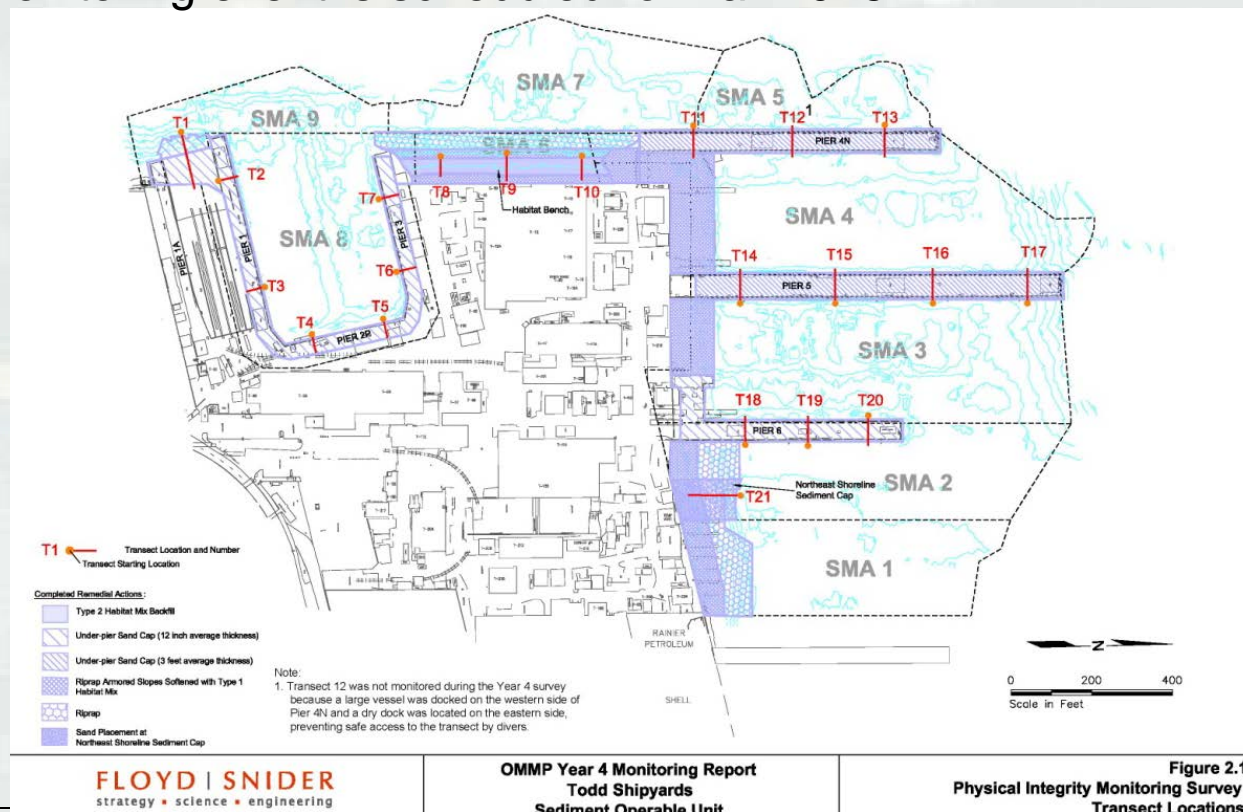
Figure 2.1  
Physical Integrity Monitoring Survey  
Transect Locations

- Physical integrity monitoring performed by divers in 2011
- Early action warning level: observation of complete erosion
- Complete erosion not observed, so no contingency actions are warranted
- Next monitoring event is scheduled for Fall 2016
