**Supplemental Environmental Services
Summary**

Former Texaco Service Station
5059 Wilson Avenue South
Seattle, Washington

July 21, 2011

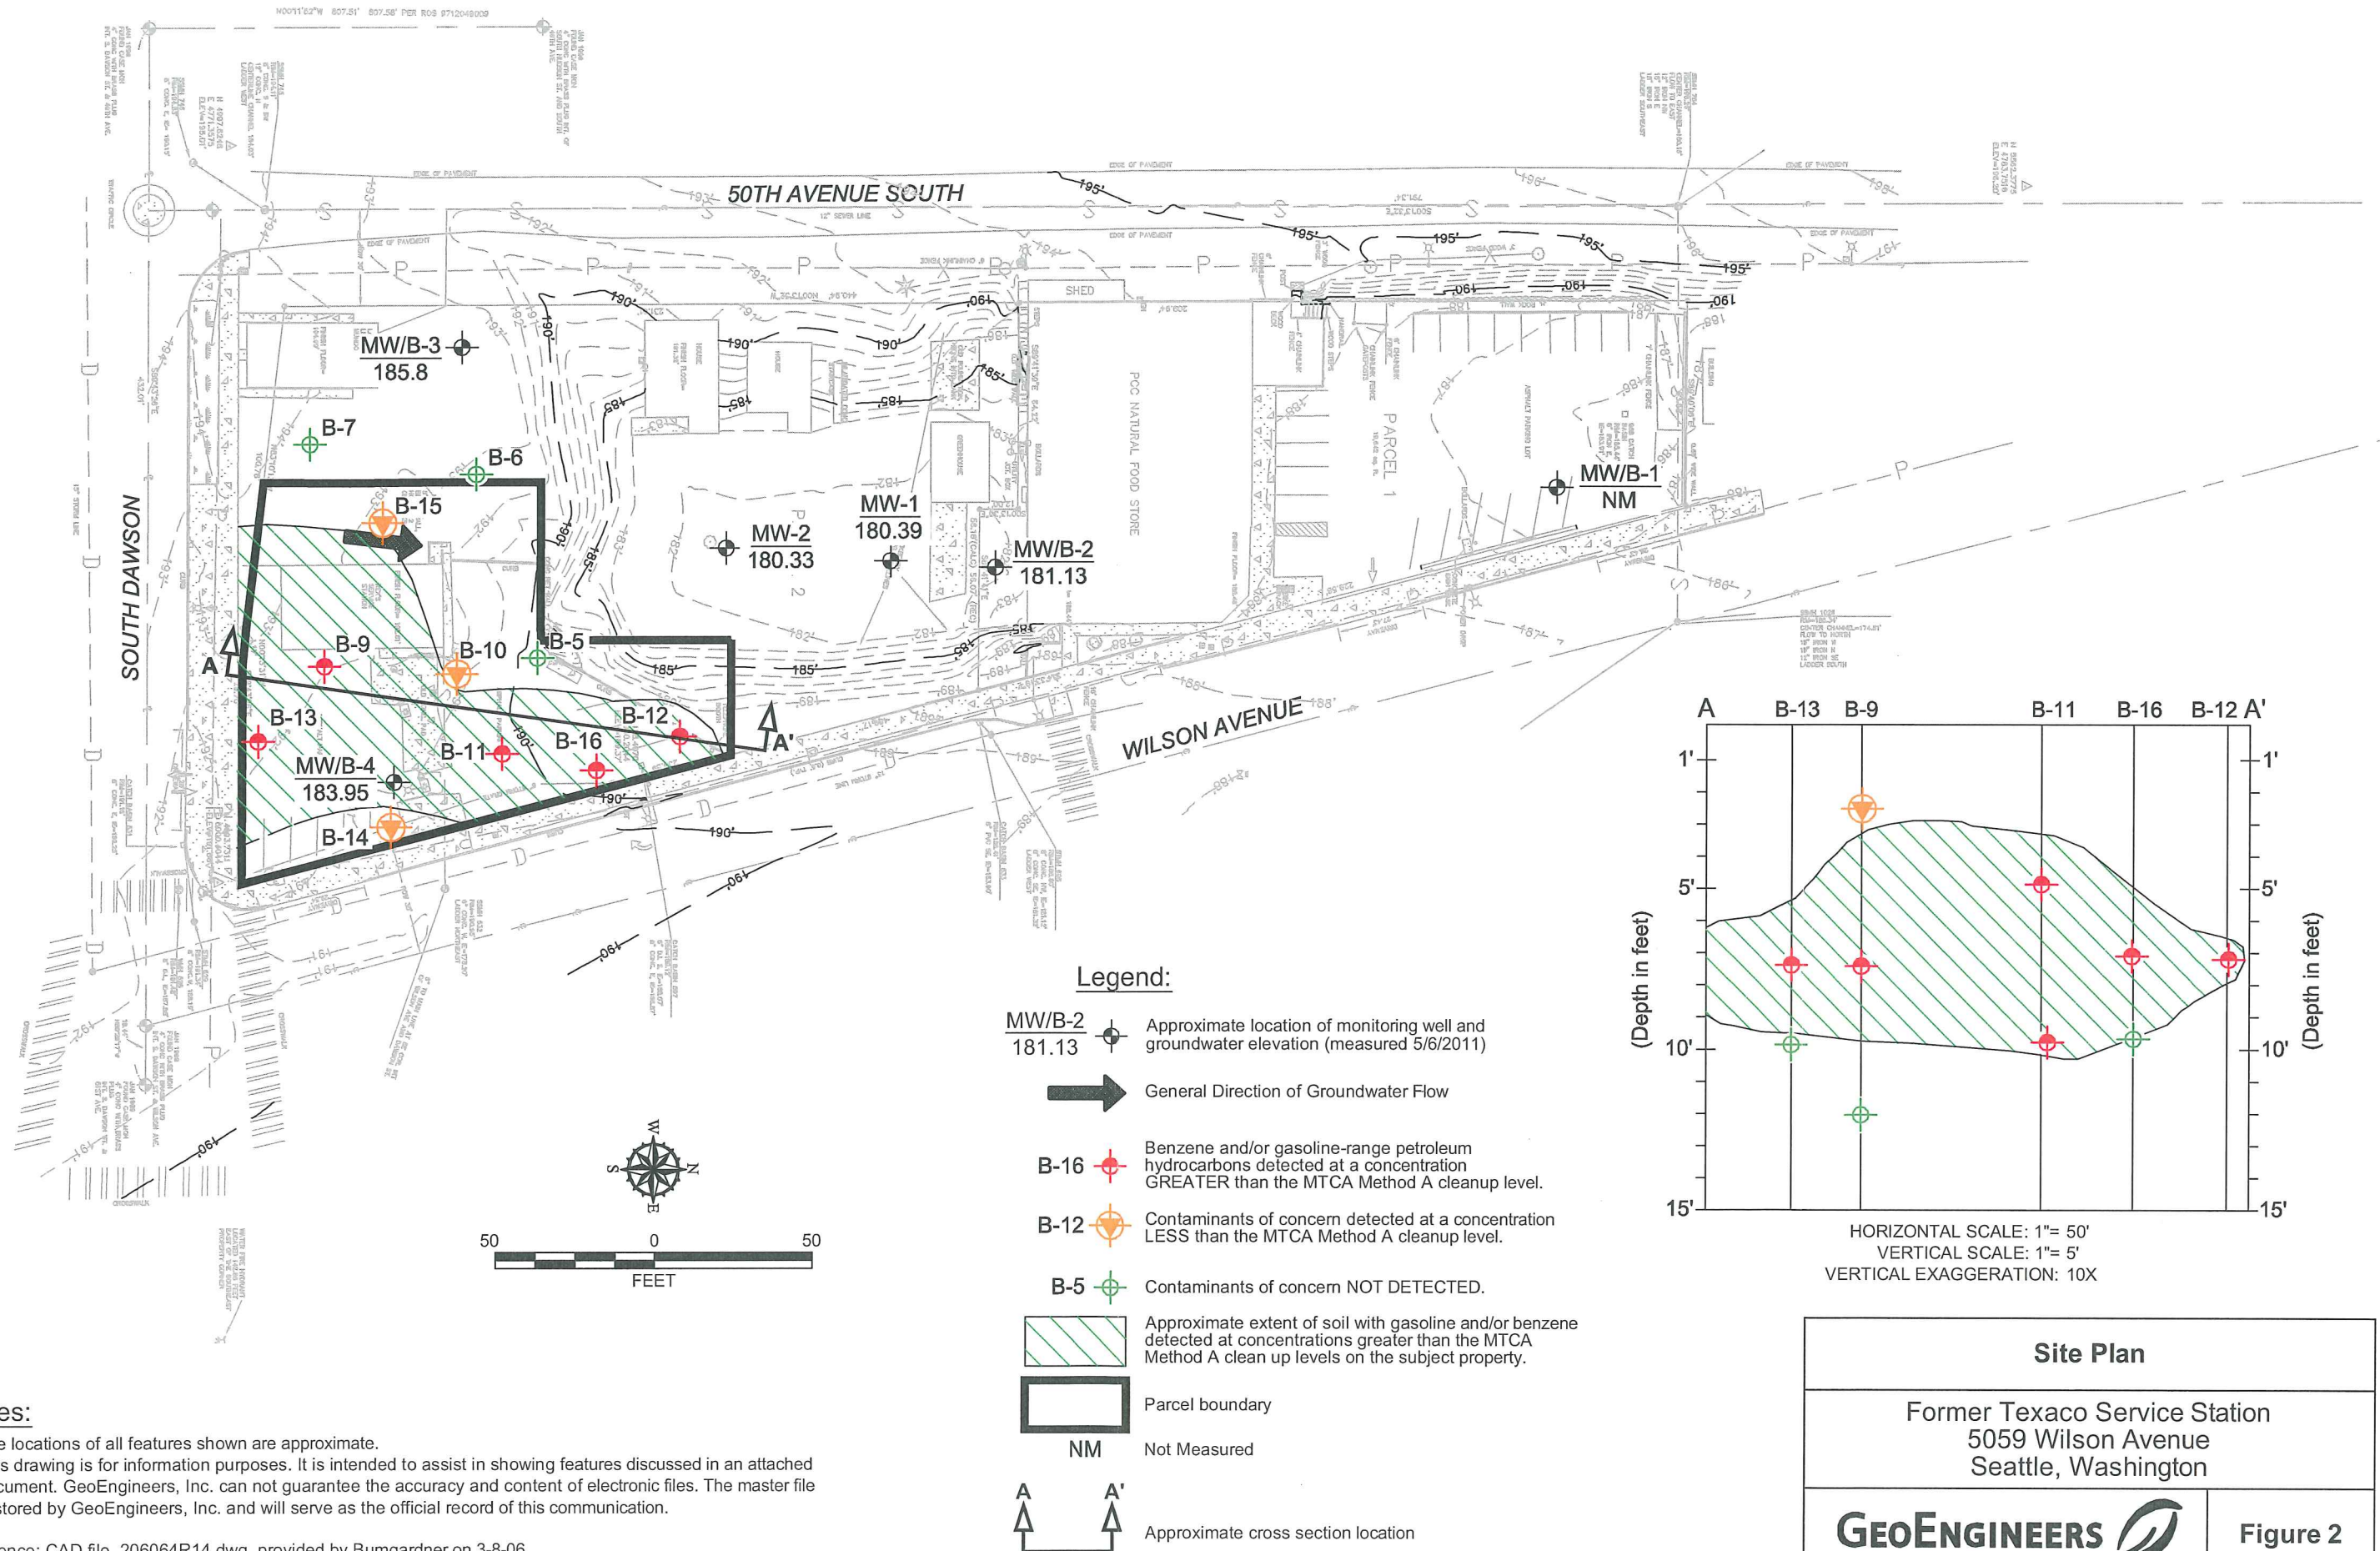
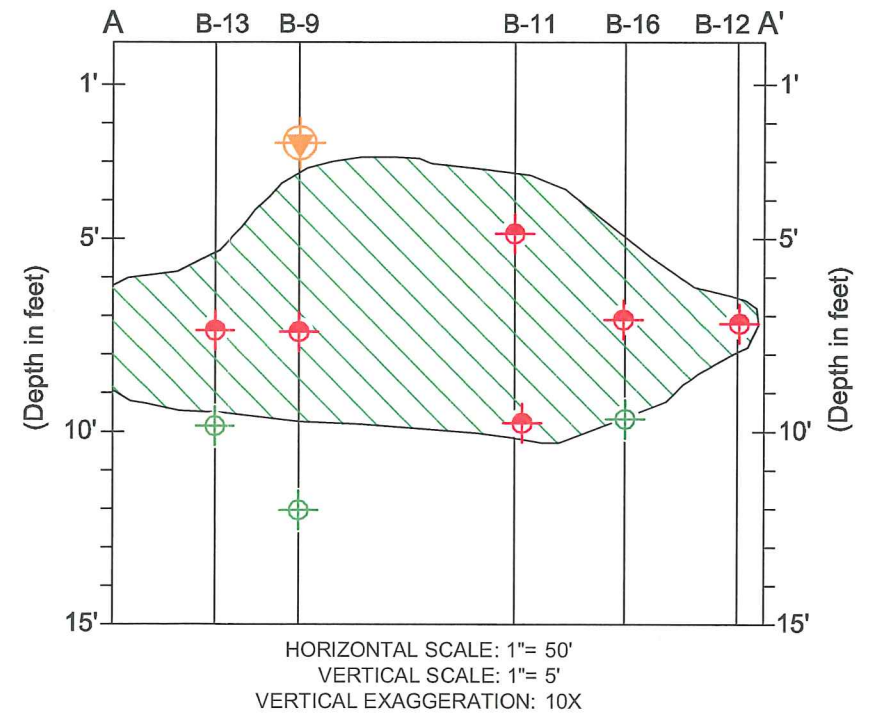
Site Plan	
Former Texaco Service Station 5059 Wilson Avenue Seattle, Washington	
	Figure 2

- Benzene and/or gasoline-range petroleum hydrocarbons were detected at concentrations greater than the MTCA Method A cleanup levels in the following soil samples:
- B-9-7.5 (obtained from boring B-9 at a depth of approximately 7.5 feet bgs);
- B-11-5.0 (obtained from boring B-11 at a depth of approximately 5 feet bgs);
- B-12-7.5 (obtained from boring B-12 at a depth of approximately 7.5 feet bgs);
- B-13-7.5 (obtained from boring B-13 at a depth of approximately 7.5 feet bgs); and
- B-16-7.5 (obtained from boring B-16 at a depth of approximately 7.5 feet bgs).

- **MW/B-4:** Gasoline- and diesel-range petroleum hydrocarbons and benzene were detected at concentrations of 1,550 micrograms per liter ($\mu\text{g/L}$), 1.7 milligrams per liter (mg/L) and 288 $\mu\text{g/L}$, respectively. Each of these detected concentrations are greater than the corresponding MTCA Method A cleanup levels.

Based on field screening and soil chemical analytical results, soil with gasoline and/or benzene concentrations greater than the corresponding MTCA Method A cleanup levels is present at the Site in the vicinity of the former service station at depths ranging between approximately 3 to 10 feet bgs. The thickest lens of soil contamination was observed at the location of B-11 (immediately north, and downgradient, of former fueling facilities and/or tanks). Although the lateral extent of the soil contamination above MTCA cleanup levels to the west was identified during this study (borings B-10 and B-15), the lateral extent of soil contamination to the south and east is unknown and may extend off of the subject property beneath South Dawson Street and Wilson Avenue. The lateral extent of soil contamination to the north of the former service station likely terminates within approximately 5 to 15 feet of boring B-12, based on the relatively low concentrations of gasoline and benzene detected in soil samples obtained from this boring and the lack of field screening evidence of contamination observed at this location. The approximate vertical and lateral extent of potentially contaminated soil is shown on Figure 2. Based on our observations at the subject property and past experience, the source of the contaminated soil at the Site is releases attributable to historic operation of the former service station at the subject property.

Based on the results of the groundwater chemical analytical results, gasoline- and diesel-range petroleum hydrocarbons and benzene are present at concentrations greater than the MTCA Method A cleanup levels beneath the subject property in the vicinity of the former service station. Based on our observations at the subject property and experience on similar sites, the source of the contaminated groundwater at the Site is the contaminated soil, which was contaminated from releases attributable to historic operation of the former service station at the subject property.
