STATE OF WASHINGTON  
DEPARTMENT OF ECOLOGY

**Re: Partial Sufficiency and Further Action Determination under  
WAC 173-340-515(5) for the following Hazardous Waste Site:**

- Name: Groat Brothers/Former Service Station
- Address: 608 West Scott Avenue, Woodland, WA 98674
- Facility/Site No.: 5365021
- VCP No.: SW0519

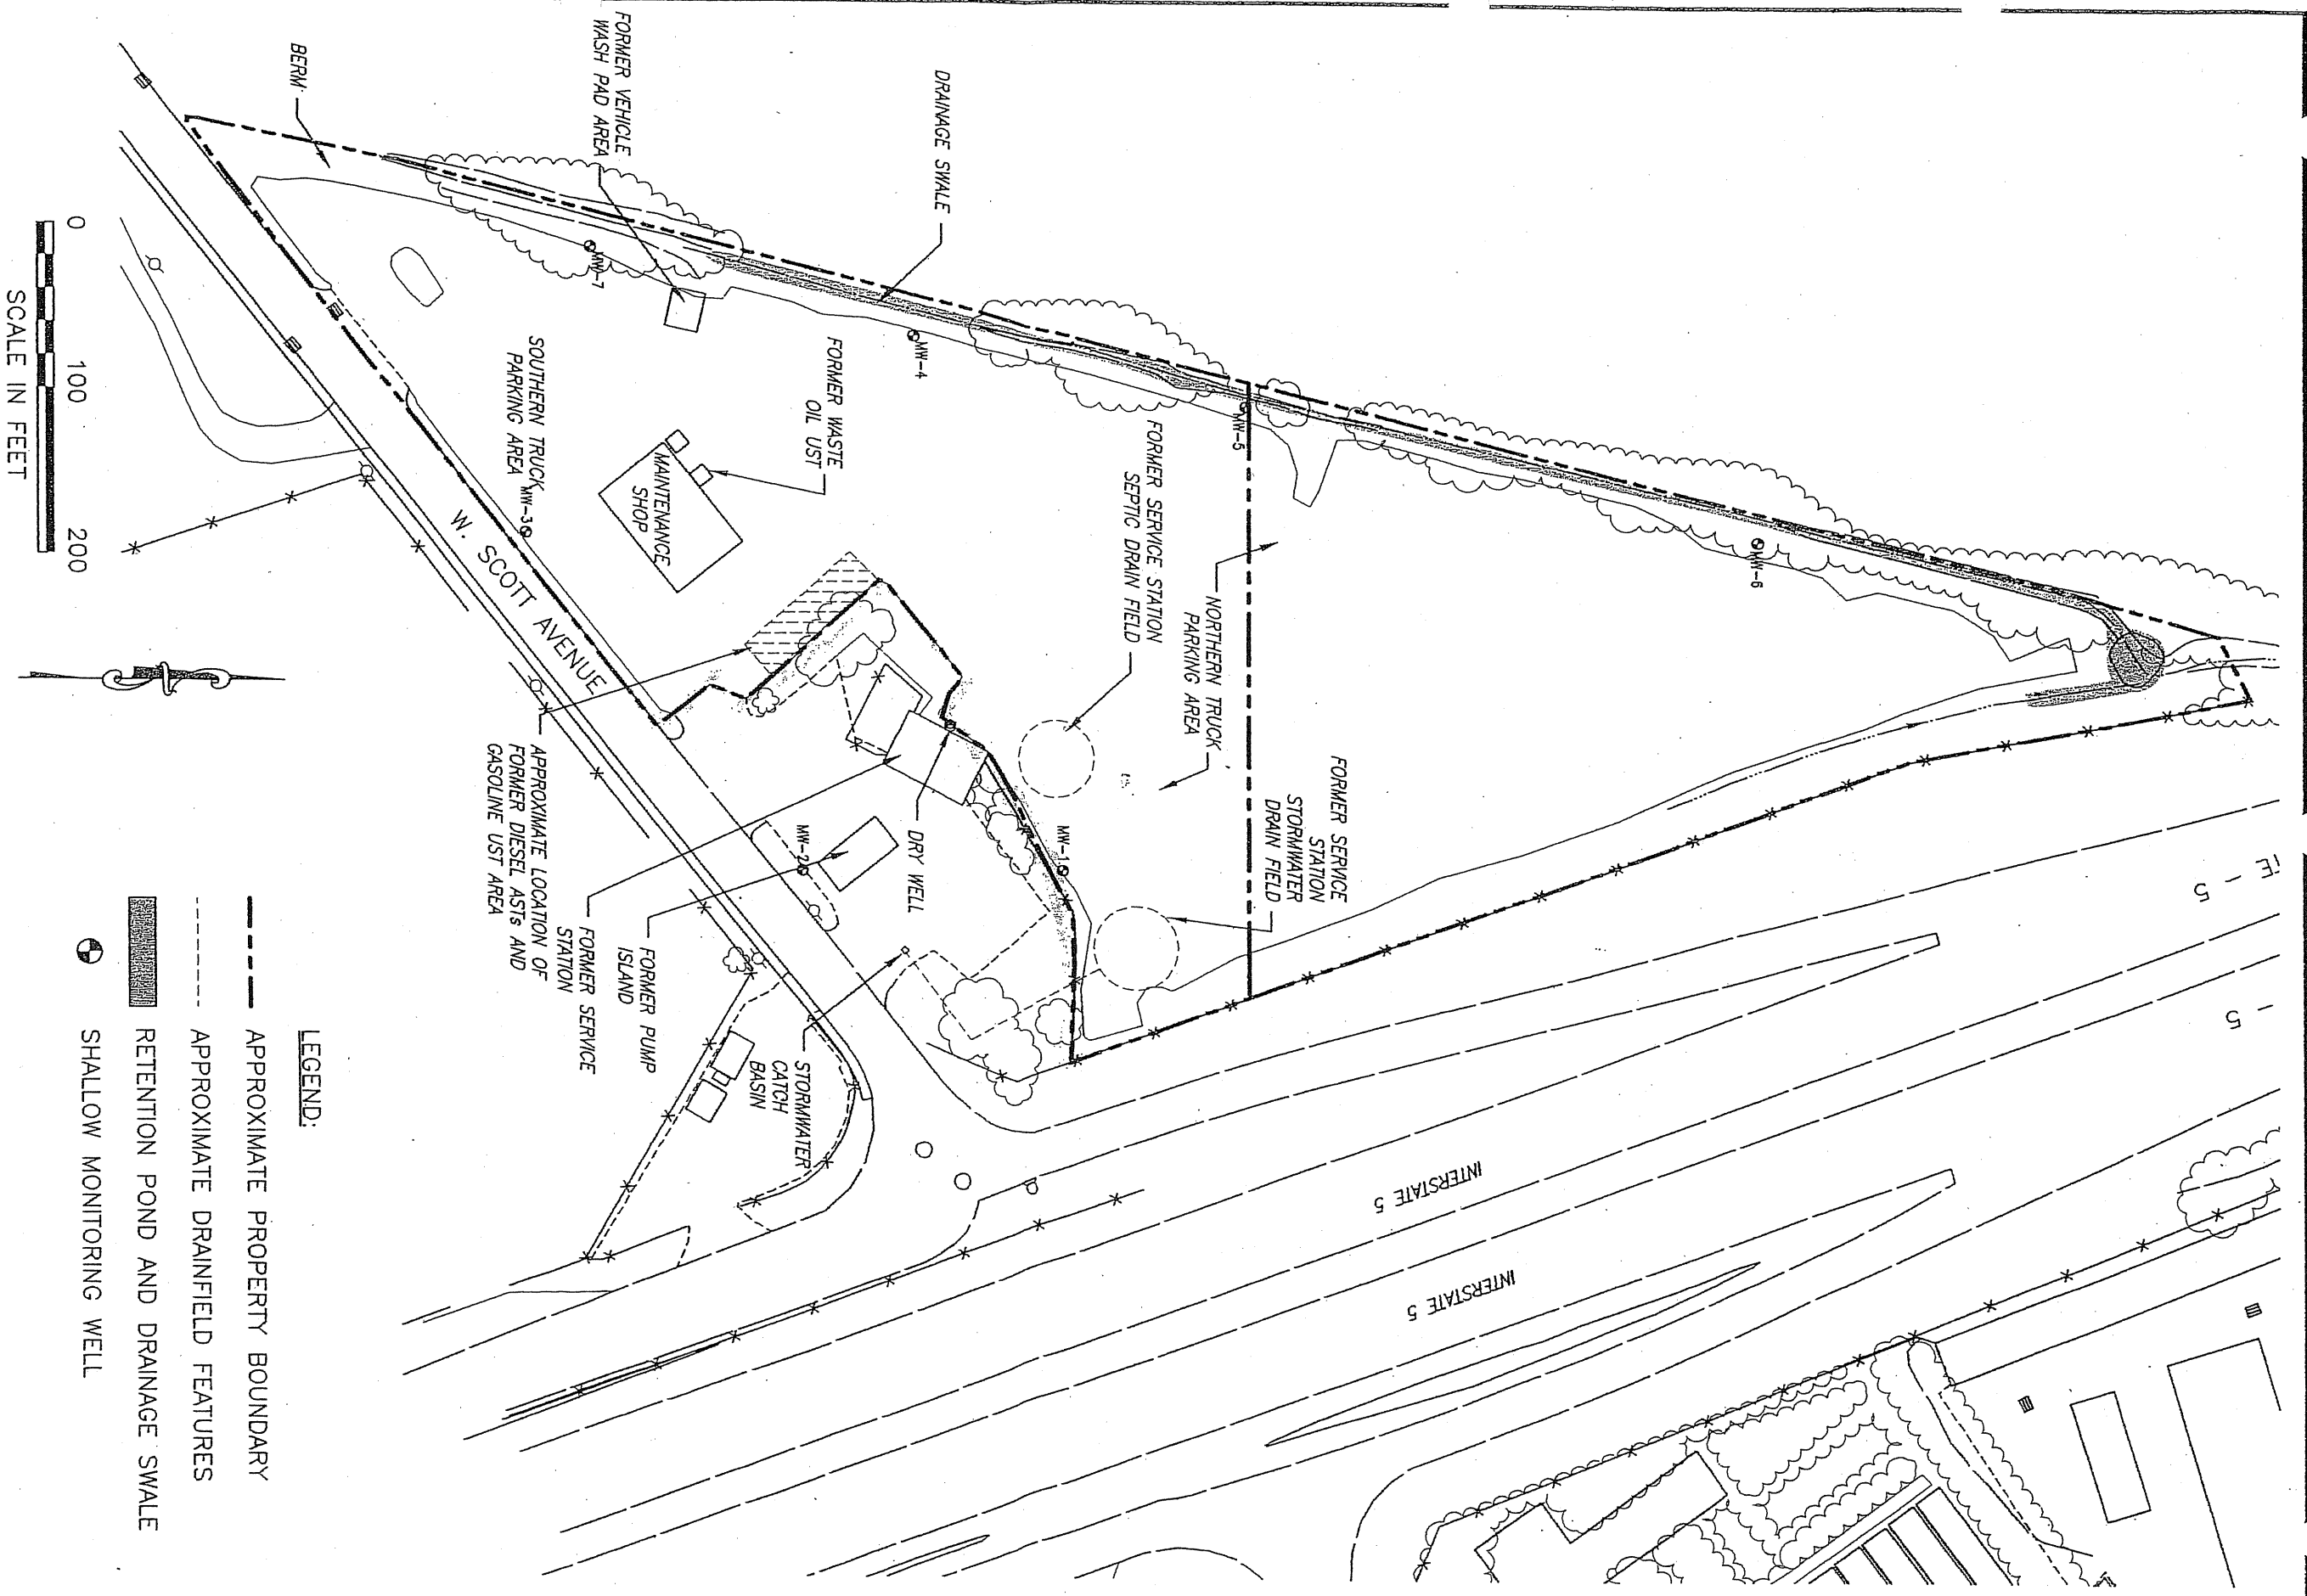
Figure 1  
 GROAT BROTHERS, INC.  
 WOODLAND, WASHINGTON

The site was used as a gasoline retail station, and automobile repair shop from 1967 to approximately 1990. The site is located in Woodland, Cowlitz County, Washington. **Figure 1** shows the layout of the service station with approximate location of former diesel Above-ground Storage Tanks (ASTs), gasoline Underground Storage Tanks (USTs), former pump island, stormwater catch basin, a dry well, and the former service station septic drain field. The application for the VCP shows there were four underground storage tanks (USTs) at the site with capacities of; 1,000 gallon waste oil tank removed in 2003, two gasoline 6,000 gallon USTs removed in 1990 and a 8,000 gallon gasoline UST removed in 1990.
