Second Periodic Review

Minnie Mine Millsite
Facility/Site ID #: 426
Cleanup Site ID #: 4356
Leecher Canyon
Carlton, WA 98814

Prepared by:
Washington State Department of Ecology
Central Regional Office
Toxics Cleanup Program

July 2015

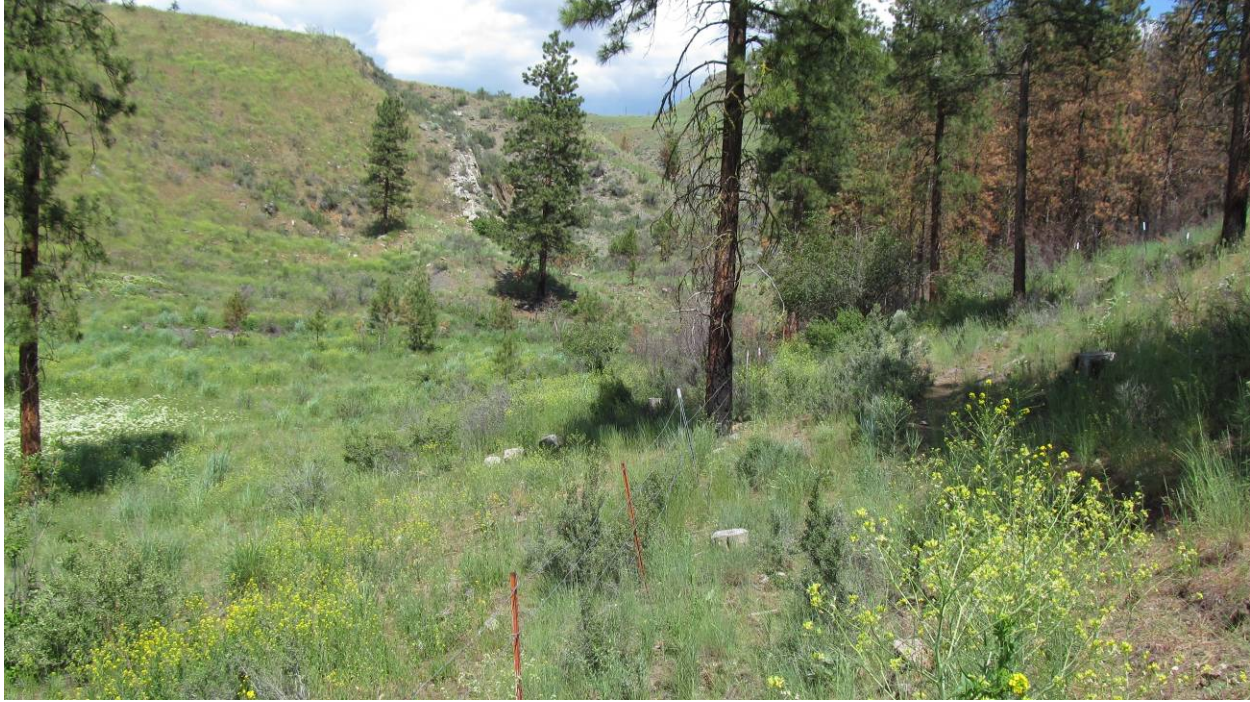
Photo 1: Access to the Site from the South with Burnt Trees Visible to the East

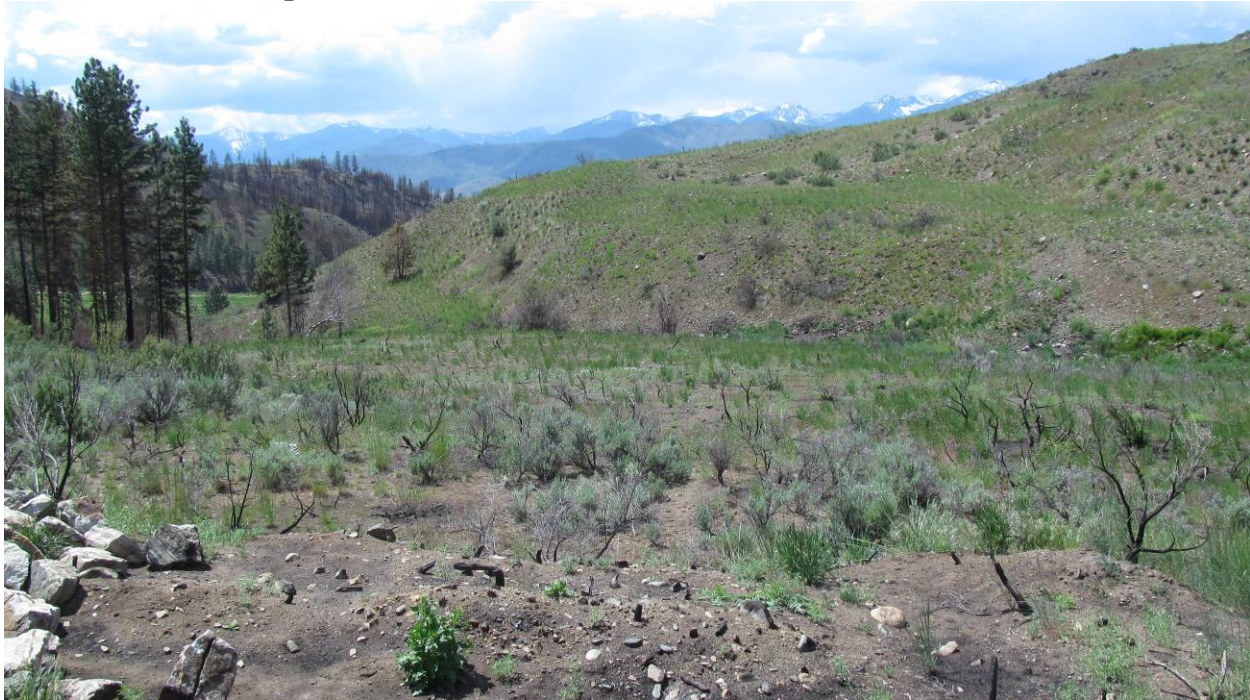
Based upon the Site visit conducted on June 2, 2015, the engineered cap at the Site continues to eliminate exposure pathways (ingestion, contact) to potentially hazardous materials contained at the Site. A wildfire passed through the area in the summer of 2014. There was evidence of burnt vegetation on the cap, and burnt trees to the south of the cap; but the cap appears in satisfactory condition with no evidence of erosion or other damage. No repairs or modifications have been required. The Site remains vacant and is not easily accessible by the public. A photo log is available as Appendix 6.4.

Photo 2: General Cap Condition - from the north

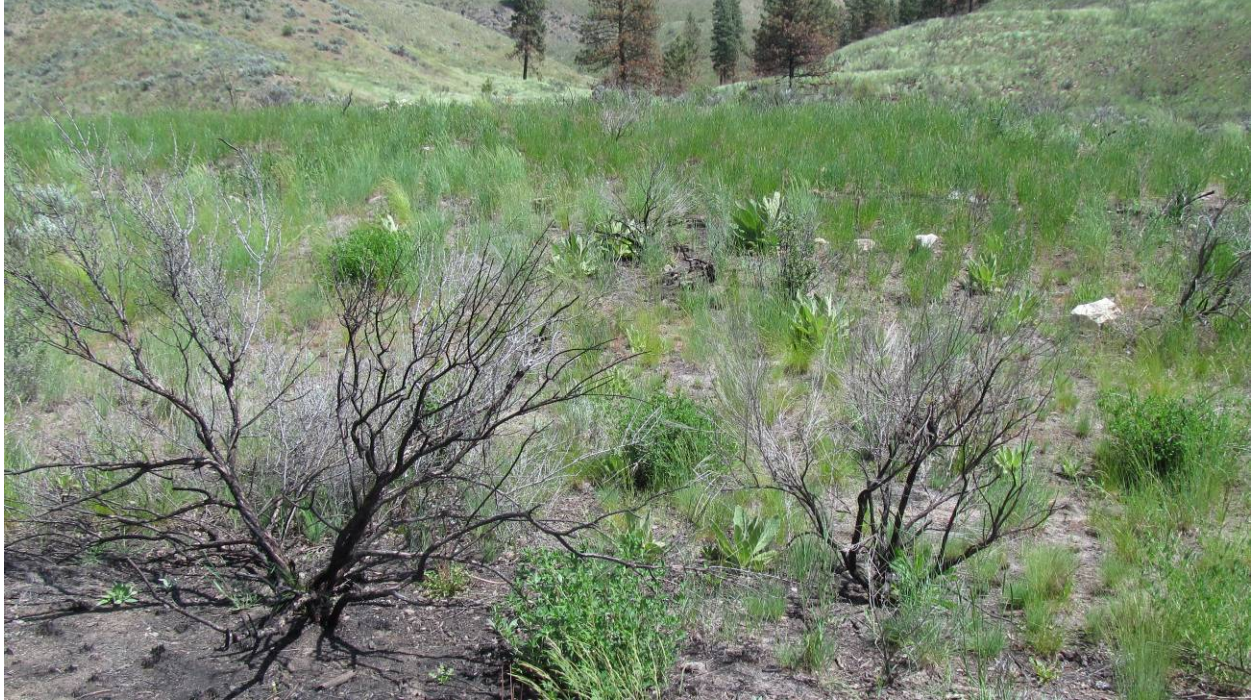
Photo 3: Capped Surface with Burnt Vegetation - from the north

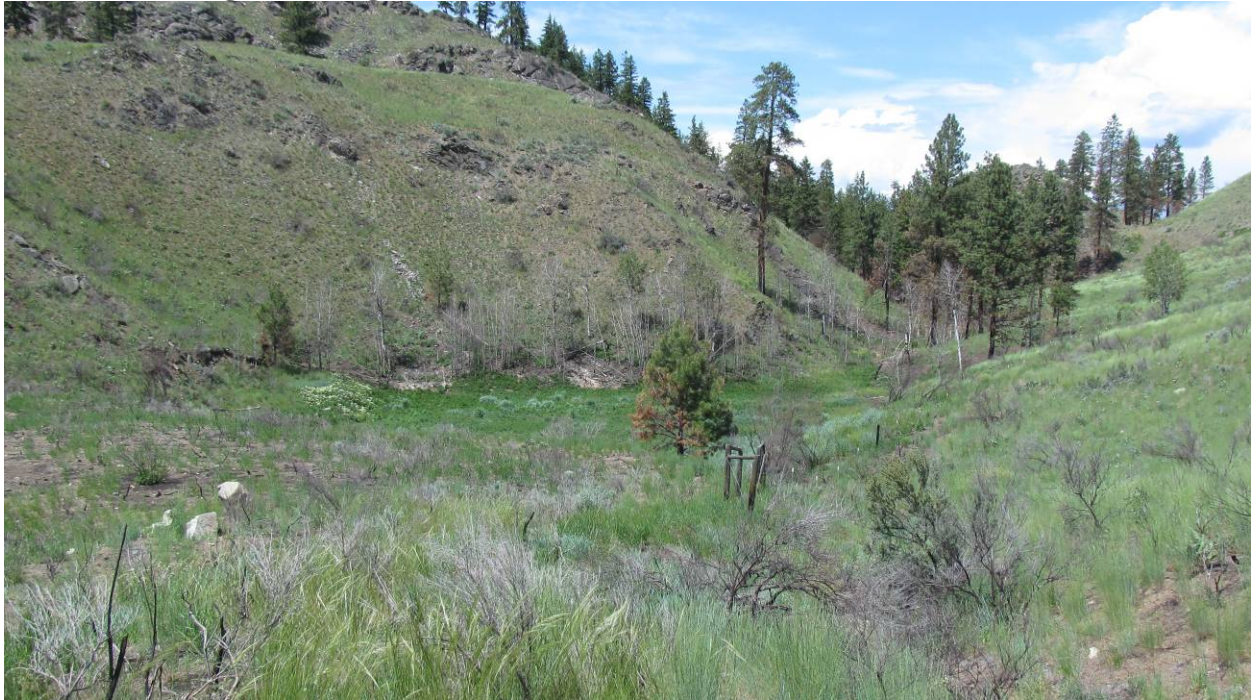
Photo 4: Drainage Entering Site from the Northwest – from the southeast
