PERIODIC REVIEW

Former Georgia Pacific Clear Lake Yard, now Clear Lake Industrial Park Facility Site ID#: 66783635

1283 Highway 9, Clear Lake, Washington

May 2011

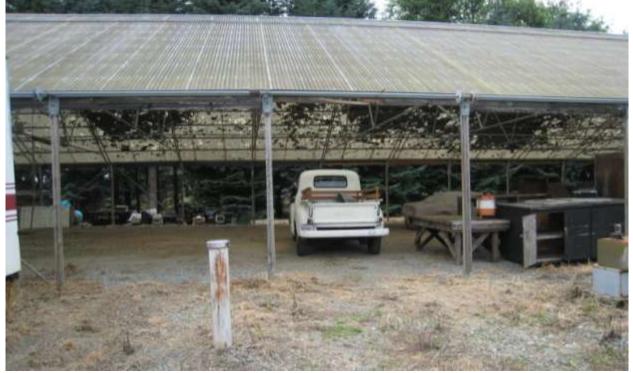
Photo 1: Building formerly used as greenhouse – MW-2 standpipe in foreground

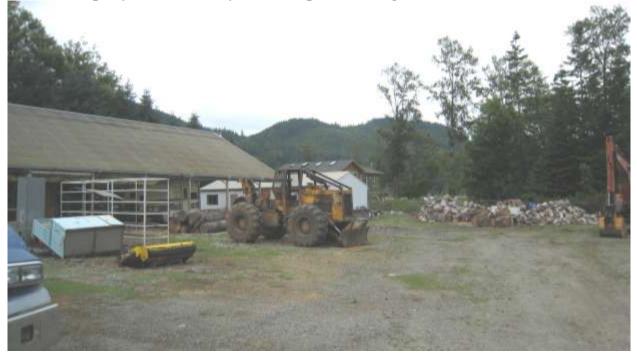
Photo 2: Property line (fence) beyond wood pile – looking toward Clear Lake

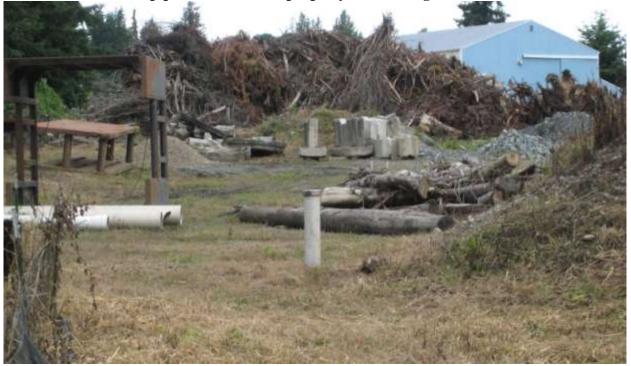
Photo 3: MW-1 standpipe - from the east property line looking west

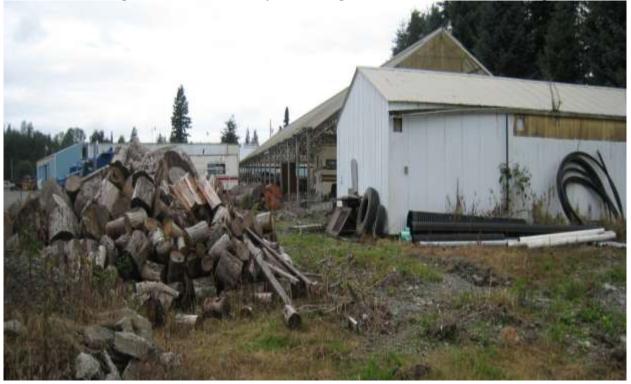
Photo 4: Former greenhouse visible beyond storage shed – from the east looking west
