STATE OF WASHINGTON
DEPARTMENT OF ECOLOGY
PO Box 47775 • Olympia, Washington 98504-7775 • (360) 407-6300

August 23, 2011

Re: Further Action at the following Site:

- **Site Name:** John's Auto Wrecking
- **Site Address:** 411 93rd Avenue Southeast, Olympia, Washington 98501-9701
- **Facility/Site No.:** 57665495
- **VCP Project No.:** SW1127

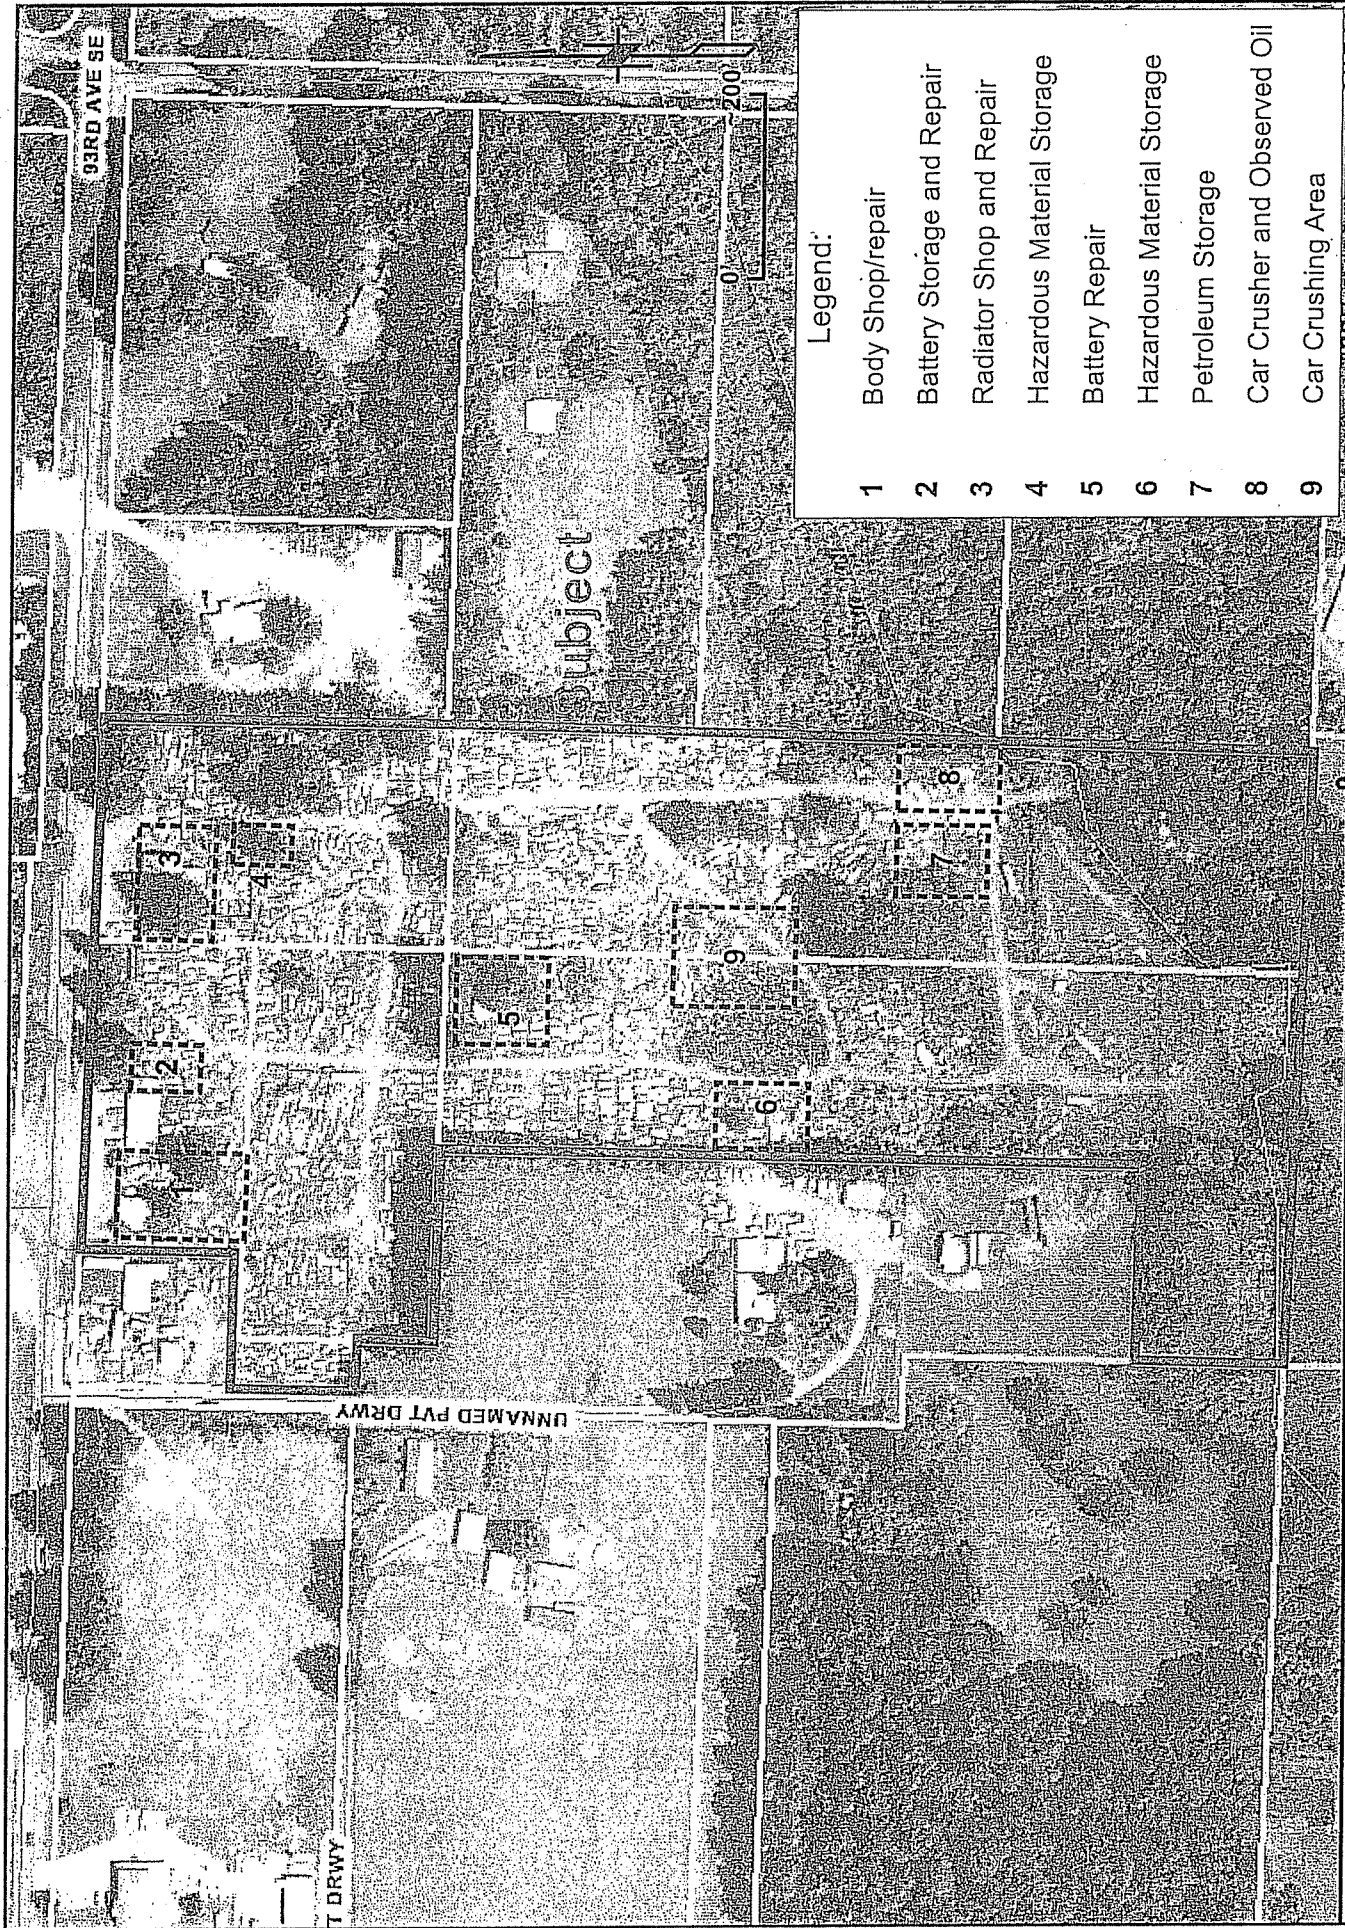
Figure 2
 Aerial Photo and Identified Areas of Concern
 Havens Property: 93rd Ave SE, Oly/Site Characterization

1. Ecology has determined previous investigations were insufficient in determining the extent of potential contamination associated with the AOCs identified at the Site. The nature of the auto salvage operations, the longevity of those operations, the hazardous materials used and dangerous wastes generated by salvage activities, and the typical effects of those operations on the physical and environmental Site conditions requires a more comprehensive evaluation of all Site media. The approach used by Robinson to evaluate the Site appeared to be a focused environmental investigation of the 15-acre Site, with emphasis on smaller AOCs within the Site. Aerial imagery over a period of 14 years indicated extensive areas of each of the parcels on the Site had some aspect of automobile salvage or storage. Previous Site visits by Ecology personnel have documented extensive soil staining from fluids leaking out of salvage vehicles or containers and dangerous waste storage issues throughout the Site. During a Site visit in December 2010, the Ecology Site manager observed extensive dark soil staining across the Site, smaller piles of tires, several piles that included debris, empty propane cylinders, and rusting metal, partial salvaged car bodies, open surface water with no storm water runoff controls, two piles, one for creosoted timbers and one for galvanized metals, and oil-stained concrete floors and pads. These potential sources of contamination should be evaluated and removed. A comprehensive Site history needs to be developed for the Site to include activity, waste products and amounts generated, history of waste handling and storage practices, longevity of that operation at that location, spills, and types of activities and practices of previous owners. Ecology does not believe the Site has been sufficiently delineated to rule out possible contamination within the AOCs or at other areas of the Site. Ecology recommends that sufficient samples be collected to delineate the Site. The United States Environmental Protection Agency (EPA) recommends automobile salvage yard processes should be evaluated for the following compounds: acetylene gas, common solvents, rubber, compressed oxygen, automotive fluids, degreasing agents, gasoline, hydraulic oils, fuel additives, diesel fuels, common lubricants, asbestos, lead, and sulfuric acid. In areas where waste oil storage and burning of debris was known or suspected to have occurred, the soil should be evaluated for the presence of polycyclic aromatic hydrocarbons (PAHs). If the evaluation indicates the salvage processes used or produced one or more of the compounds listed above, then those compounds should be analyzed for during the Site characterization. Unless documentation can be provided to disqualify specific constituents of concern

5. AOC numbers 3 and 4 have not been adequately delineated. During a Site visit in December 2010, Ecology personnel observed a partially enclosed, lean-to shed attached to a dilapidated building that housed the former radiator repair and auto shop in AOC 3 and the former hazardous material storage area in AOC 4. While the interior condition of the former radiator repair and auto shop could not be observed, the shed area was open to inspection. The concrete floor of the shed was heavily stained with oils and the staining continued to the edges of the concrete pad. Discussions with other Ecology Waste 2 Resources personnel concerning the condition of the interior of the building provided anecdotal information describing the floor as being in poor condition and heavily stained. Ecology recommends a more detailed study in these two areas to include the soils on the perimeter of the concrete slabs floors and within the floors where conditions indicate a possible pathway to the soil underneath the slabs. Because these areas lie within the designated High Groundwater Hazards buffer, groundwater should be evaluated by at least two groundwater monitoring wells (one well in AOC 3 and the other at the MW-4 location).

Also, Ecology does not believe AOC 1, AOC 2, AOC 5, AOC 7, AOC 8, and AOC 9 have been adequately investigated. Due to the size of those identified AOCs and the lack of details or information provided concerning the AOCs, Ecology determined the investigation was insufficient for Ecology to properly evaluate and make a determination on the environmental condition of those areas.

4. Given the shallow groundwater table and concerns for potential impacts, Ecology recommends a minimum of six groundwater monitoring wells in addition to the three monitoring wells already on the Site. According to Ecology's *Guidance on Sampling and Data Analysis Methods* (Publication No. 94-49) "Ecology expects that a hydrogeological investigation will be conducted at any site where (1) soil contamination is found within 10 feet of the groundwater table and there is permeable soil, or (2) when a soil contaminant is potentially mobile considering the site's geological setting, particularly if there is a high concentration of contamination relative to the groundwater standard". As stated in comment 3 above, one well each should be installed at TP1A and TP6A. Ecology also recommends one well each for AOC 3, AOC 5, and AOC 9, and one well located on the east property boundary between parcels 12723210400 and 12723210700 in the identified High Groundwater Hazard area (MW-4). Groundwater should be evaluated via temporary monitoring wells or probes at AOC 2, AOC 4, AOC 7, and AOC 8.

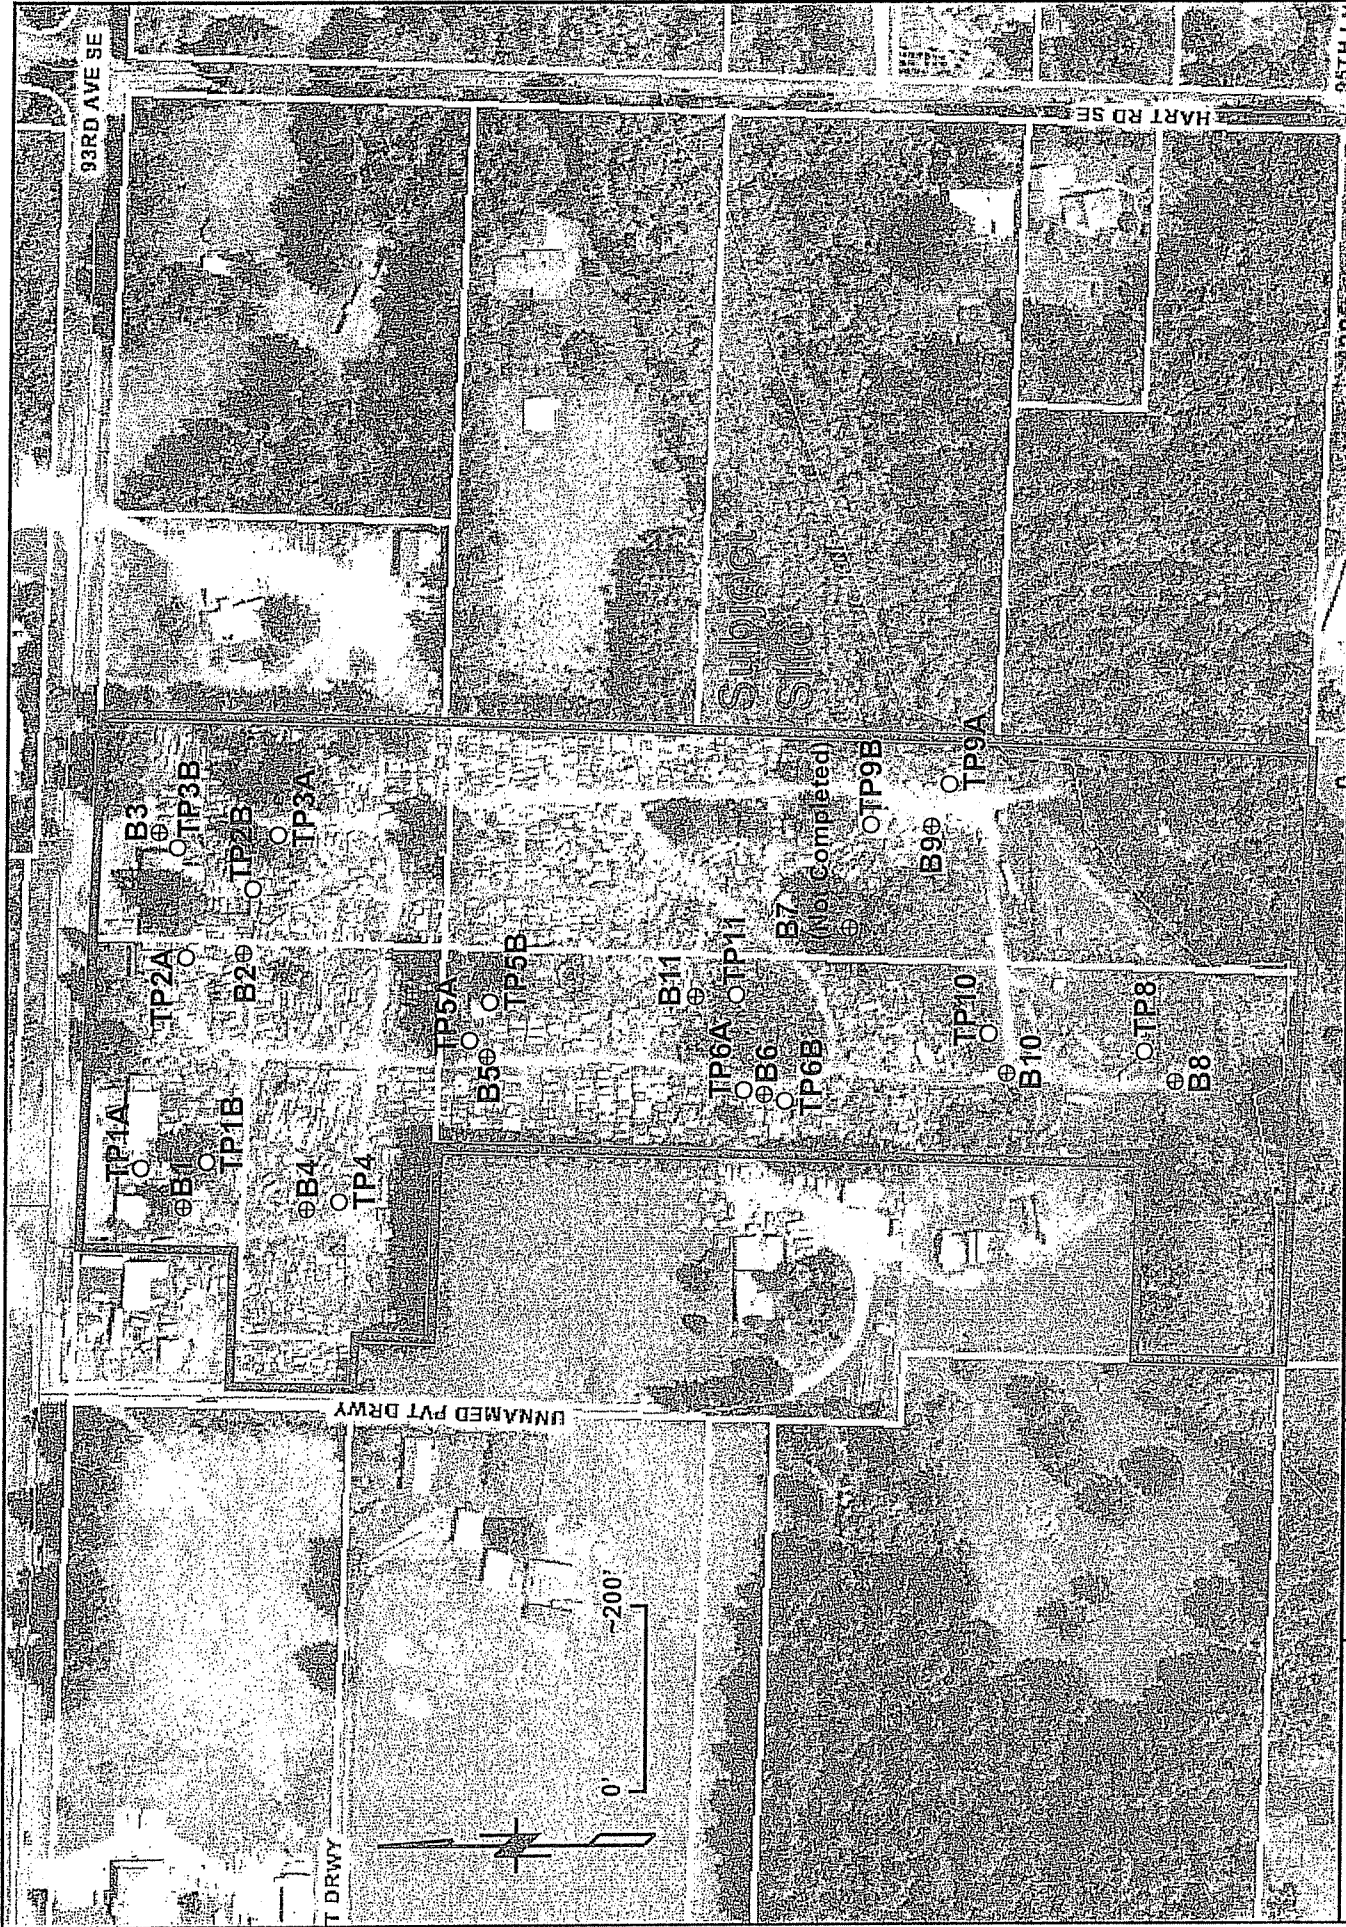
Figure 3
 Test Pits and Boring Locations Photo
 Havens Property: 93rd Ave SE, Oly/Site Characterization

3. Groundwater was sampled from all borings. Borings B-1 and B-6 analytical results indicated there was no groundwater contamination caused by the evaluated COCs; however, these two borings were not collocated with the contaminated locations (Test Pit TP1A and TP6A) where PCS above the applicable MTCA Method A Soil CULs was found. Ecology does not consider those groundwater analytical results representative of groundwater at those PCS locations (Please note that no logs or other details of the test pit investigations were provided for Ecology review). Ecology recommends that the groundwater at previous PCS locations TP1A and TP6A be evaluated.
