STATE OF WASHINGTON
DEPARTMENT OF ECOLOGY

December 2, 2015

Re: Further Action at the Following Site:

- **Site Name:** Precision Engineering
- **Site Address:** 1231 South Director Street, Seattle, WA
- **Facility/Site No.:** 2056
- **Cleanup Site Id.:** 4532
- **VCP Project No.:** NW1511

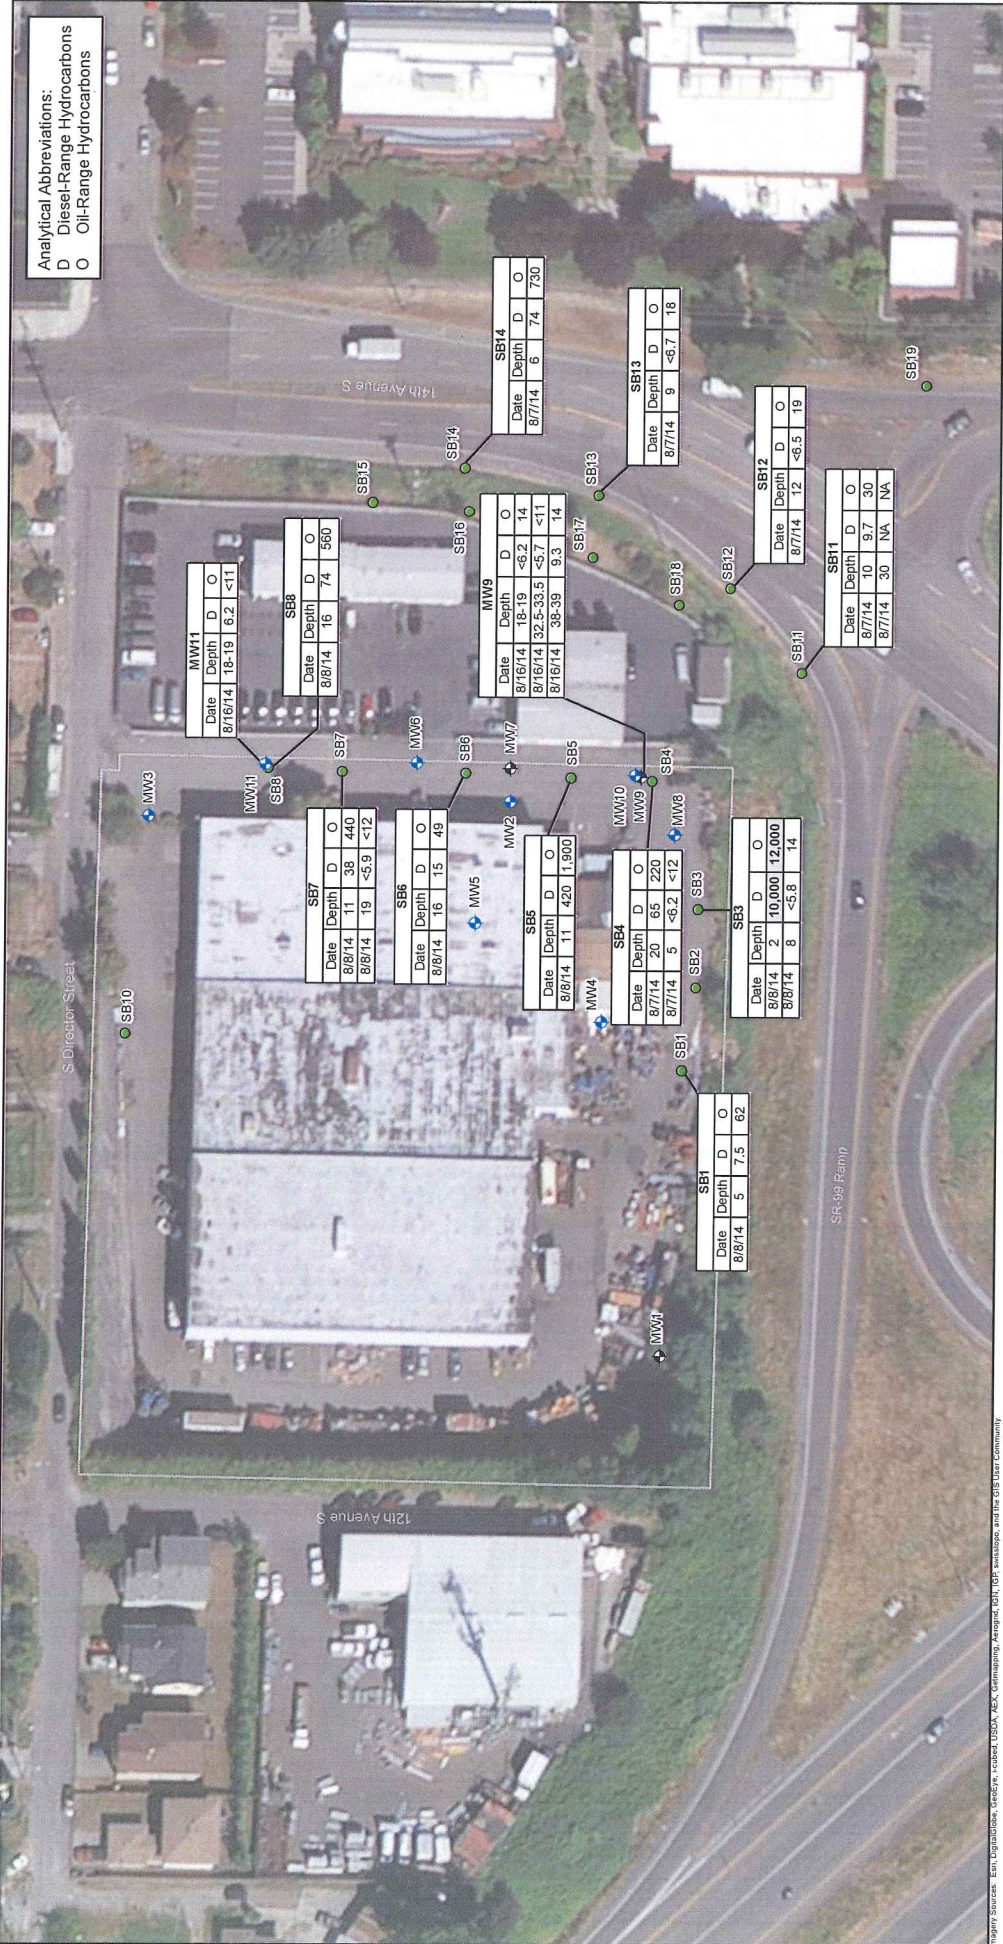
Date	Depth	D	O
8/8/14	5	7.5	62

Date	Depth	D	O
8/8/14	11	38	440
8/8/14	19	<5.9	<12

Date	Depth	D	O
8/8/14	18-19	<6.2	14
8/16/14	32.5-33.5	<5.7	<11
8/16/14	35-39	9.3	14

Date	Depth	D	O
8/8/14	16	15	49
8/8/14	11	420	1,900

Date	Depth	D	O
8/7/14	20	65	220
8/7/14	5	<6.2	<12

Date	Depth	D	O
8/8/14	2	10,000	12,000
8/8/14	8	<5.8	14
