INDEPENDENT REMEDIAL ACTION REPORT
WEYERHAEUSER ABERDEEN SAWMILL
ABERDEEN, WASHINGTON

Prepared for
Weyerhaeuser Company
January 17, 1997

Prepared by
EMCON
18912 North Creek Parkway, Suite 100
Bothell, Washington 98011-8016

Project 40141-077.001

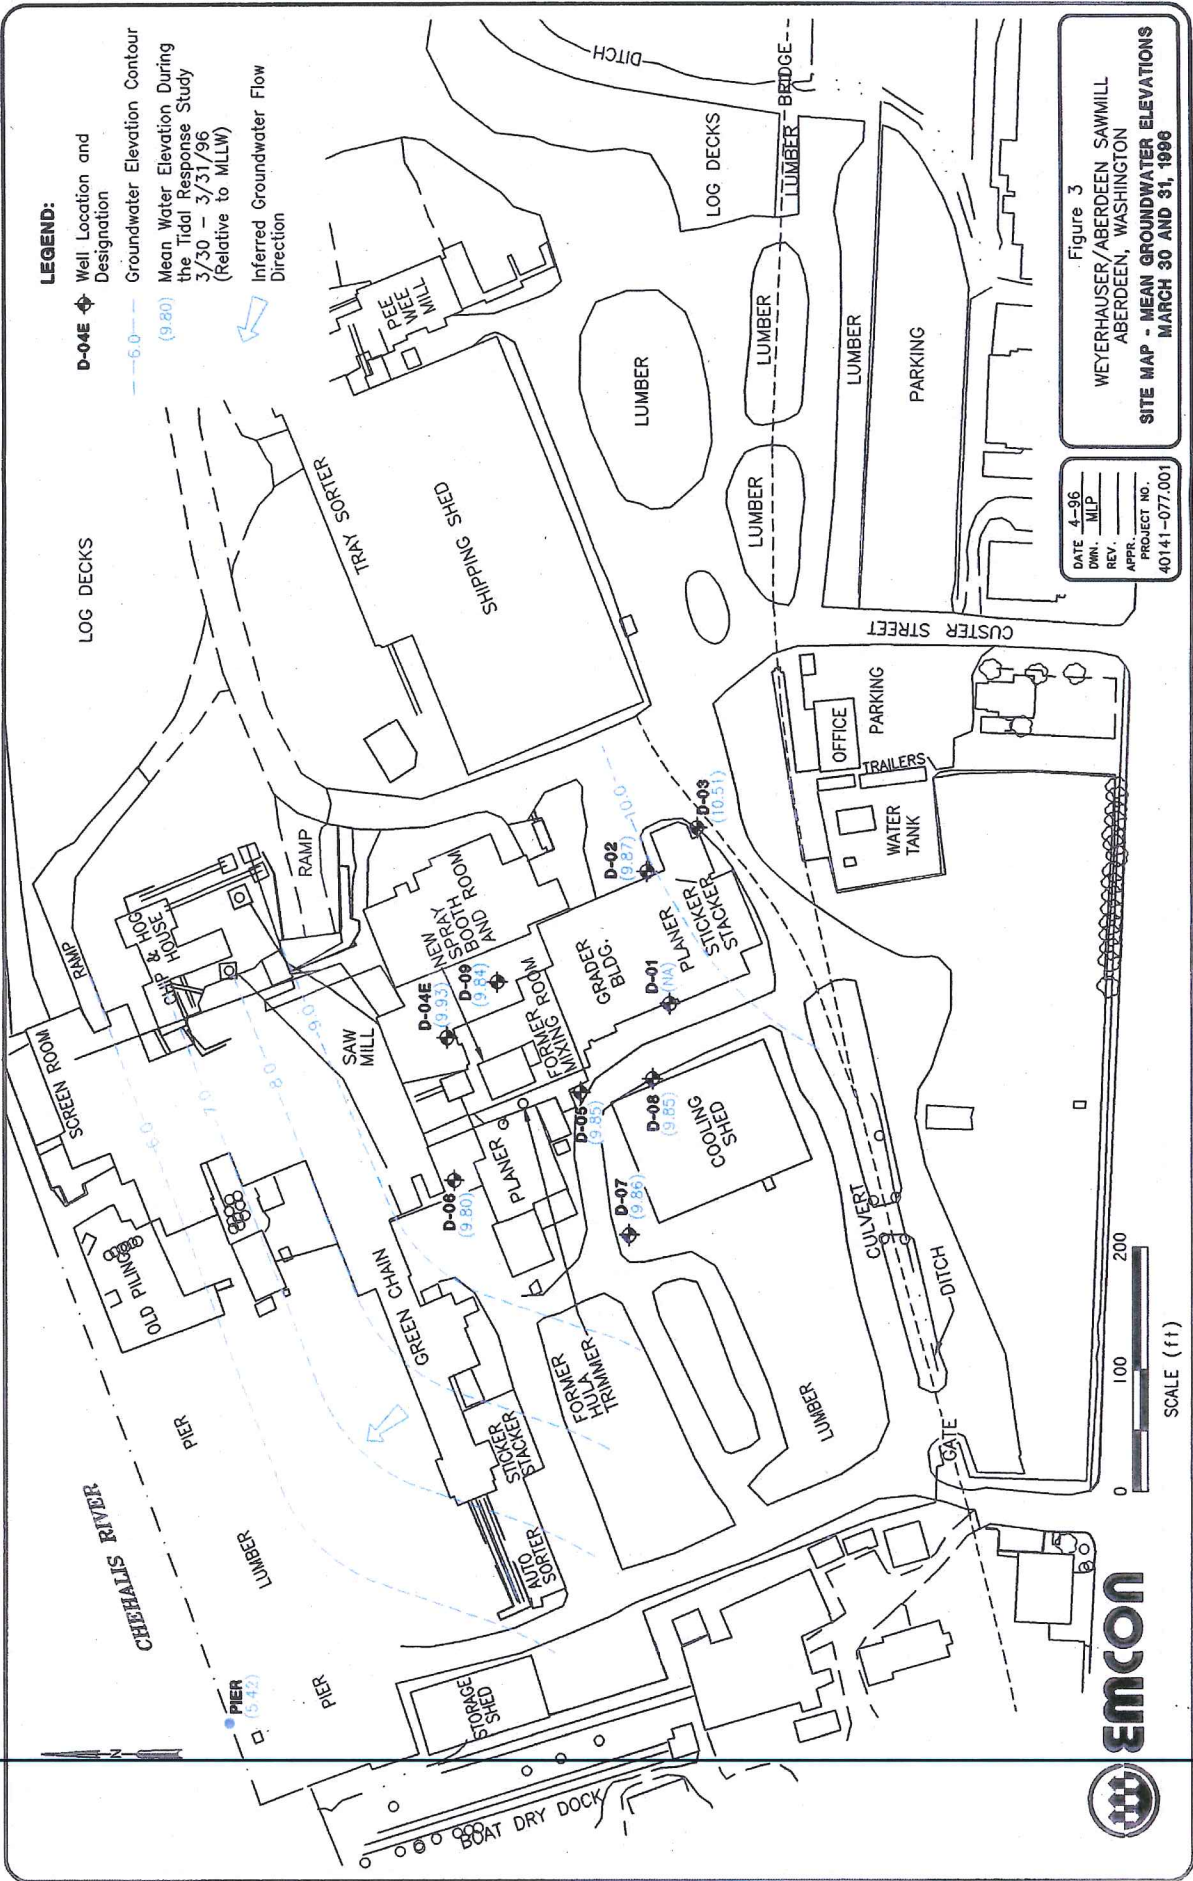
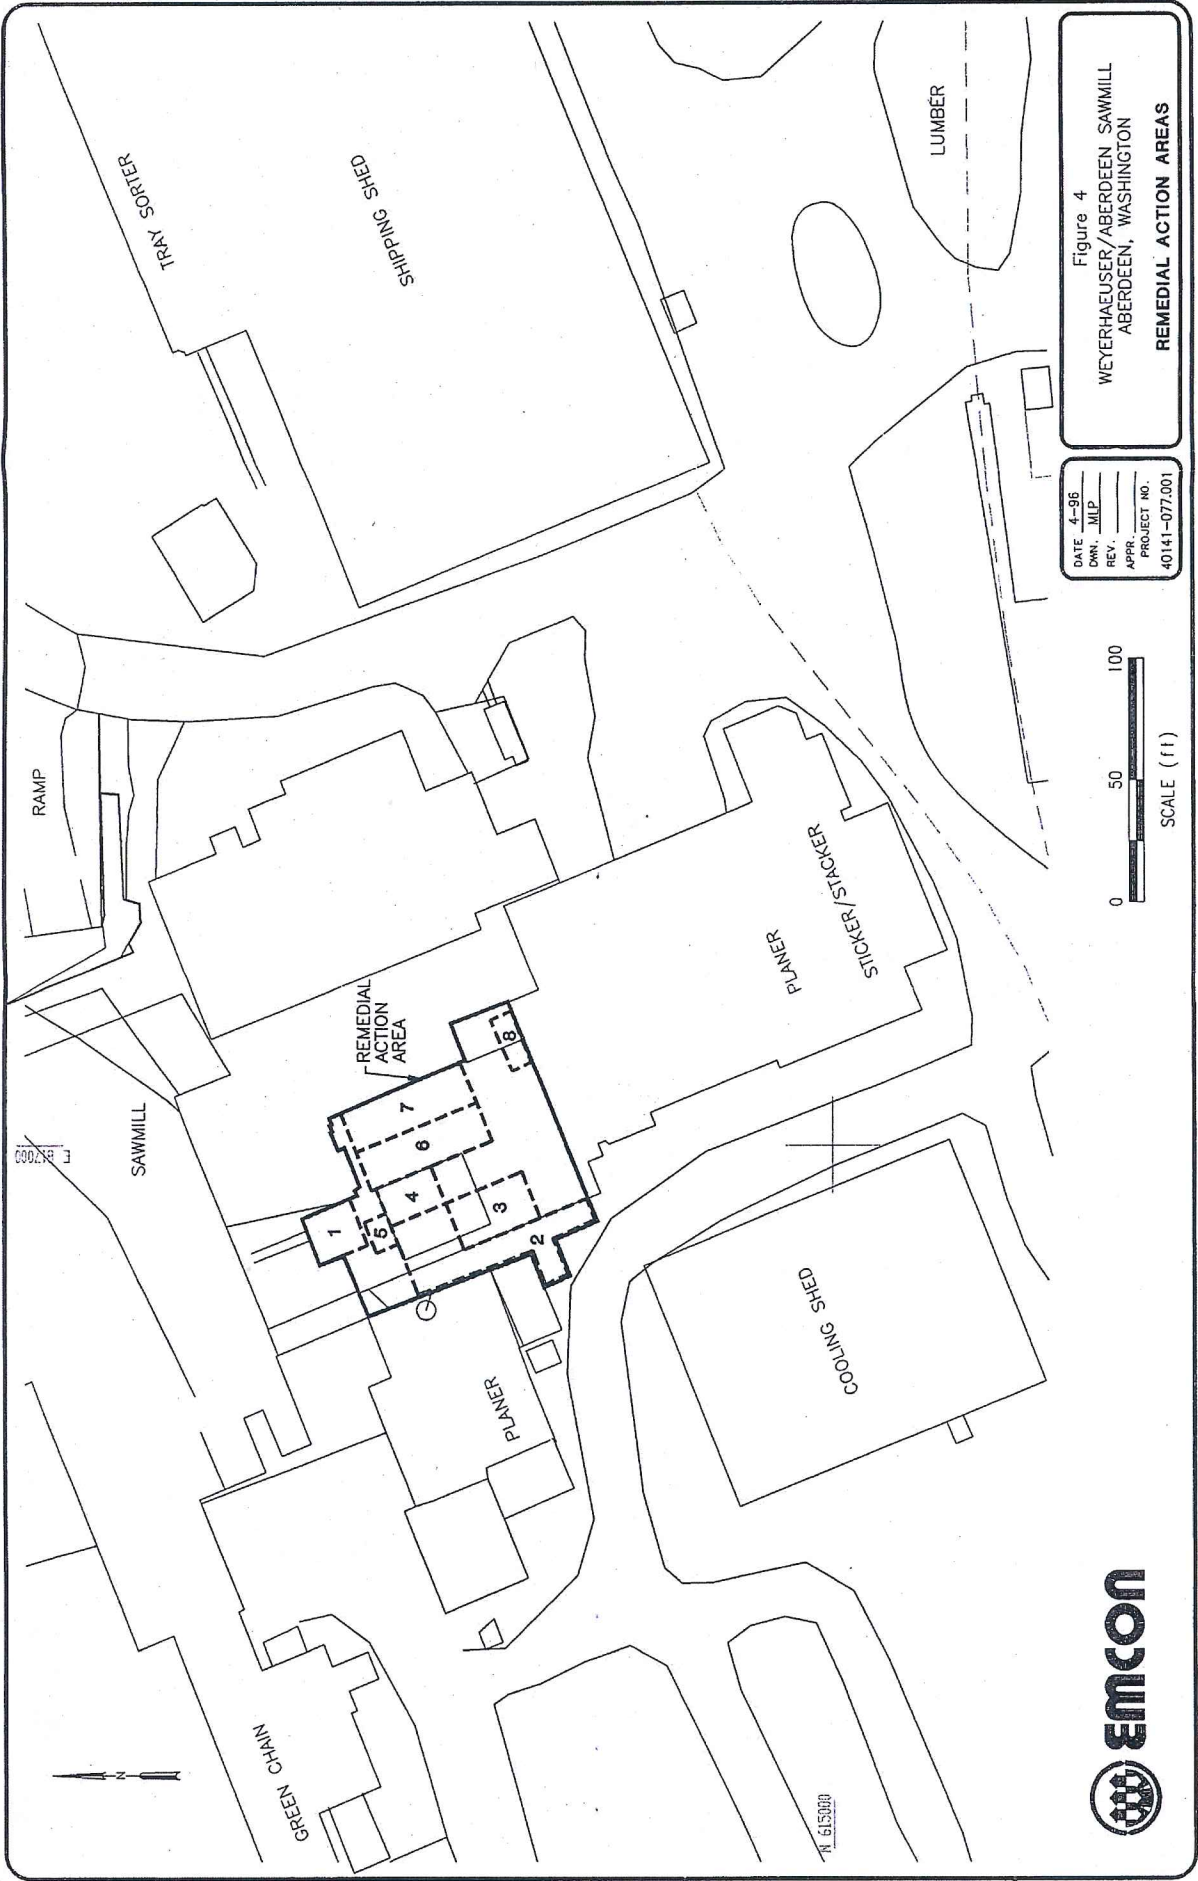
Figure 4
 WEYERHAEUSER/ABERDEEN SAWMILL
 ABERDEEN, WASHINGTON
 REMEDIAL ACTION AREAS

Remedial action began in July 1990 to clean up surface soils and debris in the former PCP-usage areas. Excavation of contaminated soil and wood debris was performed in Areas 1, 2, 3, 4, 6, 7, and 8, where the current or former spray booths and dip tank were located (see Figure B-4, Appendix B). Surface soils and sawdust were removed by hand or with the vacuum truck. A total of 262 tons of contaminated soil and debris was removed from the site and disposed of as dangerous waste at Chemical Waste Management's hazardous waste landfill in Arlington, Oregon. The extent of the excavation in some areas was limited by the presence of large pieces of process equipment, building foundations, and the shallow groundwater table.

Area 1 was excavated first to facilitate construction of the new mixing room and spray booth in this area. Contaminated soil and fill were excavated to the extent practicable. Complete excavation of all of the impacted soil was not possible because of limited accessibility and the potential for undermining the concrete foundation. The area was backfilled with clean fill to return the area to operation by the end of August. The confirmation soil sample collected in this area was below the Method C cleanup level for PCP.

Since it was found impractical to dewater Area 2, the excavation plan was modified. Weyerhaeuser evaluated installing sheet piling and barrier walls to allow excavation below the water table, but determined it was not practical due to severe access restrictions; including current building foundation. Therefore, soil and wood waste were excavated "in the wet," using a backhoe, to a maximum depth of approximately 16 feet bgs (6 feet below the water table) and placed in a staging area, to allow the liquids to drain back into the excavation. The excavated material was then placed in a roll-on/roll-off container and mixed with kiln dust to reduce the potential for a release of liquids from the debris. The excavated material was classified as a dangerous waste and transported to Chemical Waste Management's hazardous waste landfill in Arlington, Oregon. A total of 160 tons of PCP-contaminated soil and debris was removed from Areas 1, 2, 5, 6, 7, and 8 in 1991.

Confirmation samples were collected from the four sidewalls and floor of Area 3. Two confirmation soil samples collected from the south sidewall and floor of Area 3 contained PCP concentrations above the Method C cleanup level, at concentrations of 1,400 and 6,000 mg/kg, respectively. Further excavation was not possible because of concerns about the building foundation. One additional confirmation soil sample was collected in Area 2 along the conveyor and the building wall, with a concentration of PCP of 1.8 mg/kg. The soil samples collected from the decontaminated surface of Area 2 were below the Method C cleanup level. Additional confirmation soil samples collected from Areas 6 and 7 were below Method C cleanup levels.
