MEMORANDUM

To: Joyce Mercuri, Washington State Department of Ecology
Date: July 22, 2011, 2011

Re: Eddon Boat Park Long-Term Monitoring Plan Year 3 Memorandum

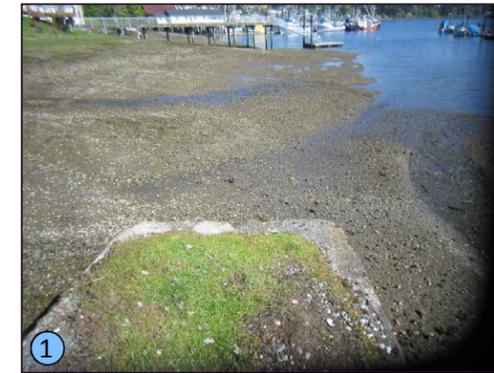
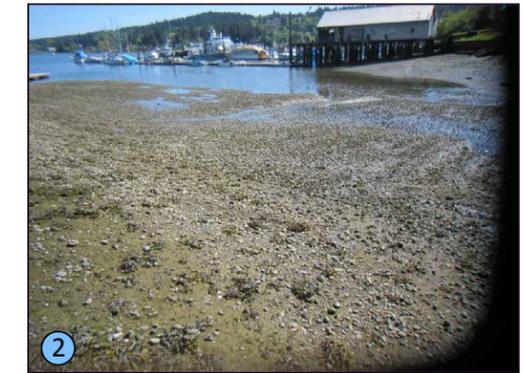
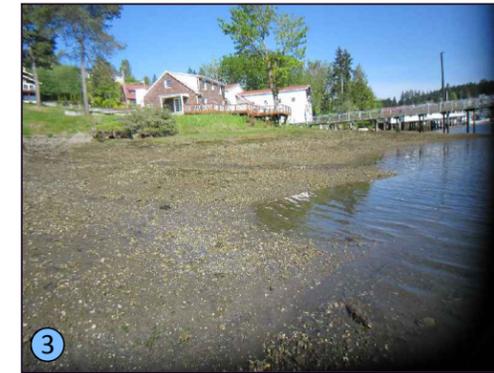
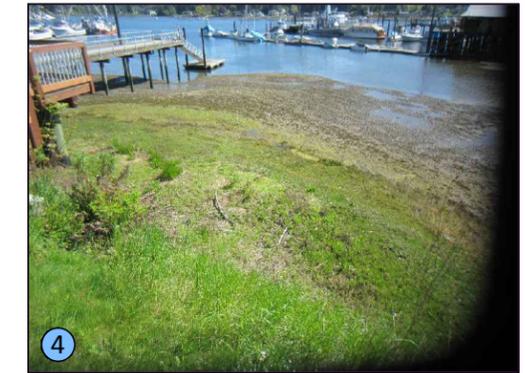
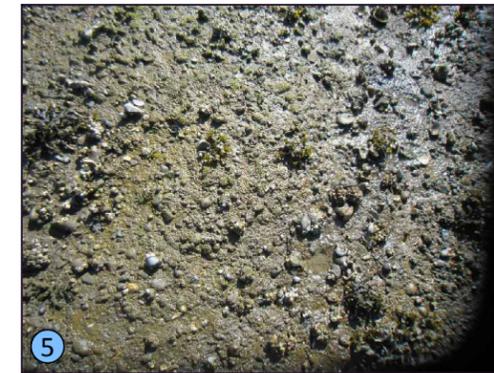
Figure 2
 SMU-3 Visual Inspection Results
 Long-Term Monitoring Plan - Year 3 Report
 Eddon Boat Park

Visual inspections were performed on May 18, 2011, between 0900 and 1100 hours. During this time, the tidal elevation ranged from +4.8 to -1.2 mean lower low water (MLLW). This allowed exposure of most of SMU-3 and part of SMU-2. Digital photographs were taken in each area from locations marked on Figure 2 and Figure 3. As shown in the photographs, the cap material is present in all areas with minimal (fewer than 2 cm) accumulation of fine-grained material. The visual inspection did not identify any areas of concern (i.e., areas where cap material is no longer present). Based on the visual survey and associated photographs, the cap and ENR areas are achieving performance standards and no additional remedial actions are recommended.

In conclusion, Year 3 monitoring was performed in accordance with the Ecology-approved LTMP. Visual inspection confirmed that the cap material is present in SMU-3 and shows no sign of erosion. As expected, fine-grained material is beginning to accumulate, and recolonization is evident. Similarly, the material placed in SMU-2 is present, has not eroded, and is showing signs of deposition. Chemical monitoring confirmed that Site contaminants are not migrating through the cap to the surface. This information confirms that the cleanup action is functioning as desired and in accordance with the CAP.

Per the LTMP, because Year 3 confirmation sampling confirmed that the cap performance standards are being met, no further sampling is required. Visual inspections will occur during spring low tides for the next 2 years.
