MEMORANDUM

To: Joyce Mercuri, Washington State Department of Ecology **Date:** July 28, 2010
From: David Templeton and Joy Dunay, Anchor QEA **Project:** 040289-02
Cc: Steve Misiurak, City of Gig Harbor
William Joyce, Salter Joyce Ziker, PLLC
Re: Eddon Boat Park Long-Term Monitoring Plan Year 2 Report

Figure 1
Site Areas and Features
Long-Term Monitoring Plan - Year 2 Report
Eddon Boat Park

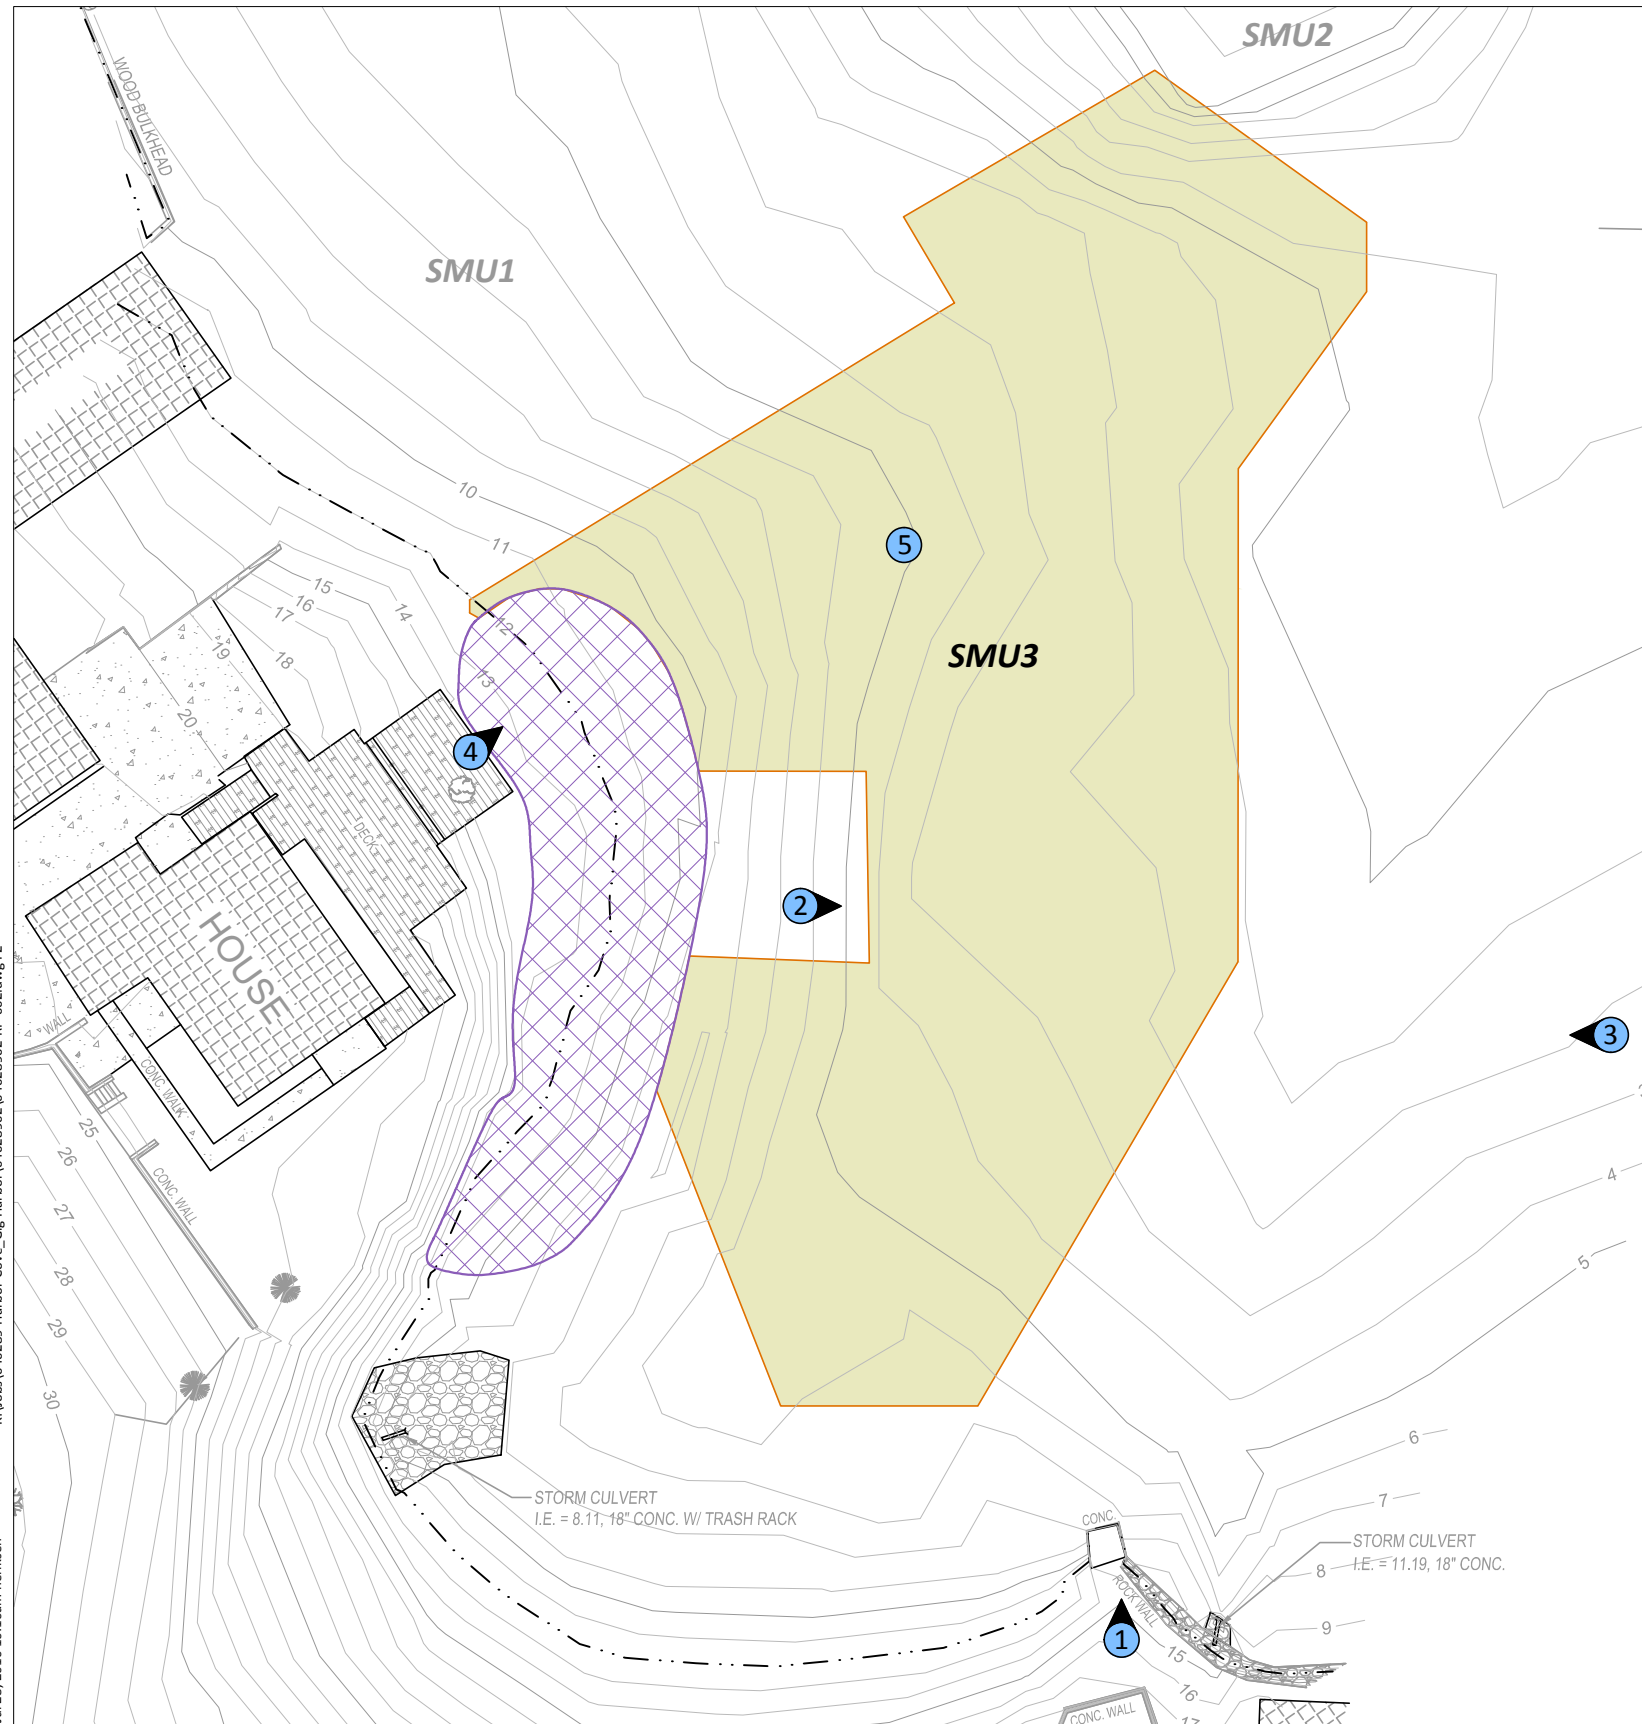
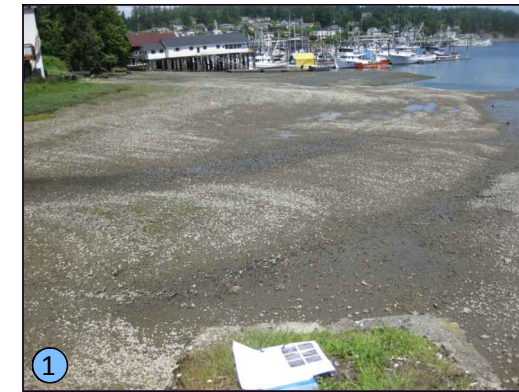
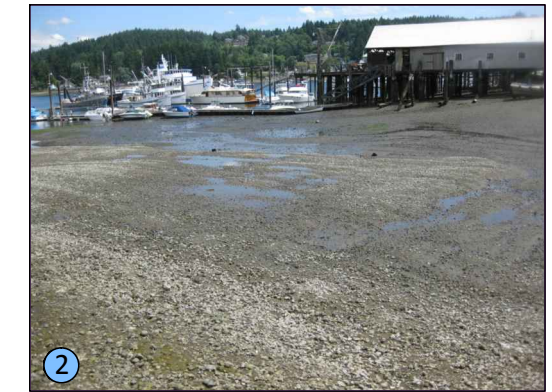
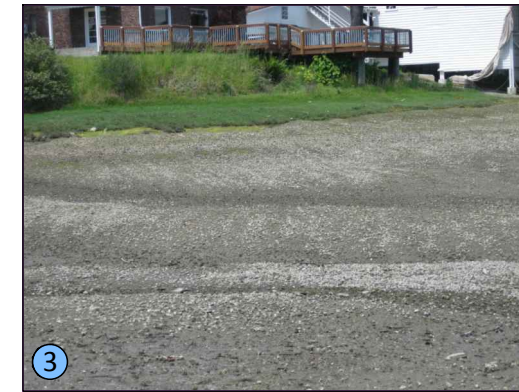
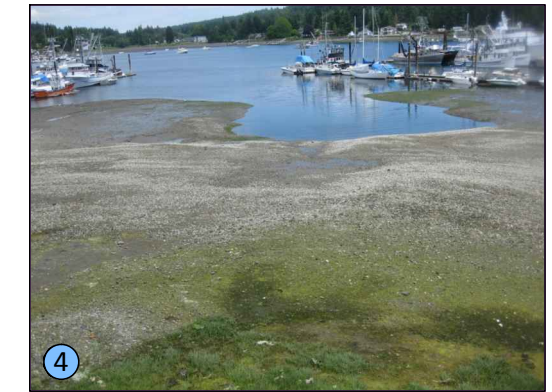
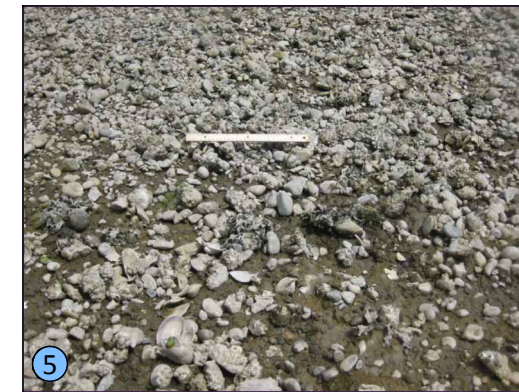
Figure 2
SMU-3 Visual Inspection Results
Long-Term Monitoring Plan - Year 2 Report
Eddon Boat Park

In conclusion, Year 2 monitoring was performed in accordance with the Ecology-approved LTMP. Visual inspection confirmed that the cap material is present in SMU-3 and shows no sign of erosion. As expected, fine-grained material is beginning to accumulate, and recolonization is evident. Similarly, the material placed in SMU-2 is present, has not eroded, and is showing signs of deposition. This information confirms that the cleanup action is functioning as desired and in accordance with the CAP.

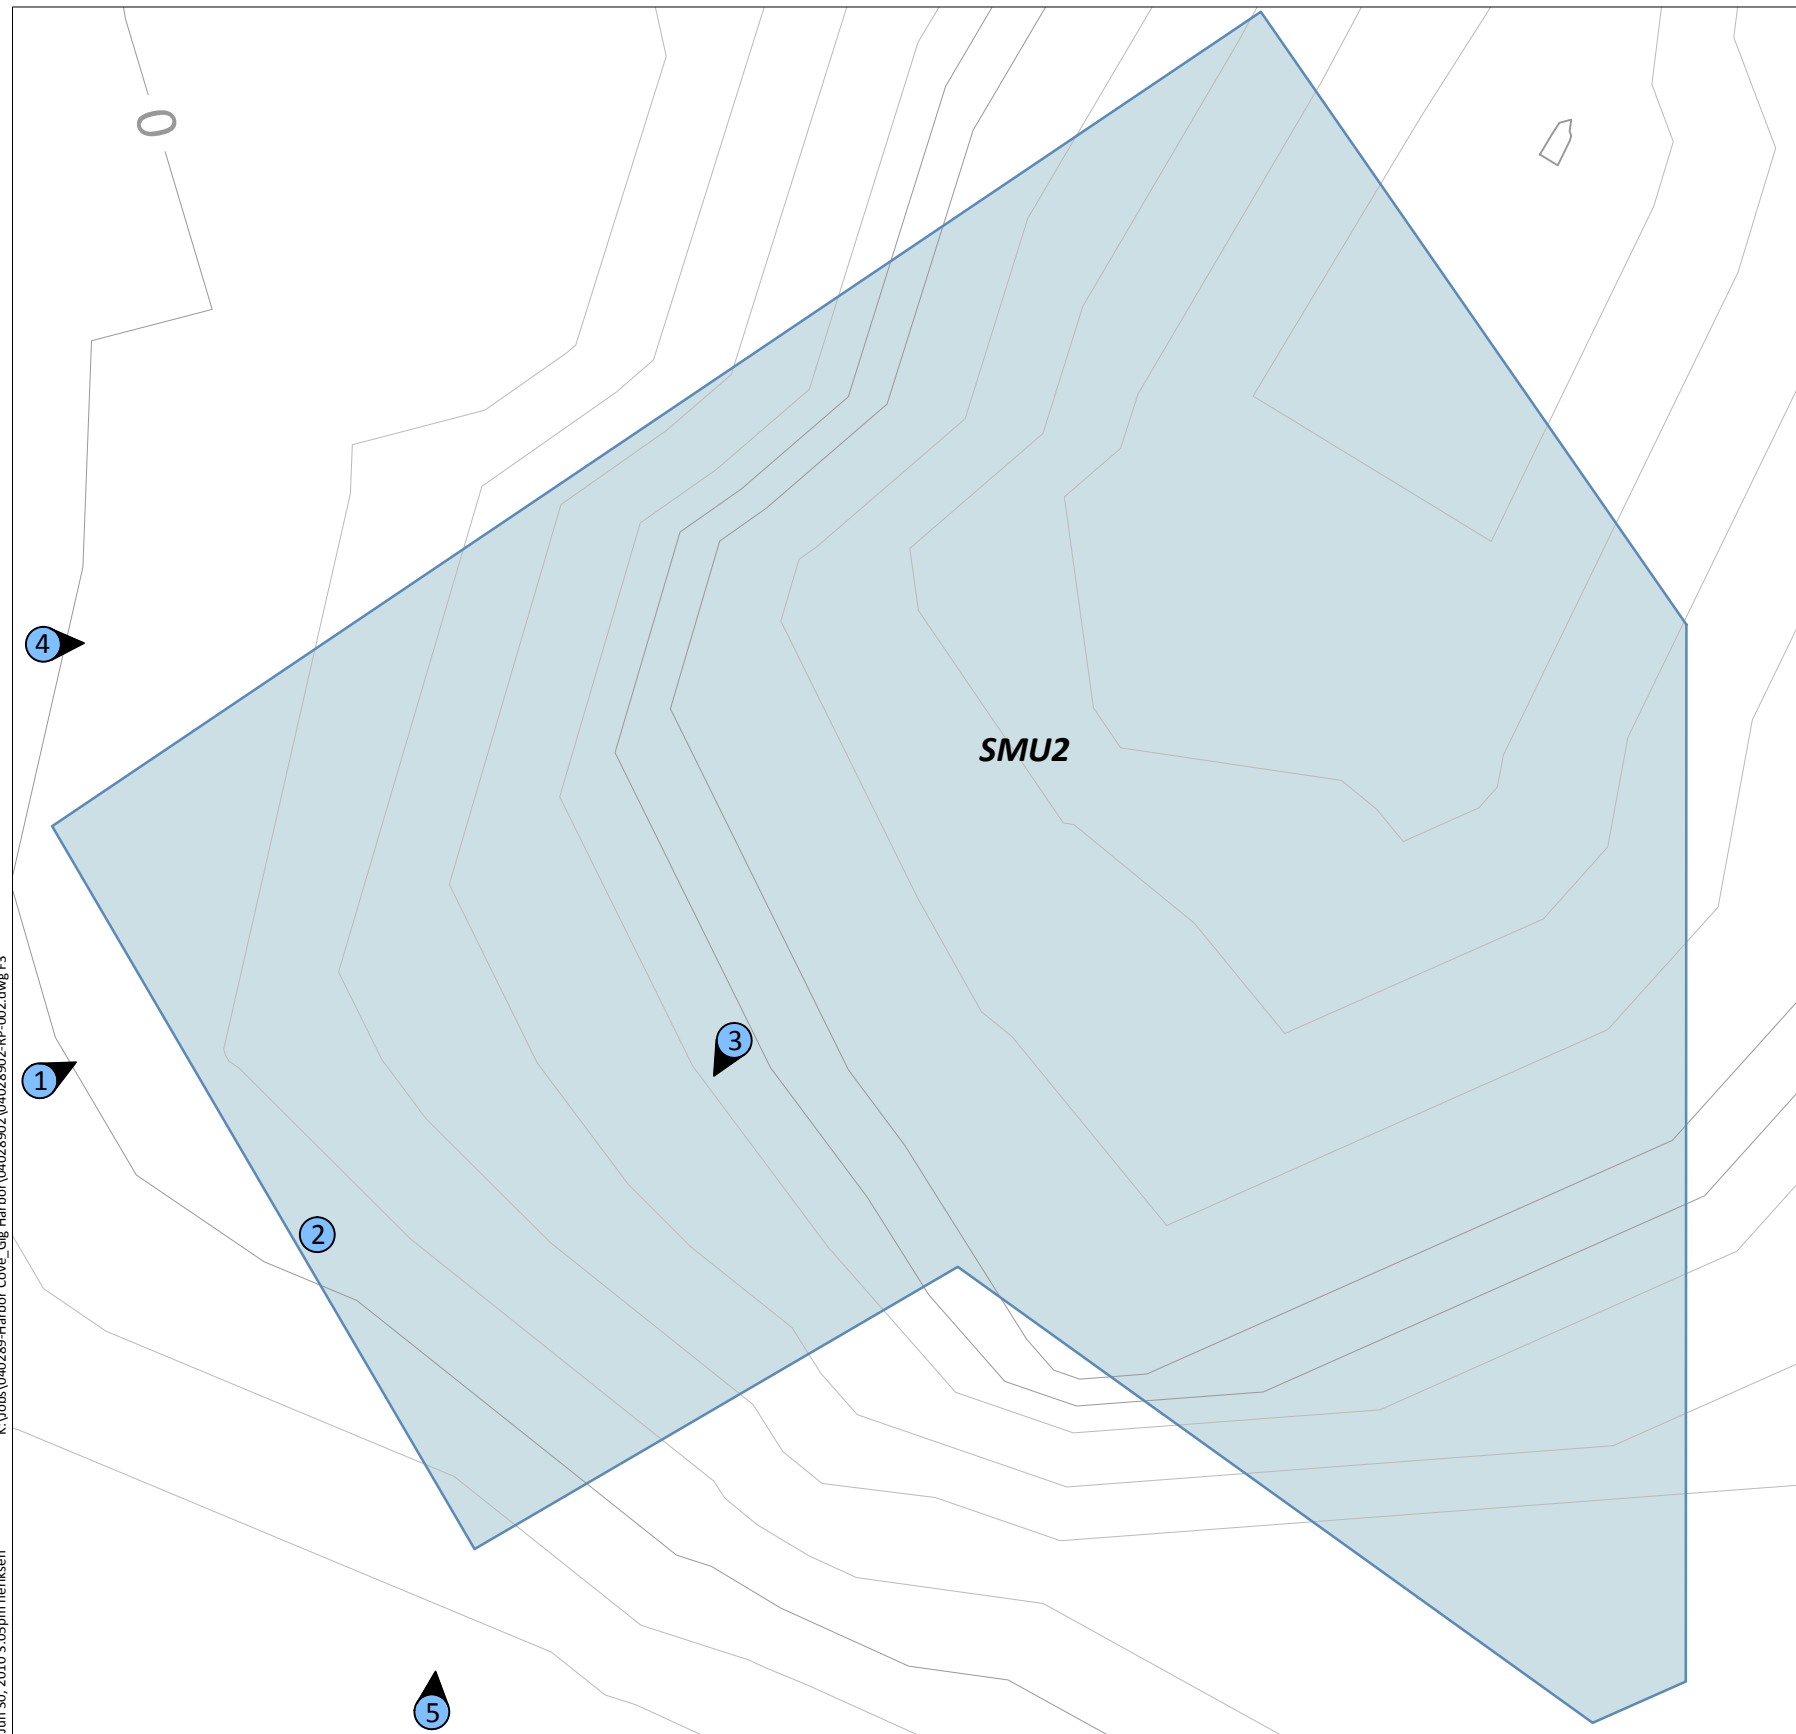
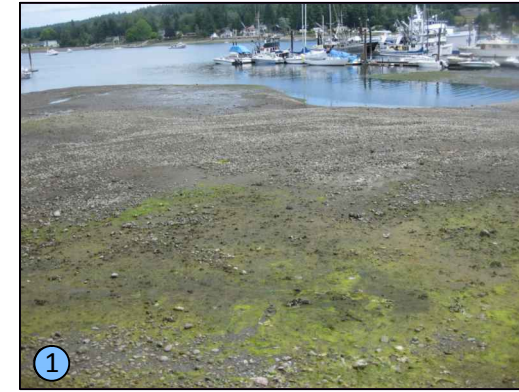
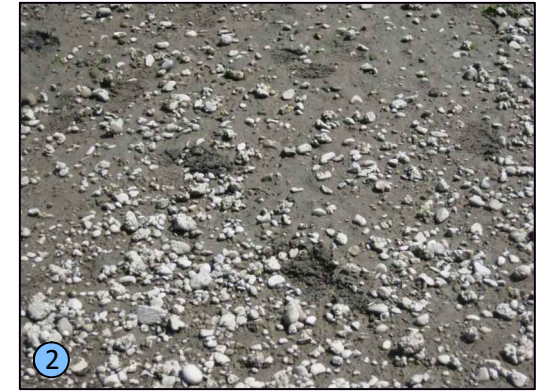
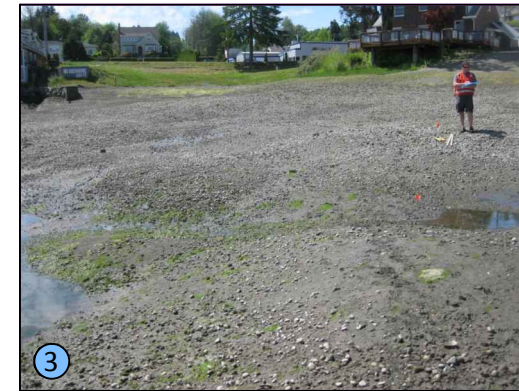
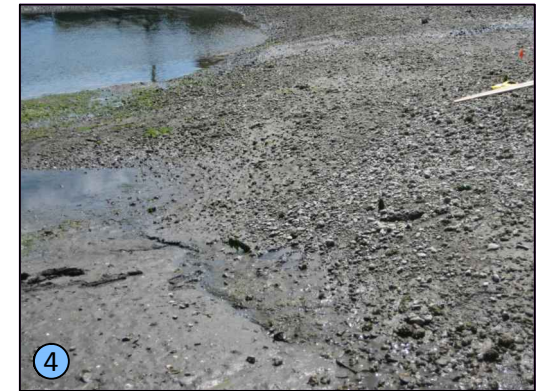
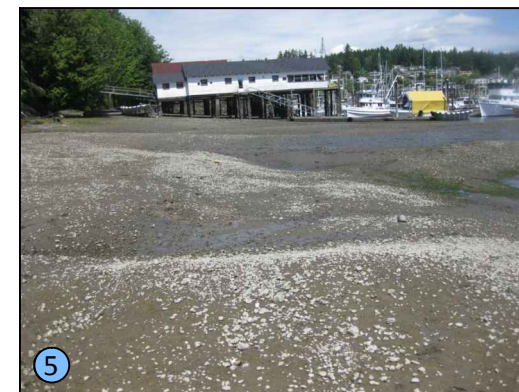
Figure 3 SMU-2 Visual Inspection Results

Visual inspections were performed on June 13, 2010 between 1100 and 1400 hours. During this time, the tidal elevation ranged from -1.0 to -3.39 mean lower low water (MLLW). This allowed exposure of most of SMU-3 and part of SMU-2 (including location SE-03 with the TBT exceedance). Digital photographs were taken in each area from locations as marked on Figures 2 and 3. As shown on the photographs, the cap material is present in all areas with minimal (less than 2 cm) accumulation of fine-grained material. The visual inspection did not identify any areas of concern (i.e., areas where cap material is no longer present). Based on the visual survey and associated photographs, the cap and ENR areas are achieving performance standards, and no additional remedial actions are recommended.
