MEMORANDUM

To: Joyce Mercuri, Washington State Department of Ecology **Date:** September 2, 2009
From: David Templeton and Joy Dunay, Anchor QEA **Project:** 040289-02
Cc: Steve Misiurak, City of Gig Harbor
William Joyce, Salter Joyce Ziker, PLLC
Re: Eddon Boat Park Long-Term Monitoring Plan Year 1 Report

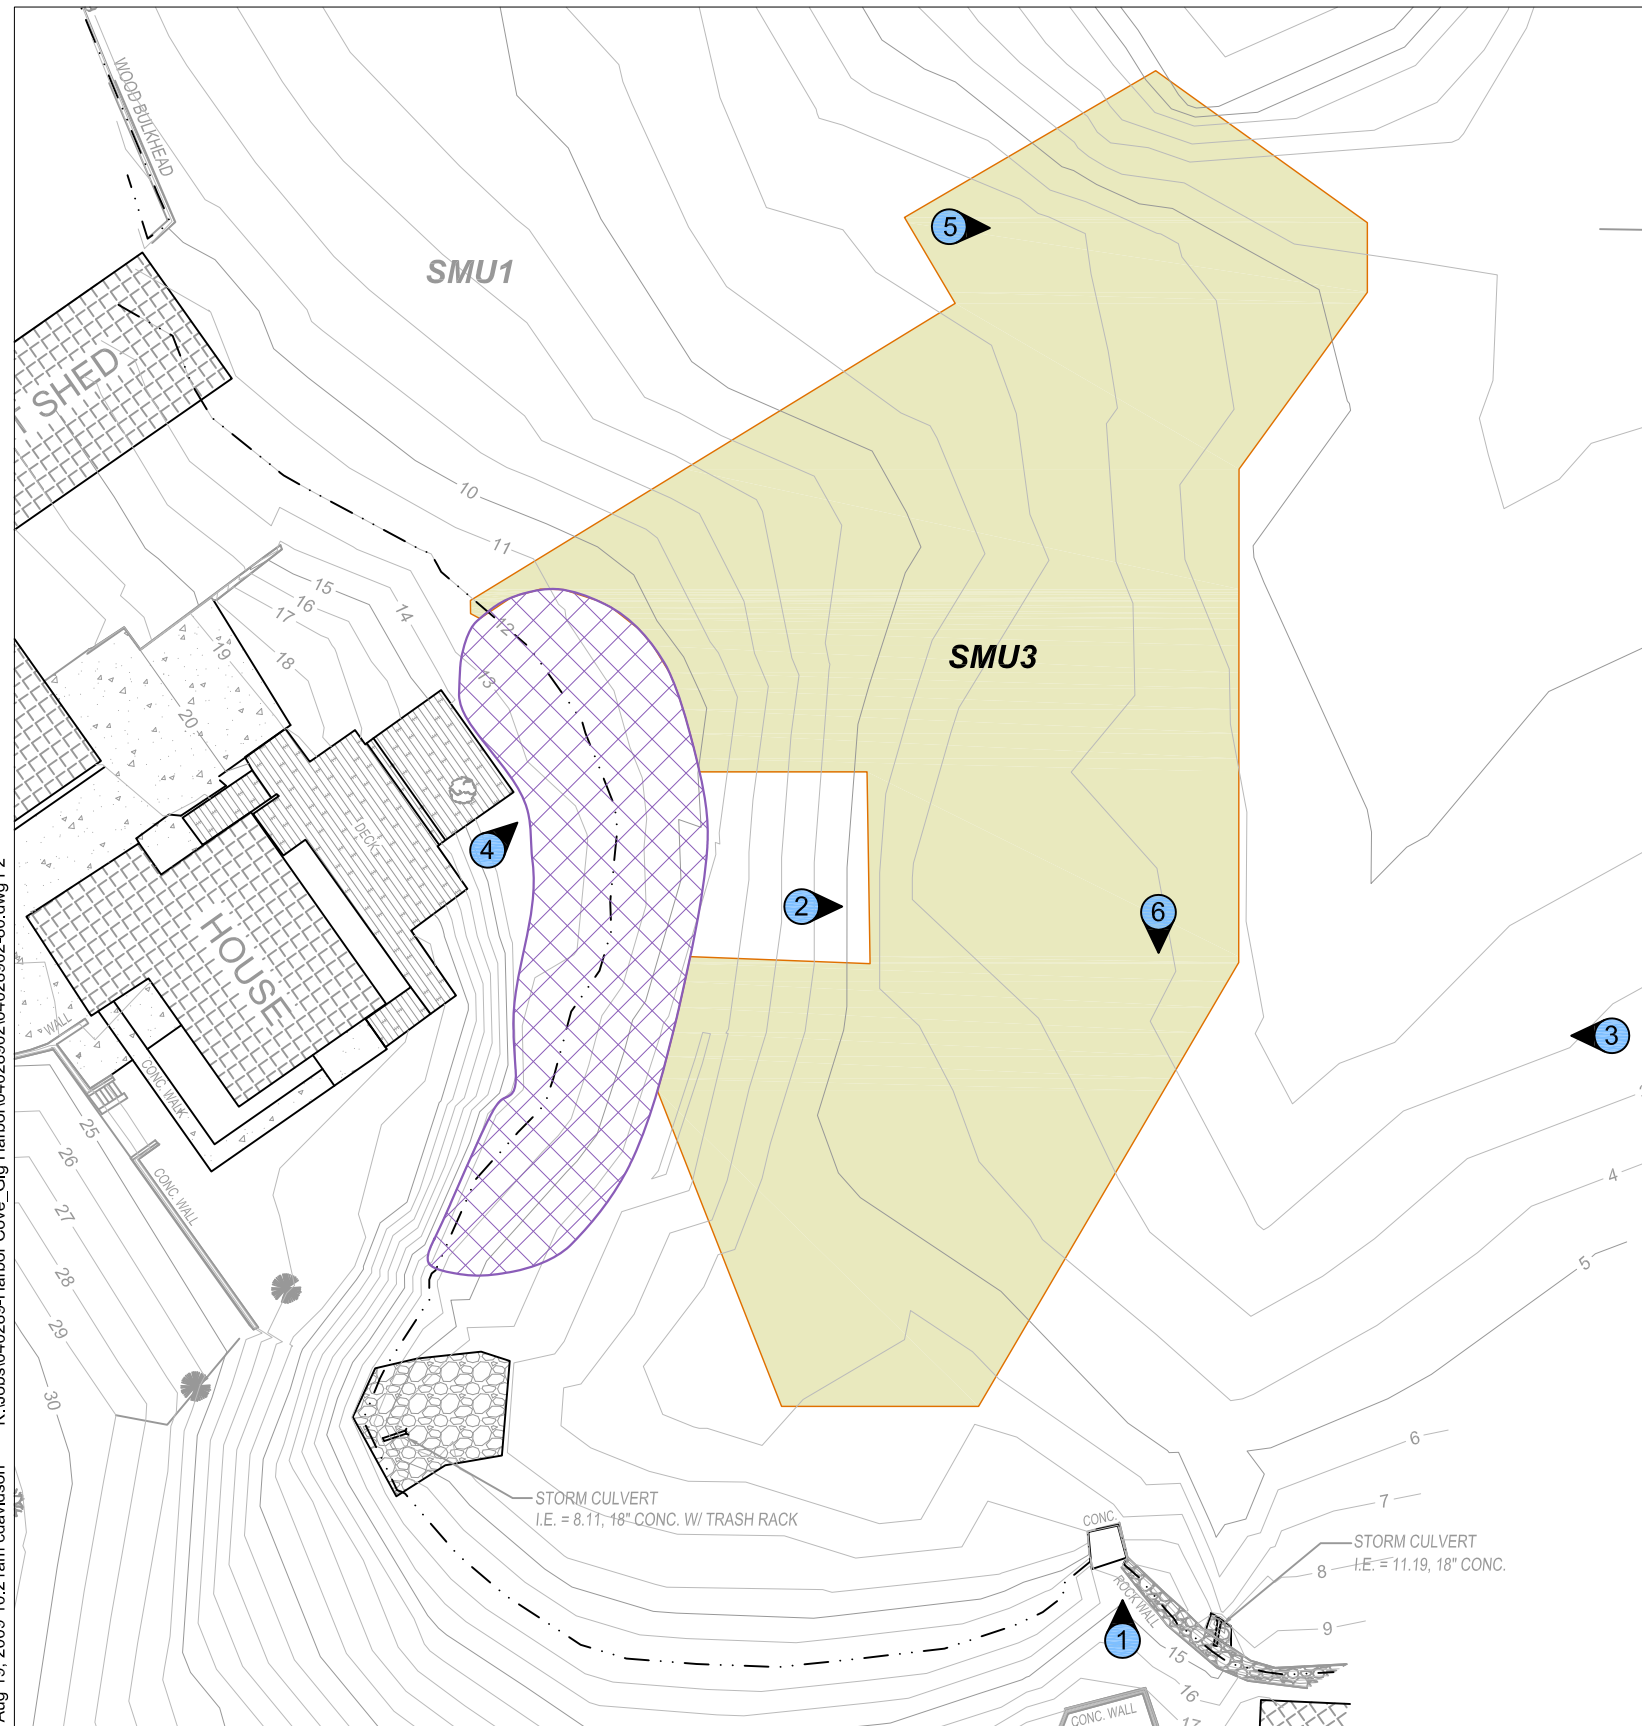
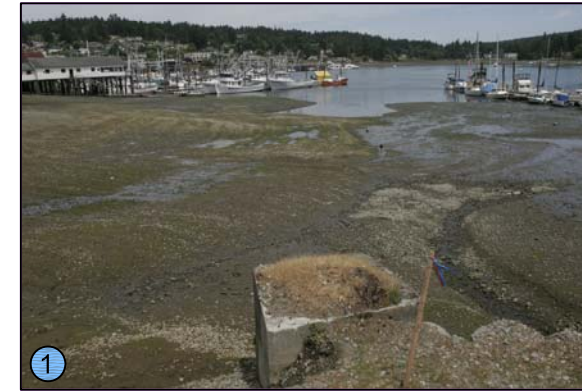
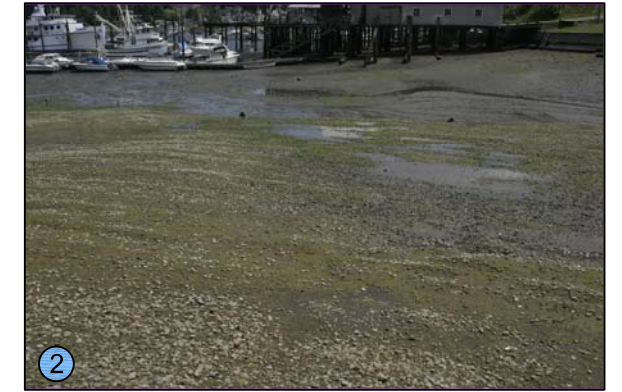
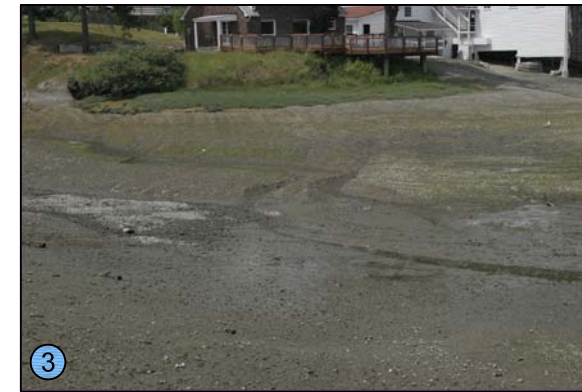
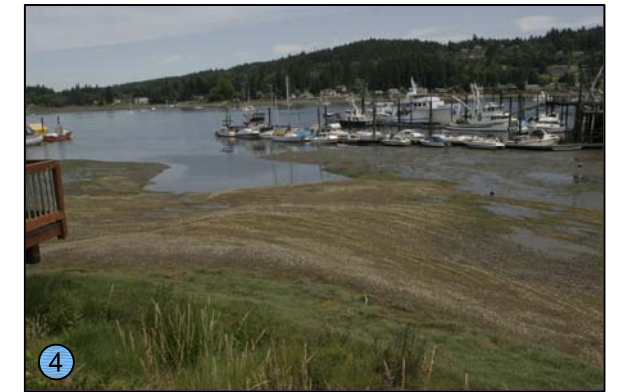
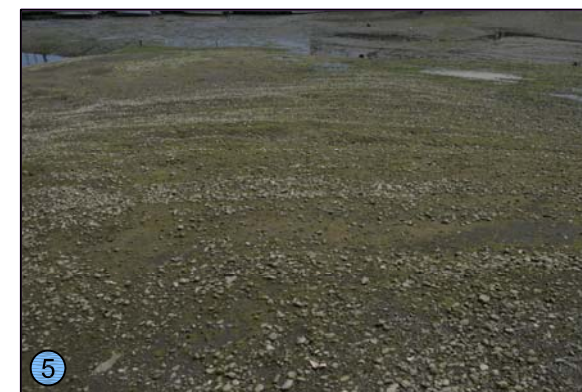
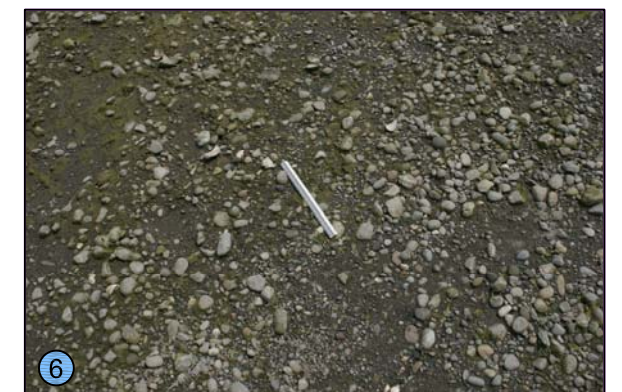
In conclusion, Year 1 monitoring was performed in accordance with the Ecology-approved LTMP. Visual inspection confirmed that the cap material is present in SMU-3 and shows no sign of erosion. As expected, fine-grained material is beginning to accumulate, and recolonization is evident. Similarly, the material placed in SMU-2 is present, has not eroded, and is showing signs of deposition. This information confirms that the cleanup action is functioning as desired and in accordance with the CAP.
