PERIODIC REVIEW

Spokane River Upriver Dam and Donkey Island PCB Sediment Site

Facility Site ID: 65178472 Cleanup Site ID: 4213

December 2015

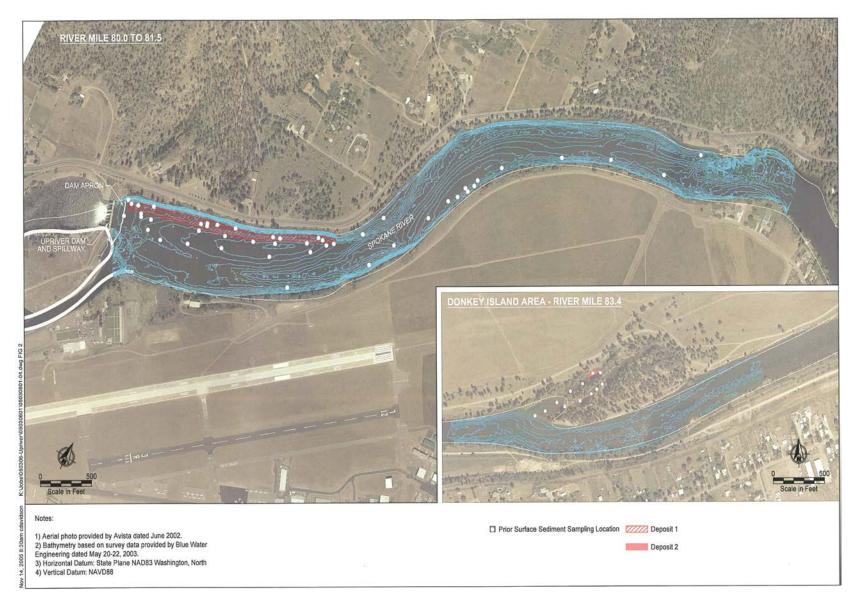
Figure 2. Overview of Site Deposits 1 and 2. Courtesy of Anchor Environmental, L.L.C.

Deposit 1 – approximately 3.7 acres in deep water zones (20 to 25 feet below normal pool level) near the dam (approximately RM 80.1 to 80.6), containing dry-weight (dw) surface sediment PCB concentrations up to 1,430 μ g/Kg. Sub-surface sediments within the deposit contain PCBs at concentrations reaching 20 mg/Kg. The contaminated sediments had accumulated in a channel depression formed by the river prior to dam construction. Preliminary ownership determinations at Deposit 1 indicate that portions of the deposit or land adjacent to the deposit along the bank are owned by the City of Spokane, while the principal underwater sediments of concern are believed to be located within the bed and banks of the river owned by the State of Washington, under the control of the DNR.

Deposit 2 – a smaller (0.2 acre) shallow water area on the north bank side channels near Donkey Island (RM 83.4), containing surface sediment PCB concentrations up to $330 \mu g/Kg$. The upland area is owned by the Washington Department of Parks and Recreation. Some submerged portions, as bed and bank of the river, may be owned by the State of Washington, under the control of DNR. Donkey Island is valuable riparian habitat that provides shelter for juvenile salmonids. Donkey Island is a highly heterogeneous environment consisting of areas that are only seasonally inundated as well as channels that have standing water throughout the year.

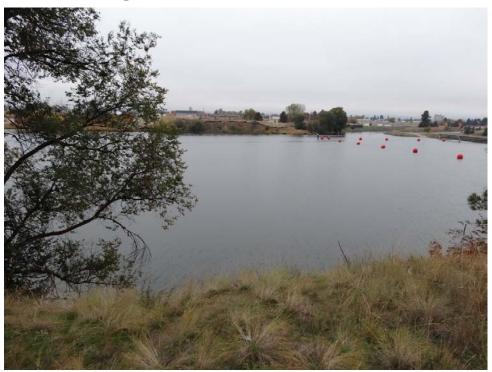
Photo 1: Location of Deposit 1 – from the north

The impermeable Site surfaces at Deposit 1 continue to eliminate direct exposure pathways to contaminated sediments based upon the last monitoring event in 2011.
