Re: No Further Action at a Property Associated with a Site:

- **Property Address:** 4910 Leary Avenue NW, Seattle, WA
- **Facility/Site No.:** 85572141
- **Cleanup Site ID No.:** 6770
- **VCP Project No.:** NW1584

FIGURE 4
 GROUNDWATER ANALYTICAL RESULTS
 FOR MARCH 2015
 TOC HOLDINGS CO. FACILITY NO. 01-443
 4910 LEARY AVE. NW
 SEATTLE, WA

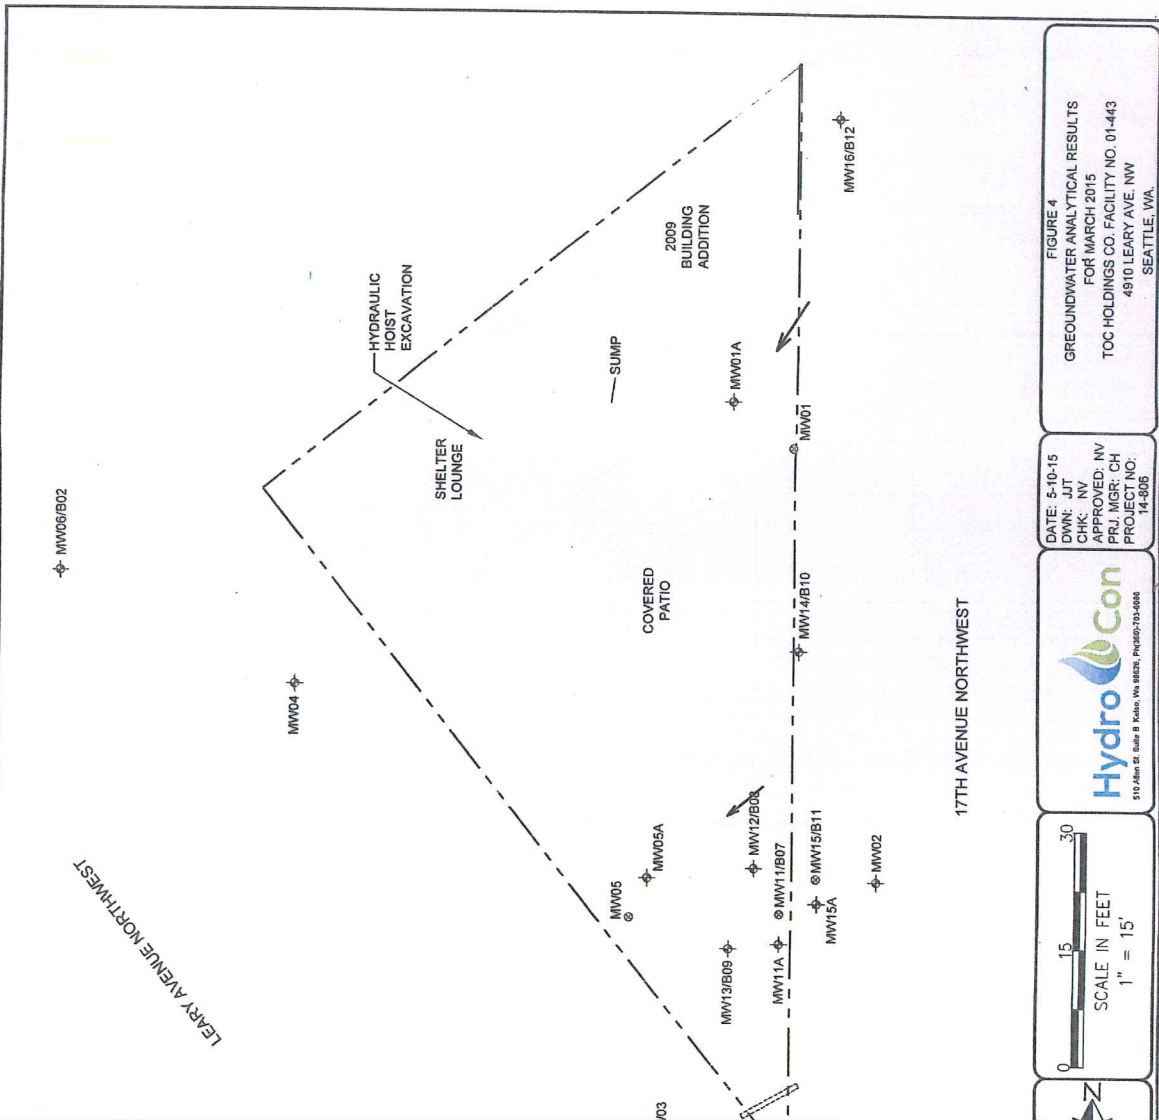
Ground water samples from MW-11A have been consistently below Method A cleanup levels since installation through 2015. Contaminant levels in other on-Property ground water wells (MW-01A and MW-05A) remain below MTCA Method A cleanup levels. The off-Property ground water wells, MW-03 and MW-09, are contaminated with gasoline, 1,2-dichloroethane (EDC), and benzene above MTCA Method A cleanup levels.

Ground water contamination remains above the Method B cleanup levels on the Site in monitoring wells located off-Property and adjacent ROW to the south and west.
