CLEANUP ACTION PLAN

HIGHLAND HILLS SHOPPING CENTER NORTHWEST FURNITURE & BRIDGESTONE FIRESTONE RETAIL CENTER

GALLOWAY ENVIRONMENTAL, INC.
3102 - 220th Place SE
Sammamish, Washington 98075-9540

September 25, 2015

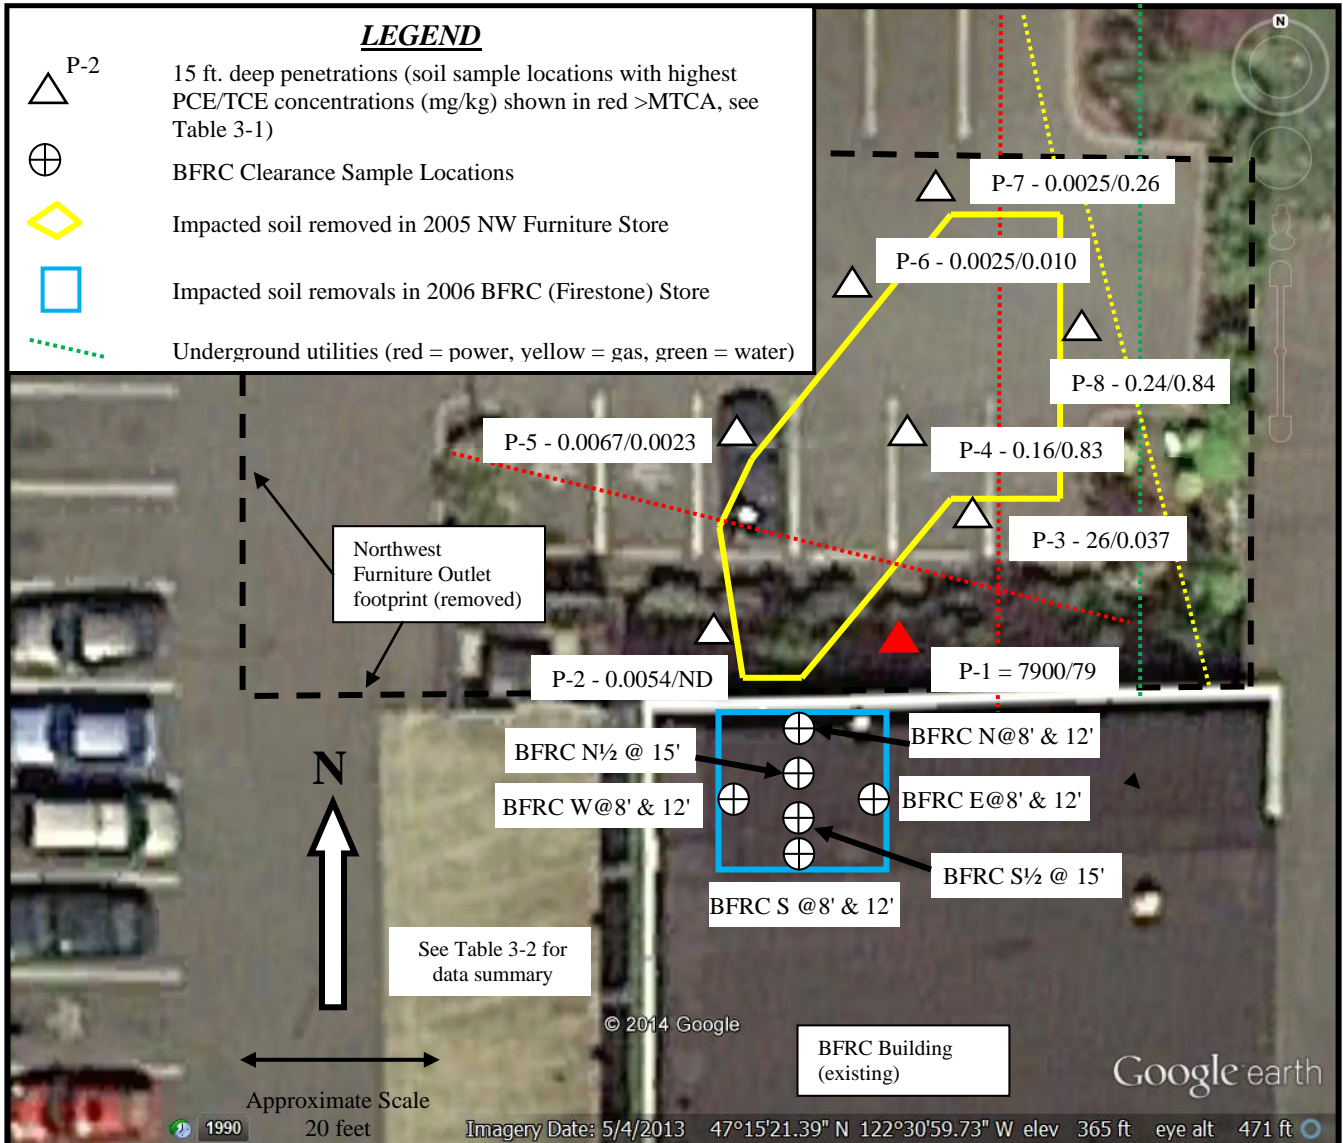
FIGURE 3-1 – SOIL SAMPLE LOCATIONS (GeoProbe & BFRC Clearance Samples)

Northwest Furniture Outlet - Laboratory analysis of soil samples collected during GEI's latest direct push (GeoProbe) investigation confirmed the presence of contaminant concentrations above the allowable MTCA CULs for "Direct Contact" under Methods B or C for Unrestricted Land Use (ULU) in one of the eight soil penetrations sampled beneath the footprint of the Northwest Furniture Outlet (previously operated as the Daisy Clothing Care facility). See Appendix A – Previous Environmental Reports, Site Cleanup Confirmation Investigation at the Highland Hills Shopping Center, by GEI, dated December 29, 2014.

BFRC - Soil samples collected from the limits of the remedial excavation at the BFRC in 2009 also exceeded MTCA CULs for "Direct Contact" under Methods B or C for in the sidewalls and bottom of the excavation. See Appendix A – Interim Cleanup Status Letter Report to the WDOE, by GEI, dated March 30, 2009.

Northwest Furniture & Bridgestone Firestone Retail Center Property Focused SCCI – See Table 3-1 for laboratory results

- Additional environmental investigation or remedial action is recommended to comply with MTCA regulations in vicinity of the one soil penetration with elevated COC concentrations in the soil.
- Institutional Controls are necessary to ensure worker protection for workers performing invasive activities in vicinity of the BFRC remedial excavation.

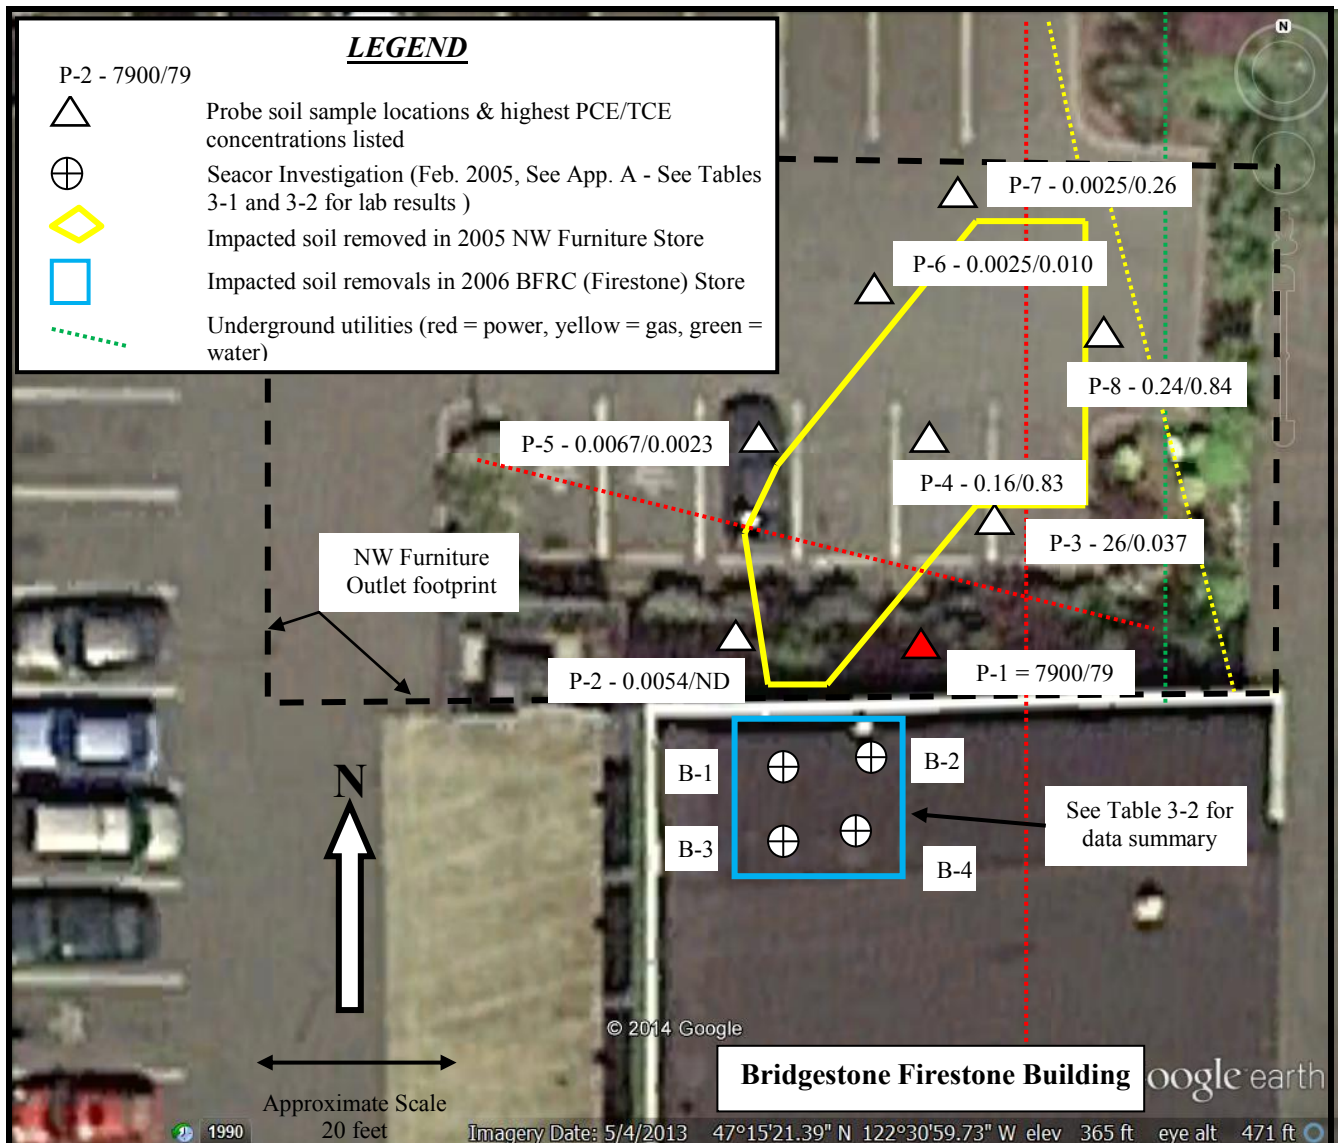
FIGURE 3-1 — SOIL SAMPLE LOCATIONS

**Sample locations shown in Figure 3-1

Northwest Furniture & Bridgestone Firestone Retail Center Property Focused SCCI
 Modified after Google May 2013, GEI Project #34045

Additional environmental investigation and/or remedial action is recommended to comply with current MTCA regulations.
