# INITIAL INVESTIGATION FIELD REPORT

ERTS # 623585  
 County Whatcom  
 Parcel #  
 FS ID # 11335 CSID# 11698

<b>Site Name</b> (e.g., Co. name over door): BNSF Switchyard - Bellingham Station	<b>Site Address</b> (including City and Zip+4): 1250 D St, Bellingham, WA 98225	<b>Site Phone:</b> (206)625-6501 ( ) -
<b>Site Contact and Title</b> (if any): Bruce Sheppard, Mgr Env Affairs Jennifer Anderson, Mgr Env. Ops	<b>Site Contact Address</b> (including City and Zip+4) if any: 2454 Occidental Ave S Ste 1A Seattle, WA 98134	<b>Site Contact Phone:</b> (206)625-6035 (206)625-6034
<b>Site Owner:</b> Burlington Northern Santa Fe Railroad	<b>Site Owner Address</b> (including City and Zip+4): 2650 Lou Menk Drive Fort Worth, TX 76131-2830	<b>Site Owner Phone:</b> (800)795-2673 ( ) -
<b>Site Owner Contact</b> (if any): David C. Clark, P.E. Director Env. Remediation	<b>Site Owner Contact Address</b> (including City and Zip+4) if any: David.Clark@bnsf.com	<b>Owner Contact Phone:</b> (785)435-2210 ( ) -
<b>Previous/Additional Site Owner(s):</b> City of Bellingham	<b>Previous/Additional Site Owner(s) Address</b> (including City and Zip+4): 210 Lottie Street, Bellingham, WA 98225	<b>Phone:</b> (36

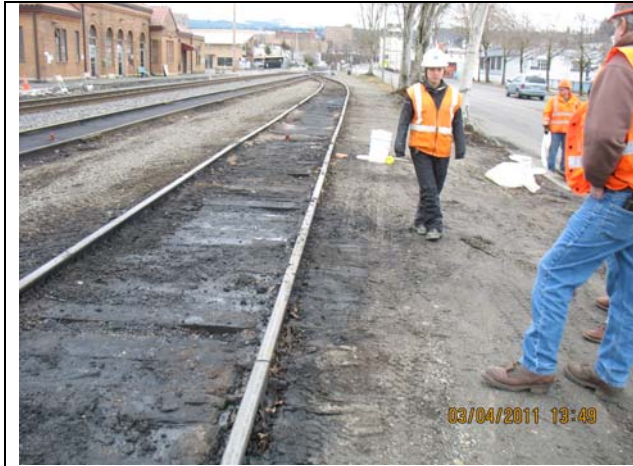
BNSF Switch yard facing SE, along Roeder Av

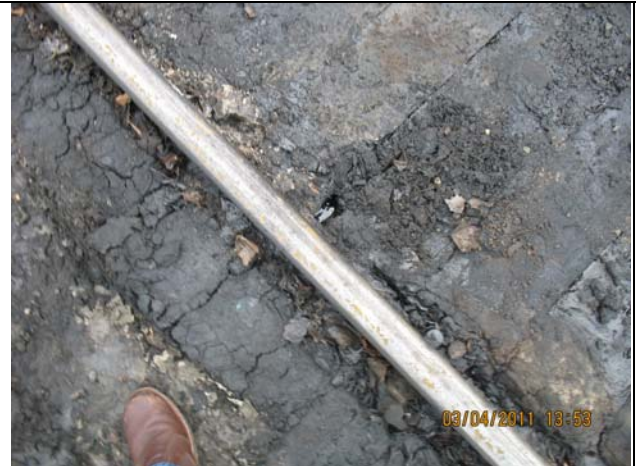
the heavy contamination present in the switchyard. The soil appeared nearly saturated with black lube oil, and the soil jiggled underfoot out side the tracks, where black oil welled up to the surface.

Apparent free product in soil between tracks.

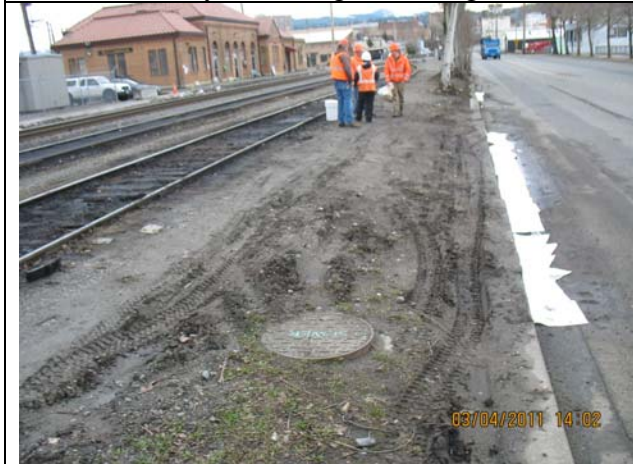
General Comments: The soil appeared nearly saturated with black lube oil, especially between the tracks, and the soil jiggled underfoot out side the tracks, and black oil welled up to the surface. The oil sheen in the water flowing to the storm drain on Roeder Ave. appeared to seep from the roadway fill dirt, through cracks in the curbing and pavement onto the roadway.
---

Petroleum seeping thru cracked paving to road.

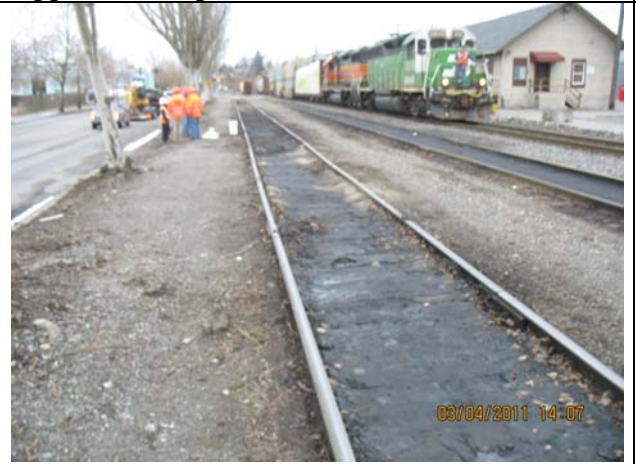
<p>Description of past practices likely to be responsible for contamination: long term issue of spills of lube oil and/or fuel oil, and other green liquids on the switchyard tracks due to maintenance or malfunction, without periodic clean up of the bulk of the contamination.</p>
---

Facing NW, heavily polluted tracks.
