August 27, 1990

15,518.001

**Preliminary Contamination Assessment
Underground Storage Tank Removal
2021 Sixth Street
Bremerton, Washington**

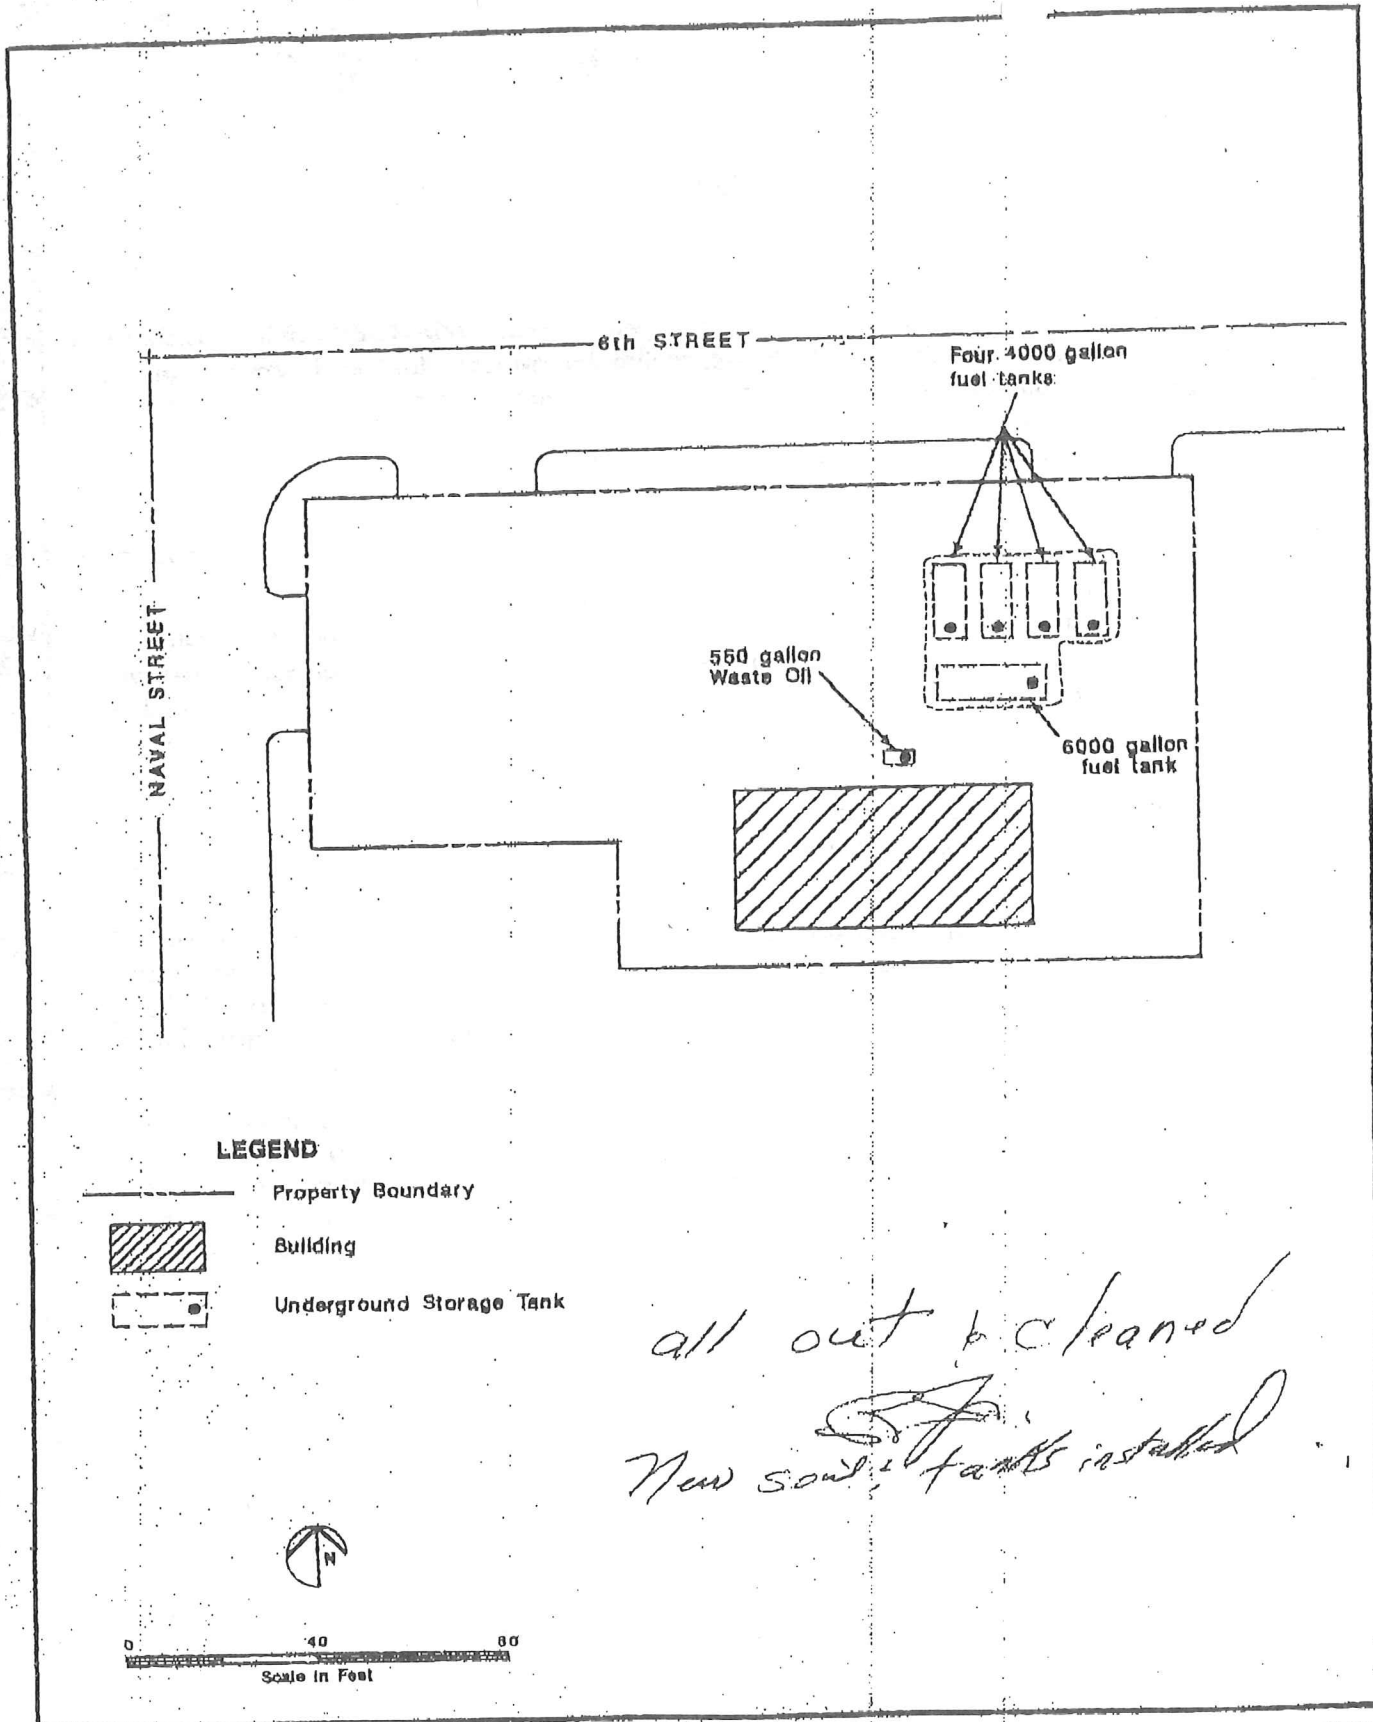
Site Plan

Six USTs were removed: one 6,000-gallon and four 4,000-gallon tanks were in one cavity, and one 550-gallon waste oil tank was in a separate cavity. Locations of tanks and the area of excavation are indicated on the enclosed Site Plan, Figure 1.

Lateral extent of contamination within the main cavity can be defined as follows. The east side of the cavity east of the 4,000-gallon tanks (Figure 1) contained less than 10 ppm Total Petroleum Hydrocarbons (TPH). A composite sample of the north (upgradient) wall of the cavity contained 346 ppm TPH in the gasoline range, but contamination would not be expected to extend far this direction. Two composited samples from the west wall of the cavity contained 245 and 1,550 ppm, identified as aged gasoline, with a possible diesel or mineral spirits component. No gasoline components were detected in the waste oil cavity, so contamination from the west wall of the main cavity has not migrated southward within the sand layer to the location of the waste oil tank. A composite of the south side of the cavity contained 4,875 ppm of gasoline, and a sample collected east of the 6,000-gallon fuel tank (Figure 1) contained 10,230 ppm of gasoline. This is the highest contamination level observed, and lateral extent remains to be defined in this area. Contamination appears to be concentrated within the sand layer, while levels within the underlying silty sand are below the Ecology guideline.

Lateral extent of contamination to the south of the main cavity remains to be defined. Test pits are scheduled to be excavated to the sand layer. The area of particular interest is south of the east end of the 6,000-gallon tank (Figure 1). This area is believed to be downgradient of the highest contamination levels observed on-site. If no additional contamination is encountered, operation of the presently installed vapor extraction piping should be sufficient to remediate remaining contamination. If additional contamination is encountered, more vapor extraction points should be installed.
