STATE OF WASHINGTON  
DEPARTMENT OF ECOLOGY

**Re: No Further Action at the following Site:**

- **Site Name:** Ralph Rush Property Well
- **Site Address:** 5003 Flagler Road, Nordland
- **Facility/Site No.:** 8707950
- **VCP Project No.:** SW0961

## Enclosure A

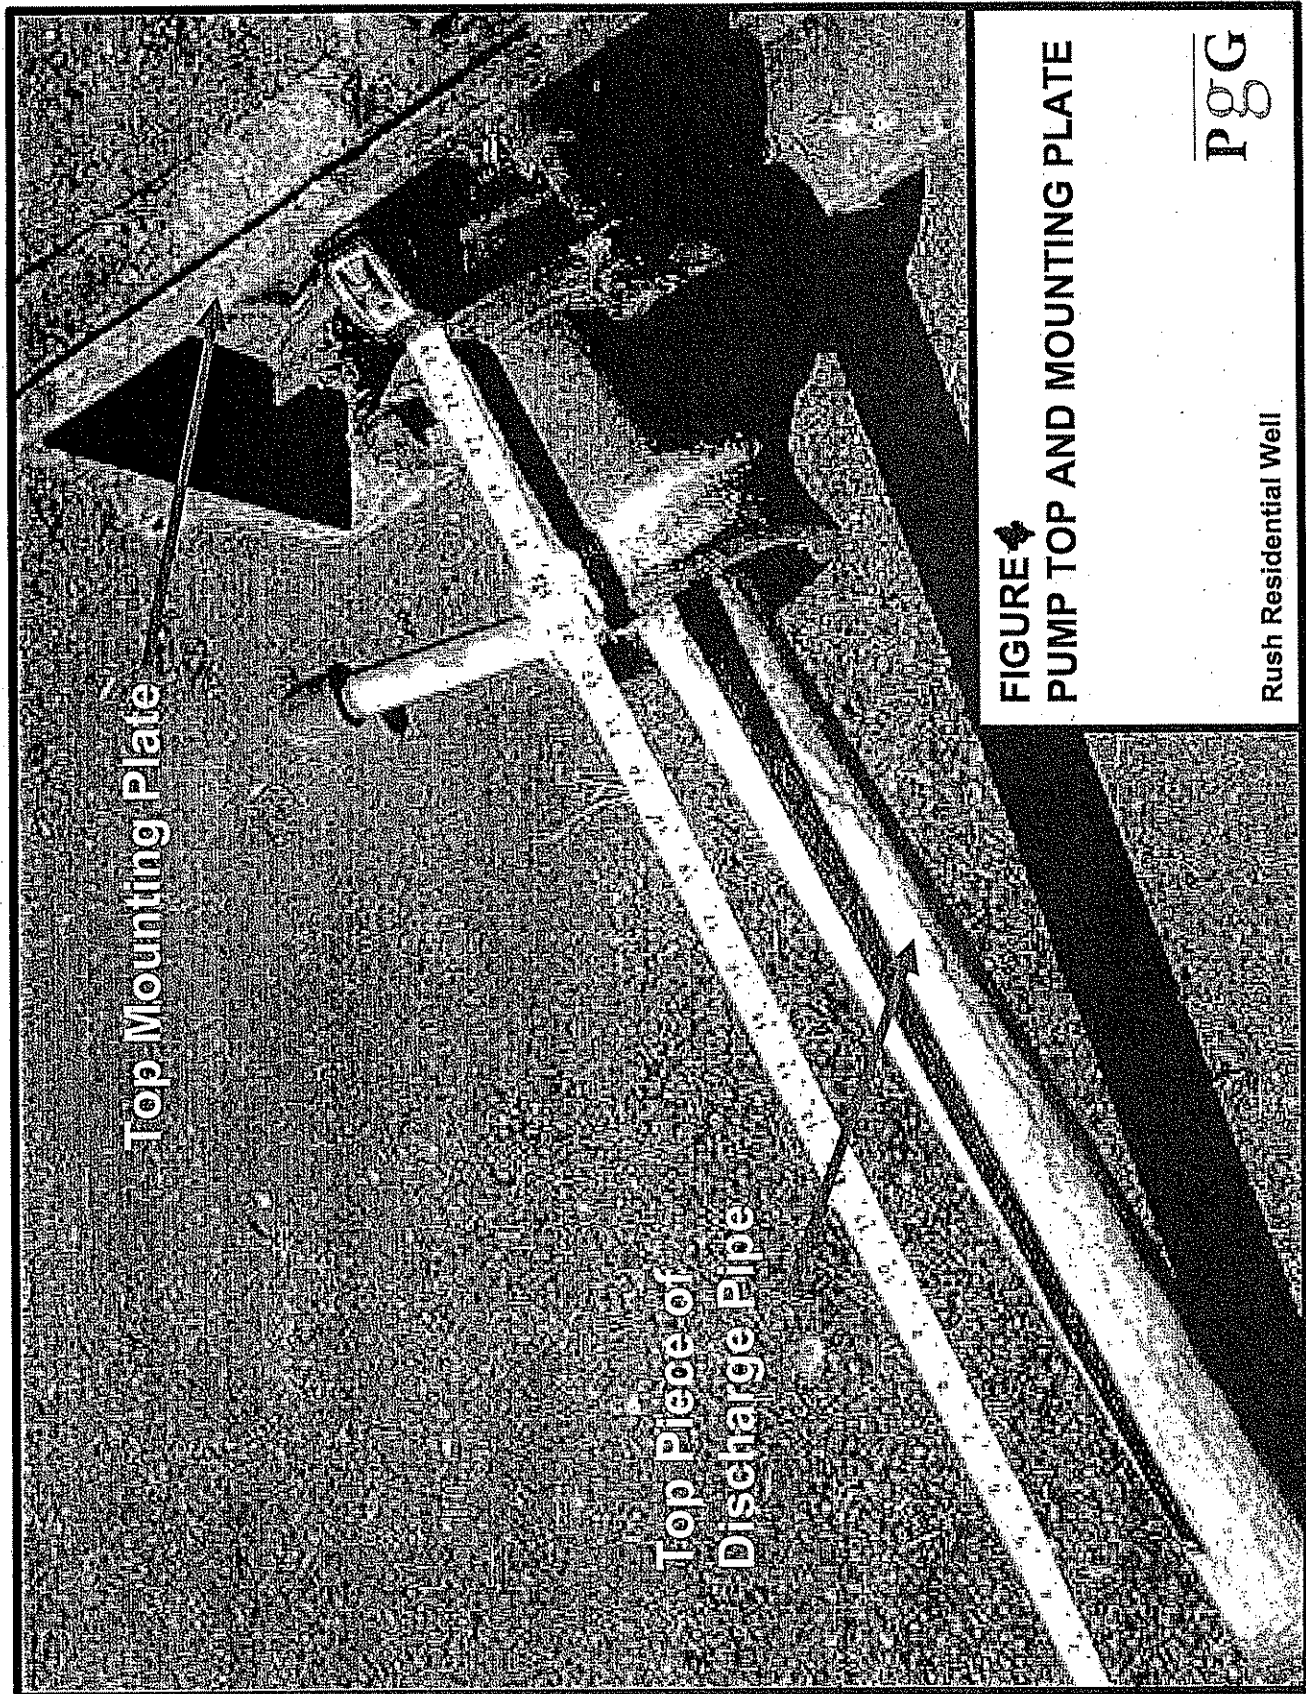
**FIGURE 4**  
**PUMP TOP AND MOUNTING PLATE**

The well pump is a 1½-inch diameter piston pump. The pump cylinder and 15 ft of pump intake combination extended to 97 ft btoc. The piston pump works by actuation of a central rod in a reciprocating motion. This motion is developed by a gearbox located at the top of the casing. The gearbox contains approximately one quart of oil for lubrication. For Well-131, the pump was powered by an electric motor that operated a pump jack through the gearbox. The understanding is that the motor and gearbox formed an integral unit bolted to a mounting plate shown in Figure 4. The mounting plate was bolted to a 4-inch thick concrete slab. The slab was 12 ft by 18 ft with 4- to 6-inch thick foundation walls that supported a well house. A 100-gallon pressure tank was located inside the well house. The concrete floor and foundation walls would have precluded leakage of oil outside of the well casing.

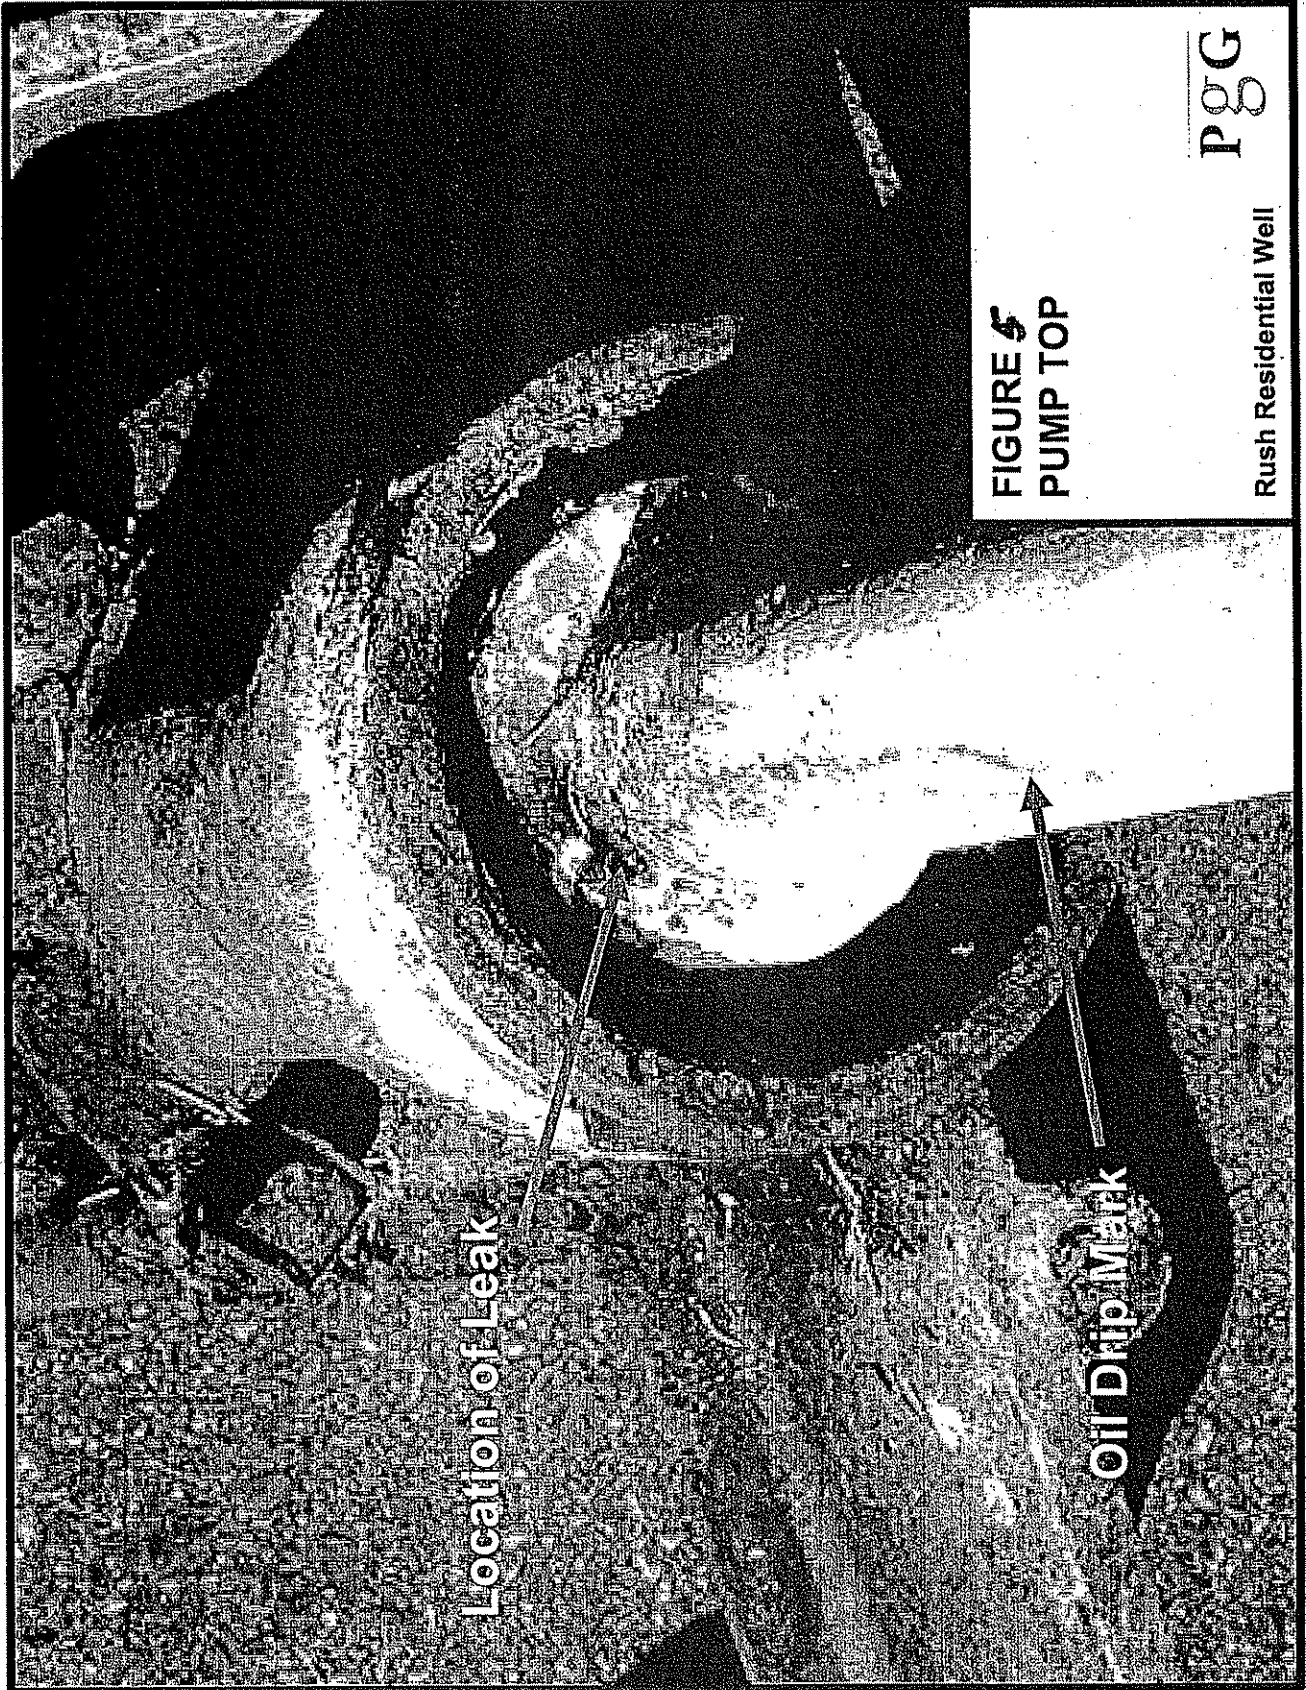
FIGURE 5  
PUMP TOP

Figure 5 is a photograph of the uppermost portion of the pump assembly that is attached to the mounting plate. The photograph shows the location of an opening and a drip pattern that appears to be traces of an oil drip mark. It is apparent that leakage occurred on the outside of the pump discharge pipe, which contaminated the water in the well. The well was contaminated with the gear oil at some unknown time because of the apparent failure of packing at the top of the discharge pipe. Because the discharge pipe is located within the well, leaking oil flowed down the discharge pipe onto the water within the well. No pathway is present to allow a release outside the well casing.

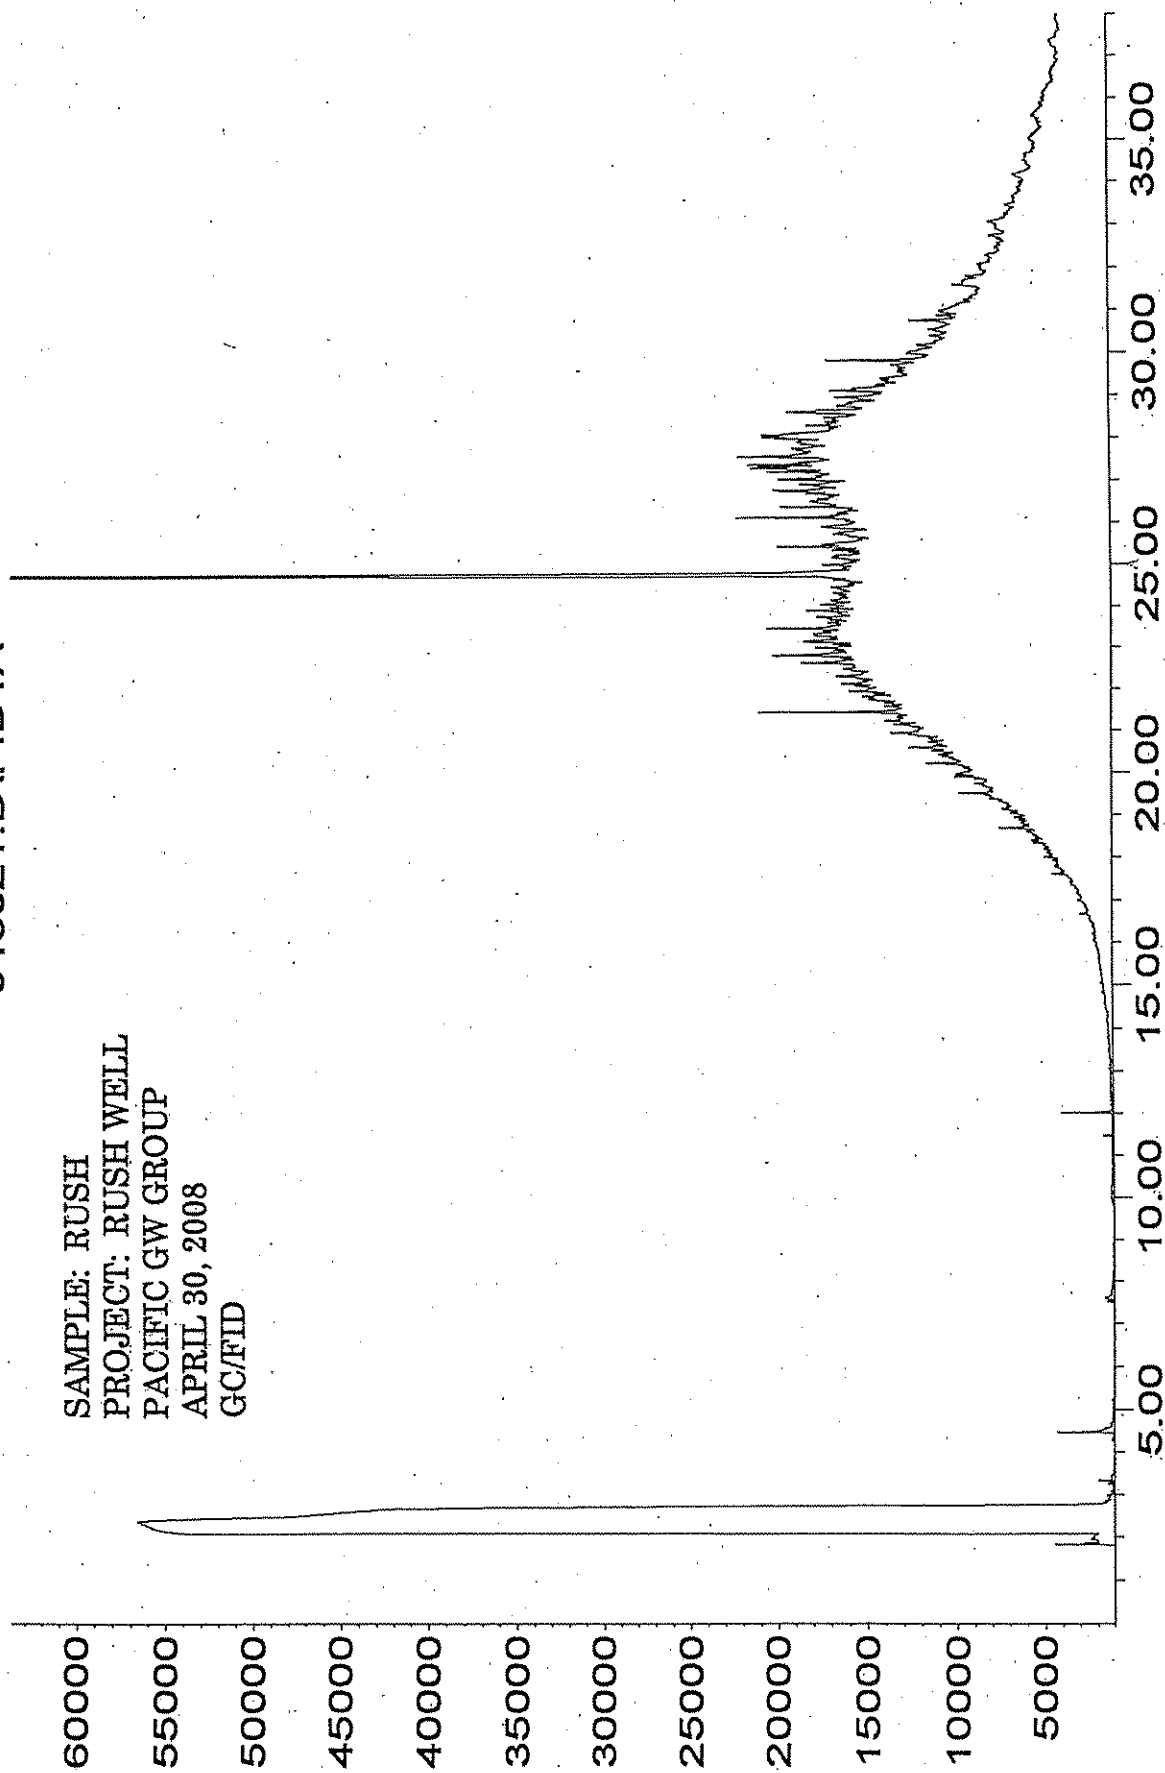
The gear oil is sticky and viscous. A sample of the oil was collected on April 28, 2008 and was submitted to Friedman Bruja, Inc. of Seattle, Washington. The laboratory describes the oil as "... medium to high boiling compounds." The material present "... is consistent with high boiling product such as lube oil...". The laboratory included a gas chromatograph that is shown as Figure 6.

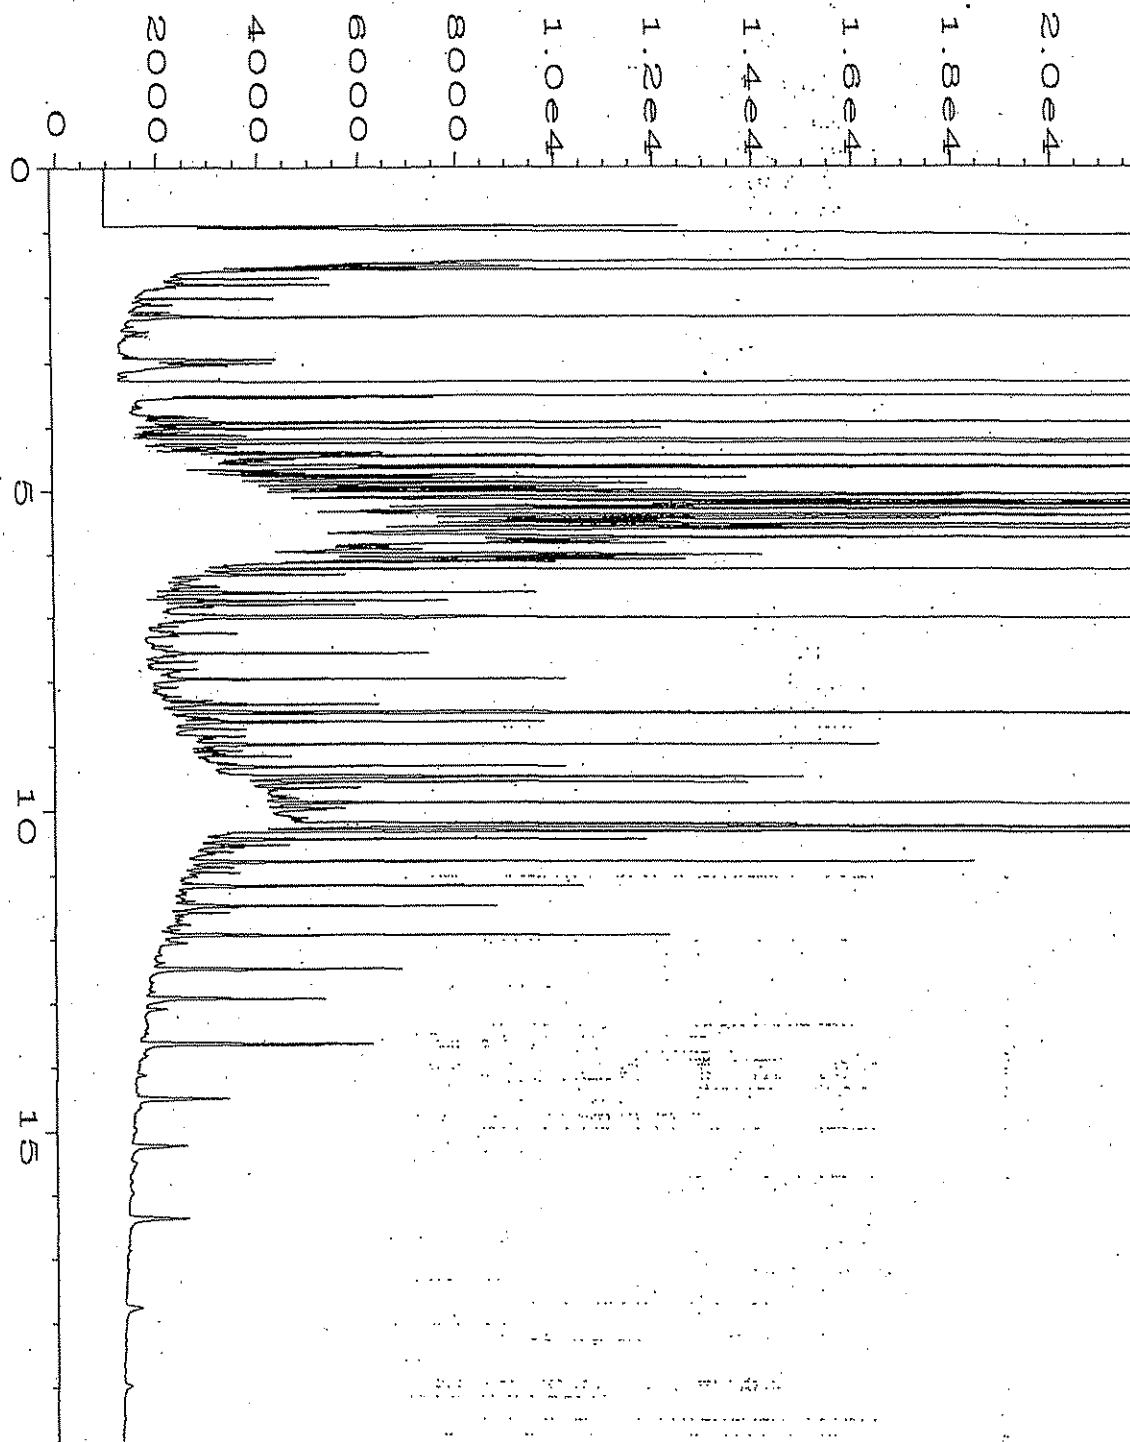
FIGURE 7

*remove sediment from the bottom of the well. Approximately 10 ft of material was removed and the well total depth was tagged at 131.5 ft bgs. The sediment bailed from the bottom was stored in six 5-gallon buckets. A three-stage, DC purge pump was lowered to a depth of approximately 85 ft bgs to purge the well. The pumping rate was estimated to be 3/4 gallon per minute (gpm). Purging continued until a sample was collected on August 22, 2008. The pump had been in continuous operation for until this date. Figure 7 shows the resulting chromatograph from this sample.*

*Analytical laboratory results from the last water sample collected indicate a "type of natural citrus-based cleaner". Based on this finding, it would appear that the well has been successfully cleaned.*
