Re: Further Action Determination under WAC 173-340-515(5) for the following Hazardous Waste Site:

• Name: Chevron 9-5311

Address: 1018 Plum Street, Olympia, WA

VCP No.: SW0733

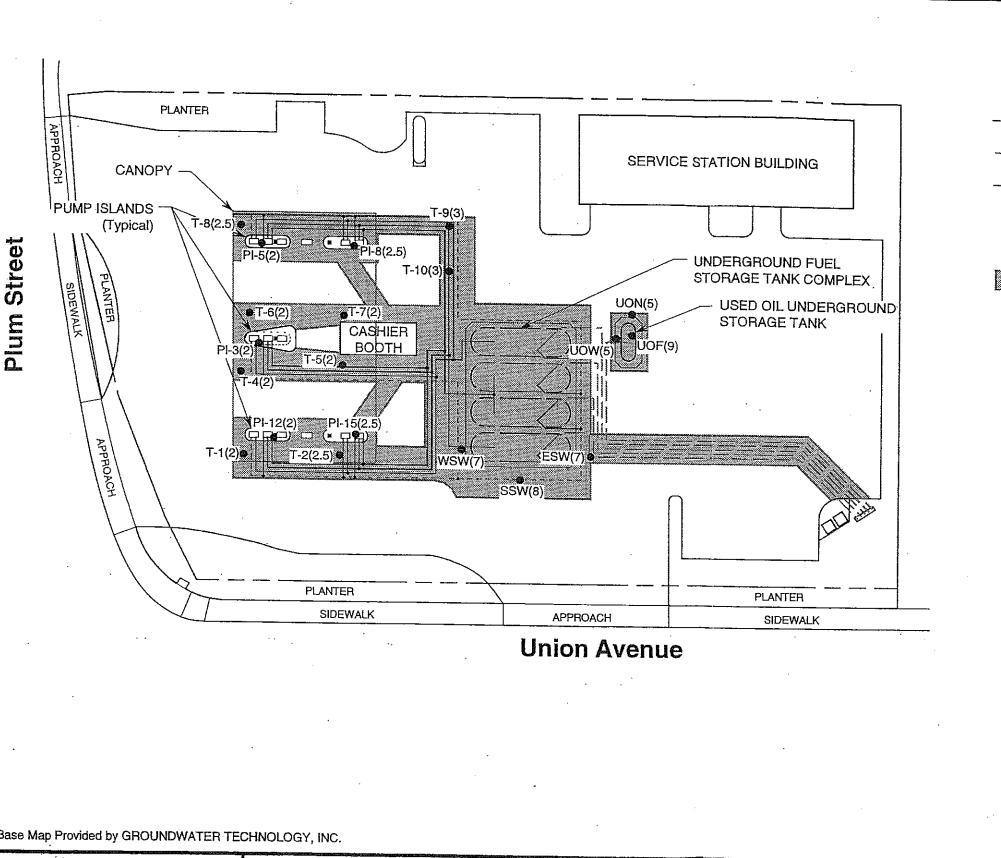
SOIL SAMPLE LOCATION MAP

Concentrations in these samples ranged from non-detect to 9900 milligrams per kilogram (mg/kg) gasoline, and non-detect to 990 mg/kg benzene. Four soil samples collected from the west ends of the fuel delivery line trenches, one soil samples collected beneath the fuel delivery piping and three soil samples collected beneath the central and northern pump islands contained concentrations of TPH-gasoline exceeding the cleanup level. All but 2 of the soil samples collected beneath the pump islands and fuel delivery piping contained concentrations of one or more BTEX compounds exceeding cleanup levels.

Significant gasoline and benzene contamination has been documented under the pump islands and fuel/vapor delivery piping systems, but has not been fully characterized.

An unknown amount of gasoline and benzene remain on site in soils under the western and northern pump islands and fuel/vapor delivery lines (see next Enclosure). It is unclear at this time whether groundwater in the vicinity of the soil contamination is impacted.

The attached figure highlights the soil samples with concentrations exceeding MTCA Method A standards. Concentrations in these samples ranged from non-detect to 9900 milligrams per kilogram (mg/kg) gasoline, and non-detect to 990 mg/kg benzene. Four soil samples collected from the west ends of the fuel delivery line trenches, one soil samples collected beneath the fuel delivery piping and three soil samples collected beneath the central and northern pump islands contained concentrations of TPH-gasoline exceeding the cleanup level. All but 2 of the soil samples collected beneath the pump islands and fuel delivery piping contained concentrations of one or more BTEX compounds exceeding cleanup levels. Excavated soil consisted predominantly of silty, gravelly sand and sand. Eleven product dispensers were completely removed (and replaced) along with the associated concrete islands.

Please submit a work plan to complete characterization of the site soil and groundwater in accordance with Table 830-1. Please include proposals for soil analyses and additional groundwater well installation locations and construction diagrams.

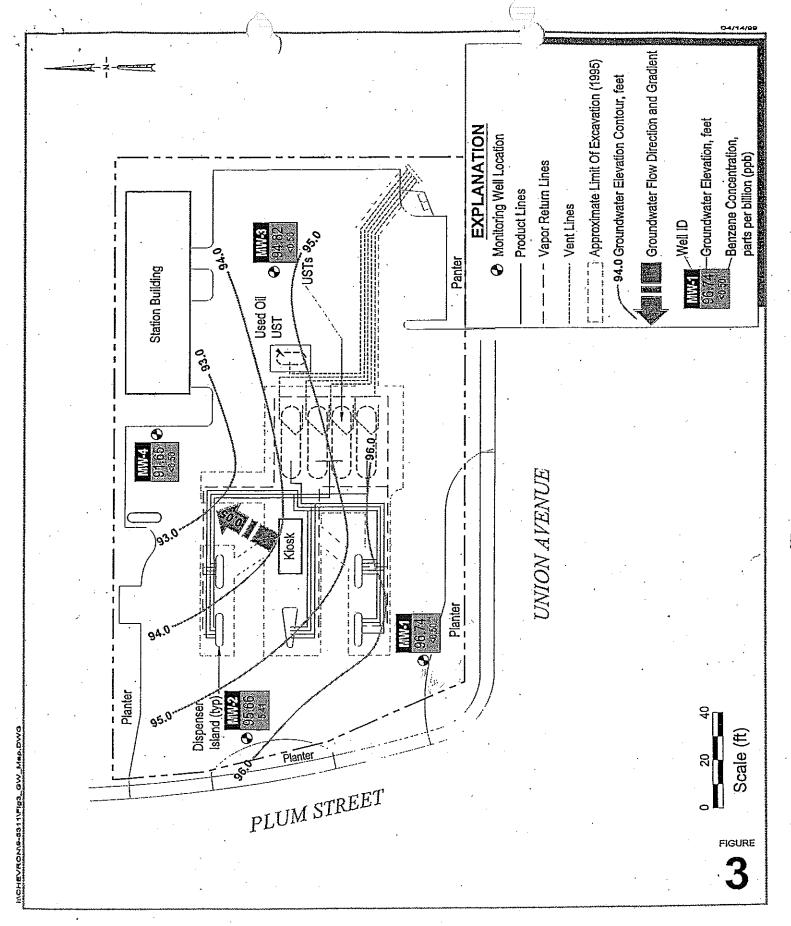
Groundwater Elevation Contour Map

In March of 1999, four borings were completed as monitoring wells in order to better characterize possible impacts to soil and groundwater. The gradient has remained very consistently northeast over the years, only wavering slightly. However, it appears the wells that are currently installed would not likely intercept the gasoline contamination remaining on site, due to the fact it is located on the north and west side of the pump islands and piping system. The gradient would likely carry the contamination right between wells 2 and 4. Although groundwater monitoring data consistently reports undetectable concentrations of petroleum constituents, this may not be representative of actual groundwater conditions near the source area.

In March of 1999, four soil borings were completed as monitoring wells in order to better assess the conditions of site soil and groundwater. See attached figure. Borings 2 and 3 had detections of petroleum constituents in soil between 4 and 5 feet bgs. Boring 3 had concentrations of diesel and heavy oil at 249 and 434 mg/kg, respectively (this is located east of the waste oil tank). Boring 2 had concentrations of gasoline and heavy oil at 28 and 124 mg/kg, respectively. The only groundwater concentration reported was 0.0054 mg/L benzene in monitoring well 2, located west of the dispenser islands. However, the gradient is calculated according to the water elevation in each monitoring well and reportedly is consistently north-northeast to northeast. This means the wells that are currently installed would not likely catch the gasoline contamination remaining on site due to the fact that it is located on the north and west side of the pump islands and piping system. The gradient would likely drag the contamination right between wells 2 and 4. Although groundwater monitoring data consistently reports undetectable concentrations of petroleum constituents, this may not be representative of actual groundwater conditions near the source area.
