STATE OF WASHINGTON DEPARTMENT OF ECOLOGY

Re: No Further Action at the following Site:

• Site Name: Minit Lube 1116

• Site Address: 1616 Freeway Drive, Mount Vernon, WA

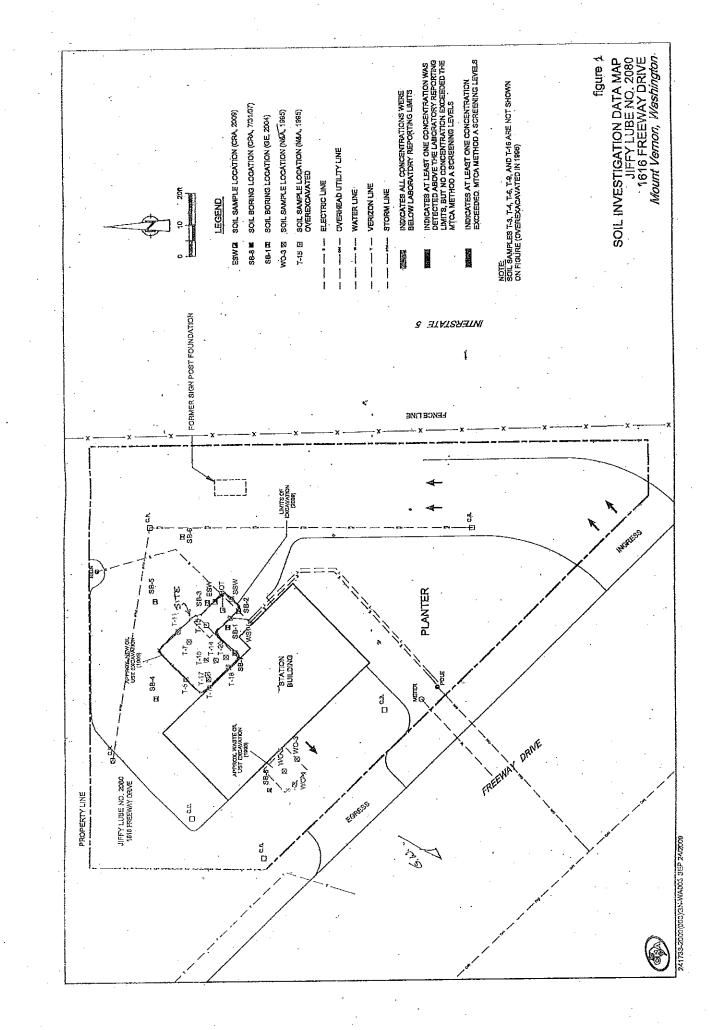
The Site soil contamination included TPHd, and TPHo that exceeded MTCA method A cleanup levels. The source was most likely from leaking product supply lines and spills. The vertical and lateral extent of soil contamination was defined and was limited to an area within the Property boundaries, as shown on the attached Figure 1.

The Site comprises an area contaminated by diesel- and oil-range hydrocarbons associated with a Jiffy Lube service station (see attached figure). The service station (the Property) is located at 1616 Freeway Drive, Mt Vernon, adjacent to a south-bound onramp for Interstate 5. A storm water pump station and car stereo shop occupy properties immediately adjacent to the north, and vacant highway right-of-way occupies the area to the south. Across Freeway Drive to the west are various commercial establishments.
