STATE OF WASHINGTON
DEPARTMENT OF ECOLOGY

Re: Further Action at the following Site:

- **Site Name:** Shell Station 121771
- **Site Address:** 22026 Marine View Drive South, Des Moines
- **Facility/Site No.:** 88387929
- **VCP Project No.:** NW2081

Description and Diagrams of the Site

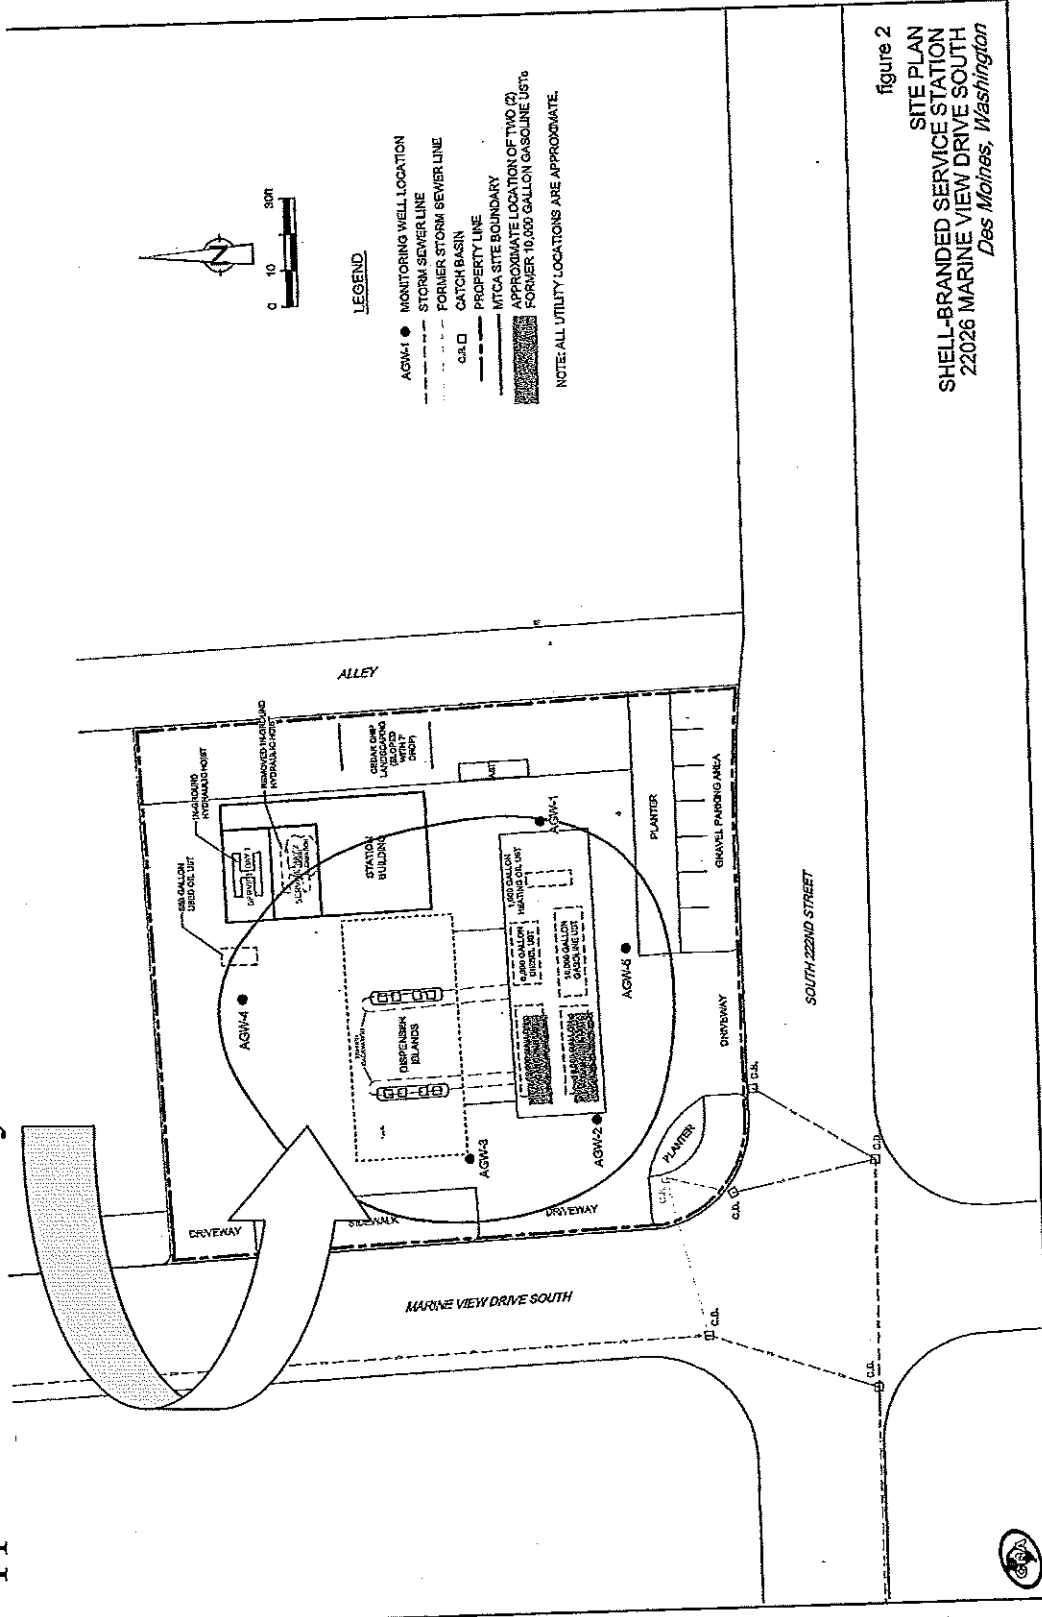
Approximate Boundary of Site

The Site consists of soil and ground water contamination associated with releases of petroleum hydrocarbon products at 22026 Marine View Drive (the Property). A Shell-branded service station operates on the Property. The Property is located in Des Moines at the northeast corner of Marine View Drive South and South 222nd Street. Key Bank is located at the northwest corner of the intersection, Des Moines Auto Service at the Southwest corner and a retail building at the southeast corner. An office building is located directly north of the Property and a residence is east of the property. Des Moines Elementary School is located approximately 1,300 feet east of the Property. The nearest surface waters include Des Moines Creek (1/4 mile northwest of the Property), Barnes Creek (1/2 mile southeast of the Property), and Puget Sound (1/4 mile west of the Property).

Gasoline-range hydrocarbons (TPHg), diesel-range hydrocarbons (TPHd) and benzene, toluene, ethylbenzene, and xylene (BTEX) contamination in soils were encountered near the dispenser island when stage II vapor recovery system was installed. The lateral and vertical extent of soil contamination in the vicinity of the dispenser islands was not defined during this investigation.

Ground water sampled from multiple wells in 1995 showed TPHg, benzene and toluene above MTCA cleanup levels. Similar elevated readings at more than one monitoring well were observed in 1997 and 2009. These observations may indicate that a source of TPHg may remain at the Site.
