Subj: Storm Drain Sediment and Grit Removal, Final Report

STORM DRAIN SYSTEM CLEANOUT

FINAL REPORT

Tacoma Boatbuilding Co.  
1840 Marine View Drive  
Tacoma, WA 98422

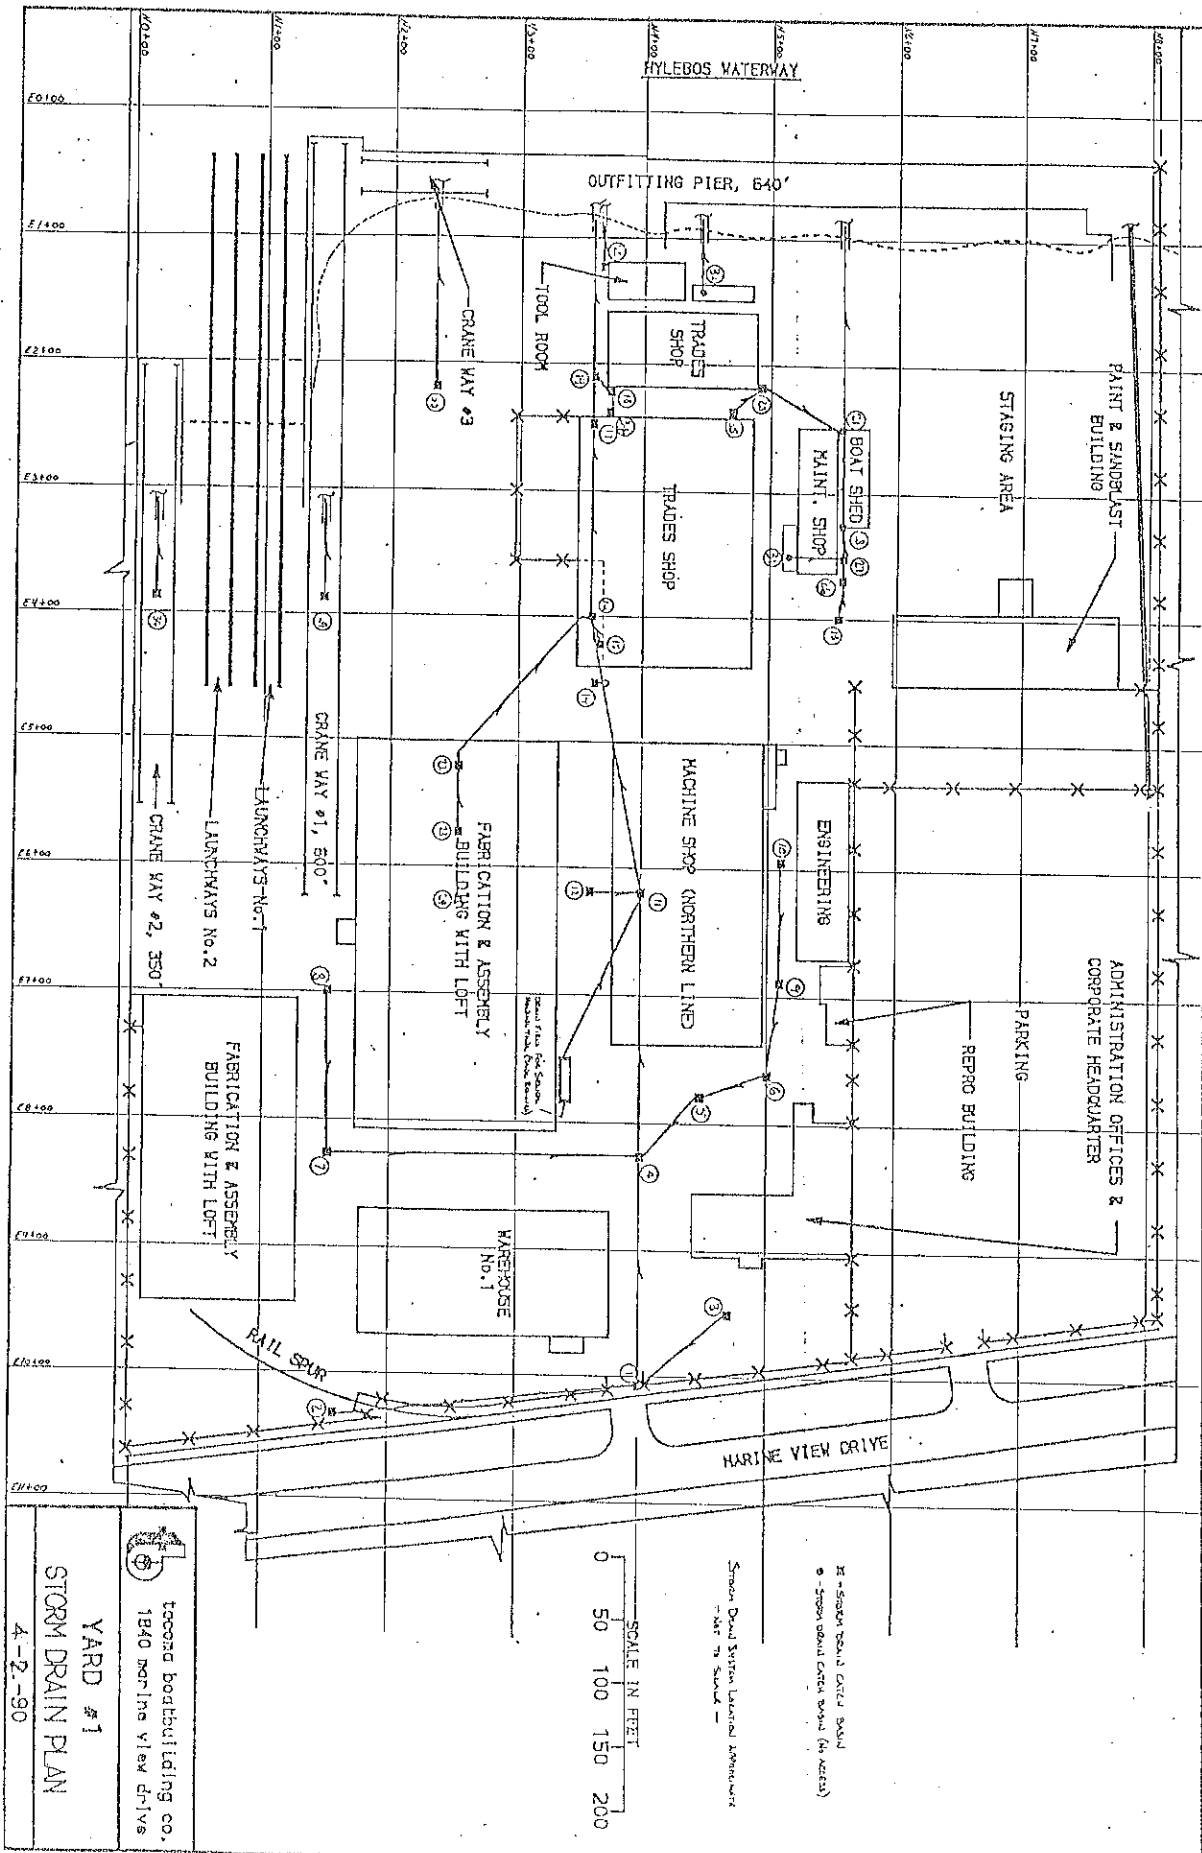
FIGURE 1

The facility covers approximately 19 acres and is fully developed with paving or structures throughout all of the facility with the exception of a strip of vegetation near the employee parking lot and areas incorporating the bank of the Hylebos Waterway. The facility is relatively flat with a slight slope toward the Hylebos shore. A storm drain system exists throughout the facility with catch basins, manholes and outfalls as shown in Figure 1.
