**Report
Independent Clean Up Action
Riverside Business Park
Everett, Washington**

August 22, 2002

**The Port of Everett
2911 Bond Street, Suite 202
Everett, WA 98201**

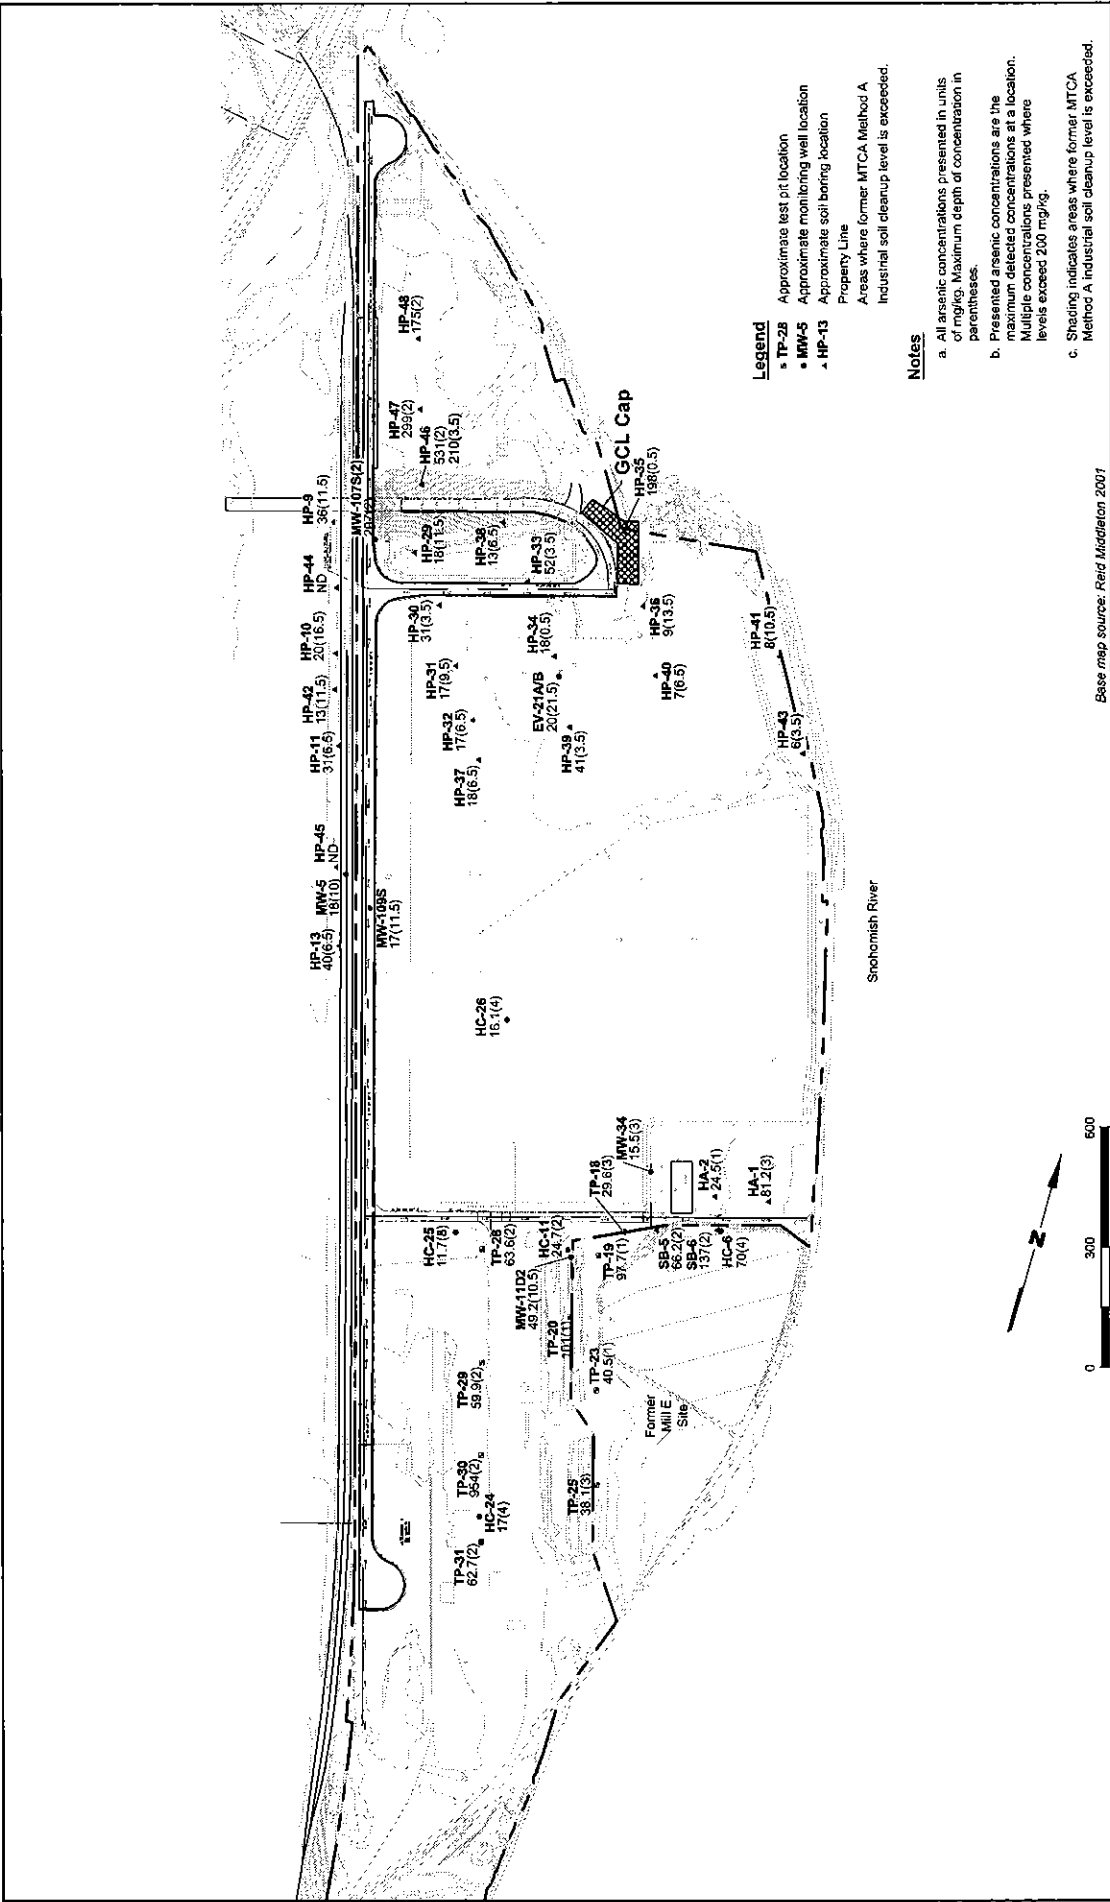
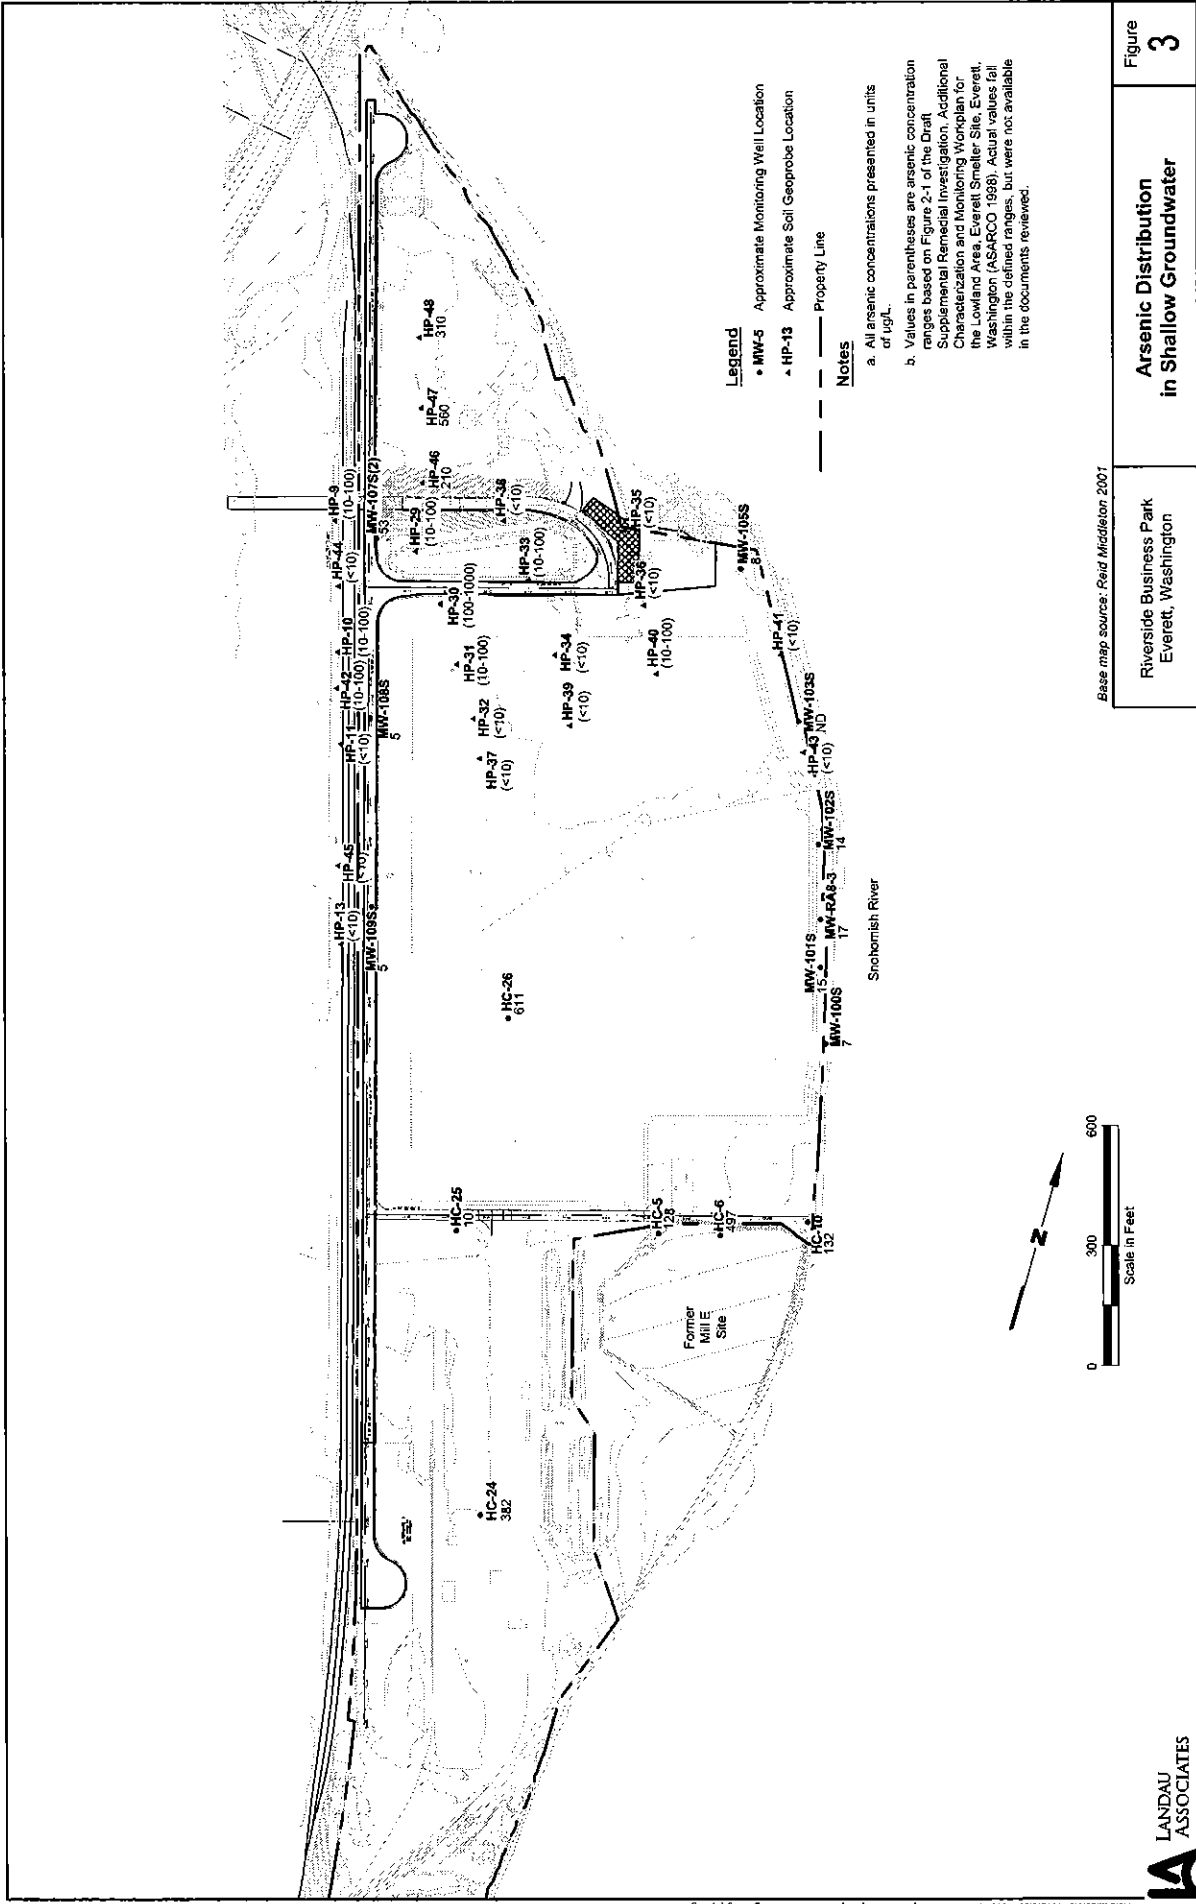
Figure
3

Arsenic groundwater concentrations in the shallow aquifer are generally less than 20 µg/L, except for an area in the northern portion of the project site and an area in the general vicinity of the former Mill E Site, as shown on Figure 3. Many of the groundwater samples exhibiting elevated arsenic concentrations were collected by geoprobe (e.g., all locations identified with a triangle on Figure 3), which often have high levels of suspended particulates, even after filtering. The high levels of suspended solids in the sample frequently result in detected metals concentrations that are higher than is actually present in the groundwater because the metals sorbed on the solids readily desorb into the groundwater sample.

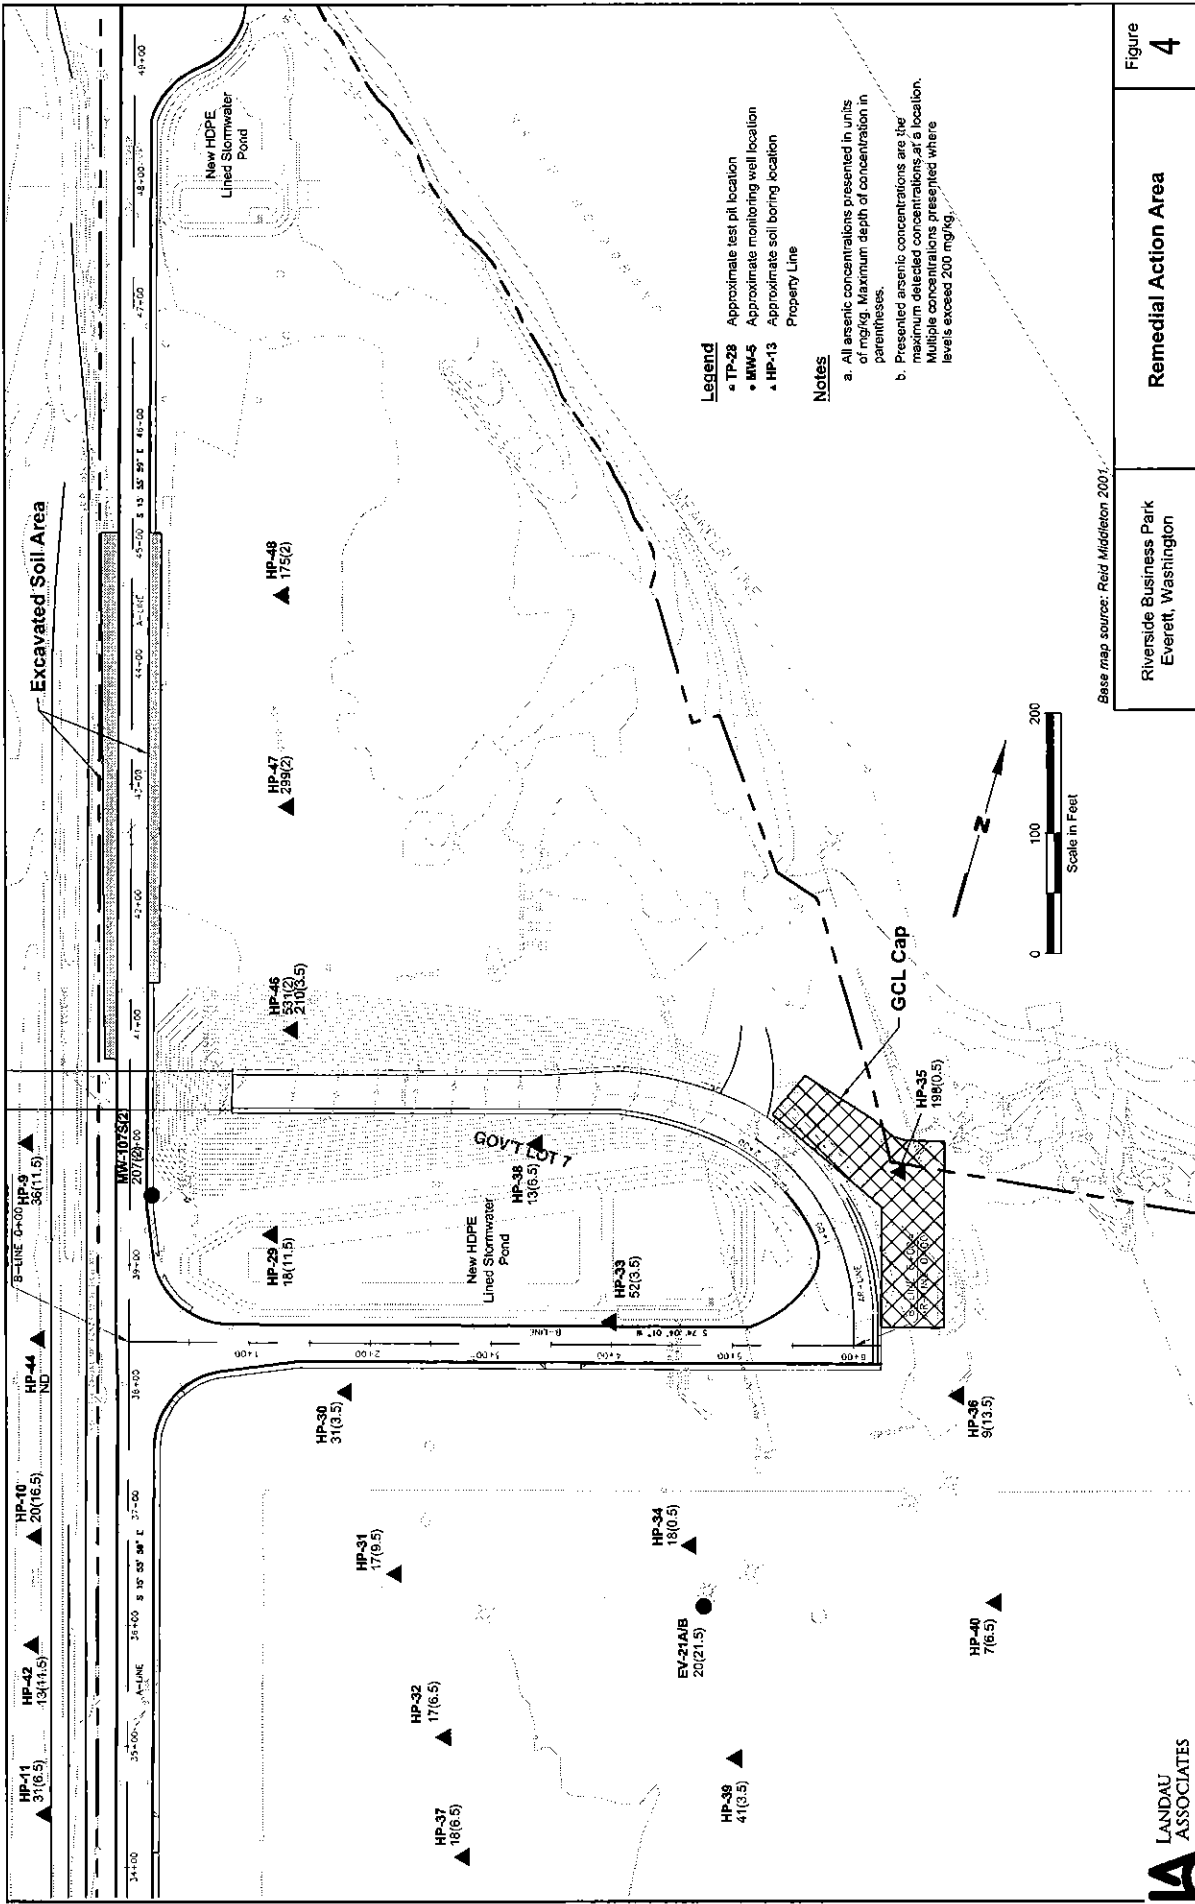
During April 2001, Wilder Construction moved the stockpile of arsenic-affected soil to near the eastern bridge approach (see Figure 4). On April 5, 2001, Landau Associates personnel confirmed that no additional soil remained in the former stockpile area.

On April 26, 2001 Landau Associates personnel visited the site to observe the completion of arsenic-affected soil capping. Landau Associates personnel did not observe all capping activities; the capping description below is based on information provided by Jeff Schock and Todd Snyder of Wilder Construction. The cap was constructed by installing a reinforced, needle punched GCL (Bentomat DN) over the arsenic-affected soil. Prior to placing the GCL, the area was crowned to promote surface water runoff. Because the width of the area being capped exceeded the width of the GCL, multiple strips were deployed. Placement of the GCL was started near the low point of the capped area, and GCL strips were placed with an overlap of between about 12 and 18 inches. The GCL strips were overlapped in a manner similar to roof shingles (i.e., surface water runoff will flow over the overlaps, not under the overlaps). Consistent with manufacturer's recommendations, the GCL strips were sealed at the overlaps with bentonite powder.
