UST SITE ASSESSMENT REPORT

HOQUIAM CITY HALL

609 8th Street

August 01, 20000

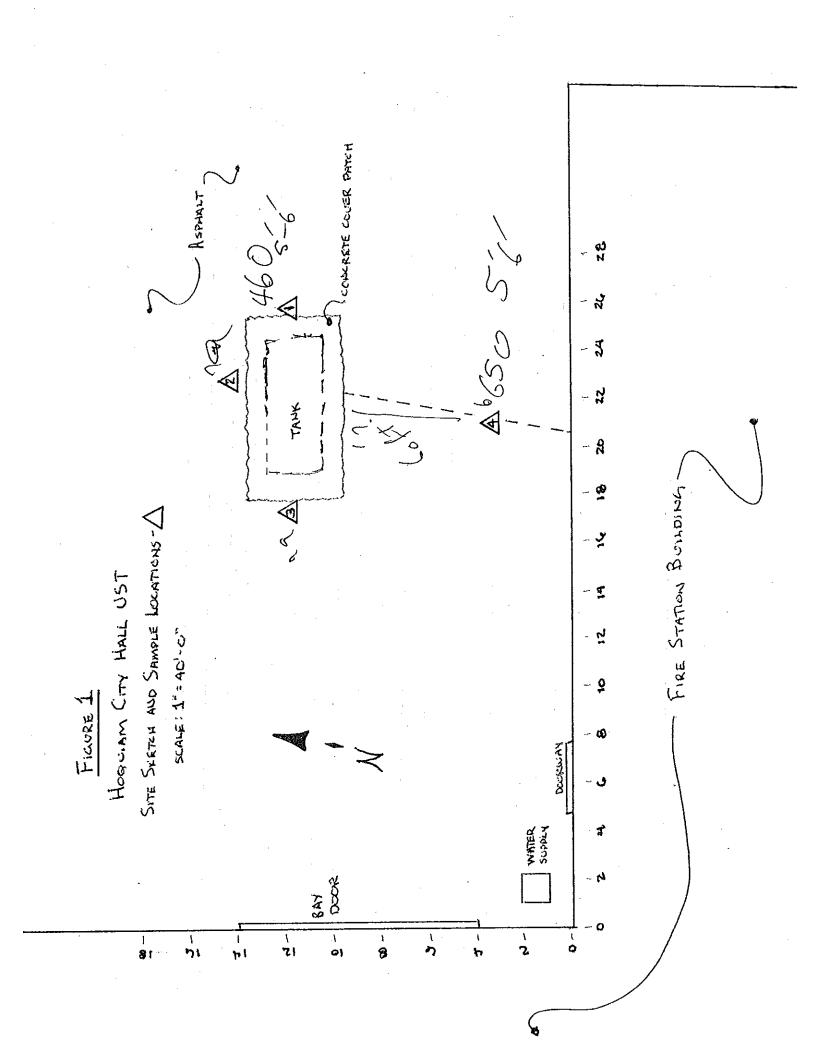
FIGURE 1: SITE SKETCH with TANK and SAMPLE LOCATIONS

The soil and water samples extracted at probe location #1 showed a slight sheen, with a PID reading of 30 ppm for soil introduced into a sealed headspace. In addition to subsurface soil, a water sample was also extracted at this location. No other locations indicated any contamination in field screening. A sand backfill was encountered from the surface to approximately five feet bgs, underlain by native silts. See attached table for test locations and results.

Laboratory analysis confirmed lead contamination in excess of Washington State Department of Ecology MTCA Method A cleanup standards remain in groundwater at the site. Lead contamination was also confirmed in soil at two locations adjacent to the tank. Further investigation of the site is recommended to map out the soil strata contaminated with excess levels of lead. Disposal of soils with high lead content would not be possible at the same facility that accepted the previous gasoline/diesel contaminated soils. The cost of disposal of lead-contaminated soil is expensive, so it would be prudent to determine the limits of contamination as accurately as possible. Filtered groundwater samples should be obtained at the site after removal of lead contaminated soils.
