Report
Property Boundary Investigation
Thompson-Isaacson Property
Tukwila, Washington

September 9, 2009

The Boeing Company

**LANDAU
ASSOCIATES**
130 2nd Avenue South
Edmonds, WA 98020
(425) 778-0907

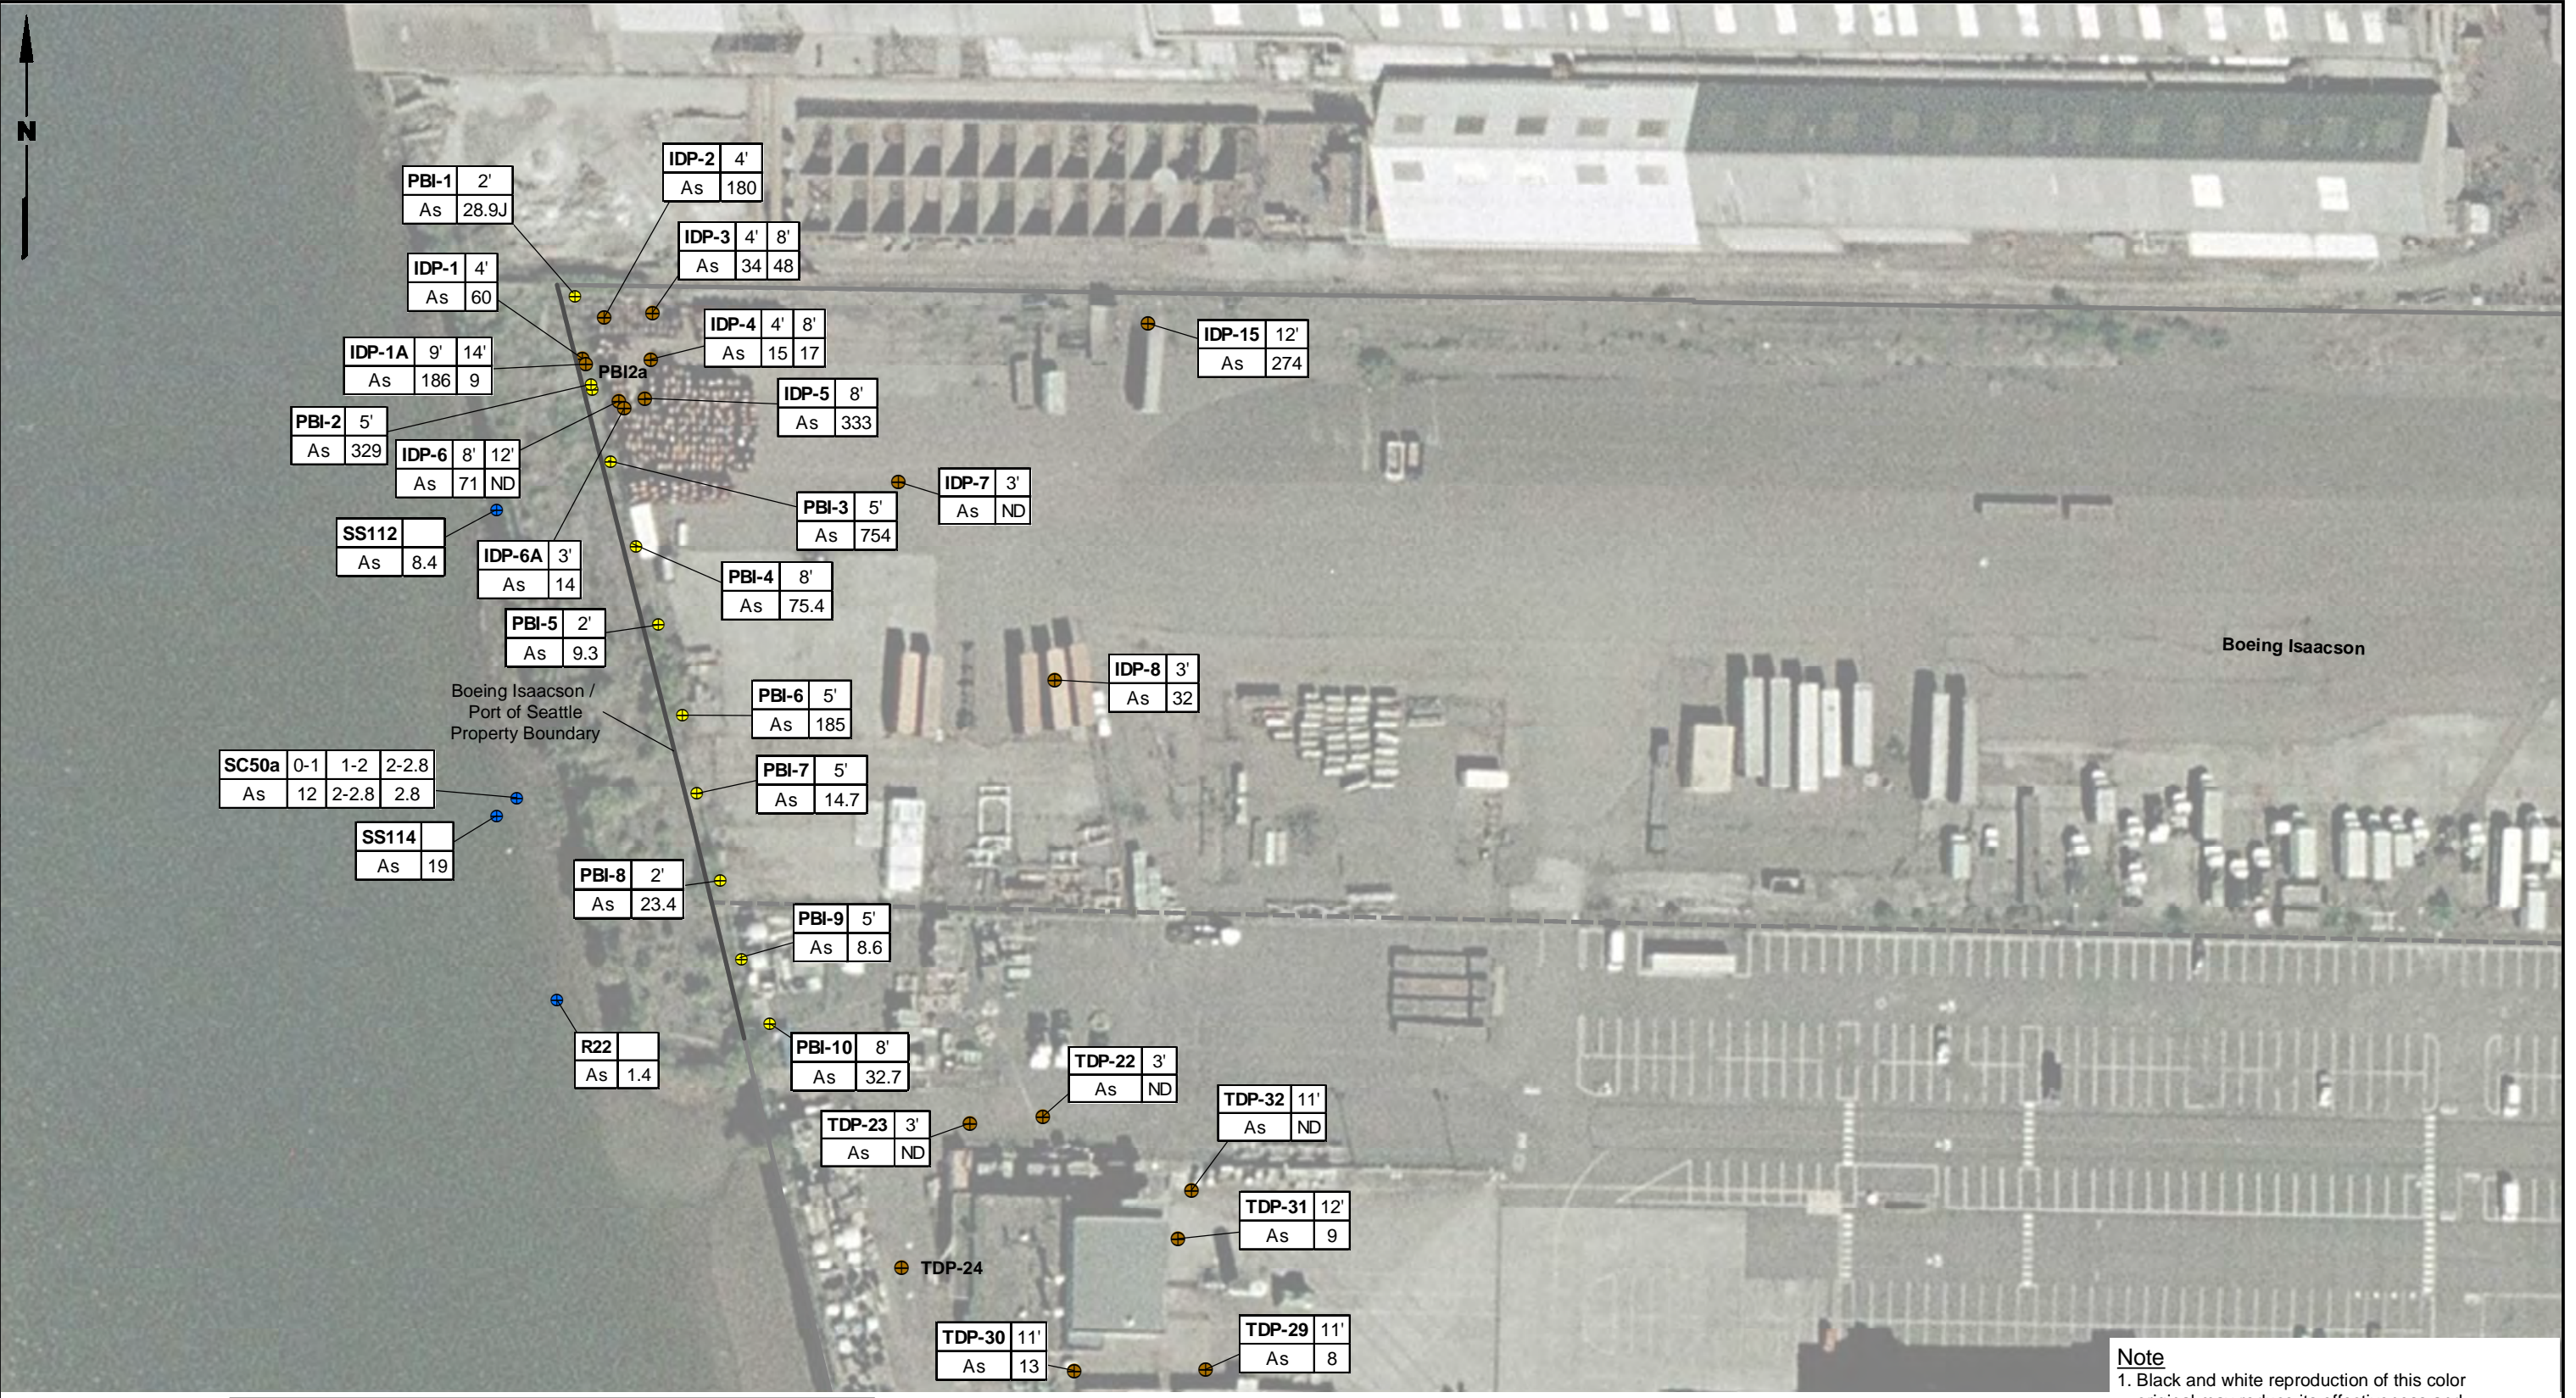
Figure
3

The results of the investigation along the Boeing Isaacson/Port property boundary were validated and tabulated and are presented in Table 1 and are shown on Figure 3. All seven metals analyzed for (arsenic, cadmium, chromium, copper, lead, mercury, and zinc) were detected at each location (PBI-1 through PBI-10). Only mercury and cadmium were not detected at some depth intervals. Because previous investigations at the Isaacson parcel have identified elevated concentrations of arsenic in groundwater and in the LDW sediment adjacent to the Port property, the focus of this discussion is arsenic. Results for the remaining metals will be evaluated and incorporated into the remedial investigation (RI).

Arsenic concentrations for the soil samples collected during the property boundary investigation ranged from 0.5 milligrams per kilogram (mg/kg) to 774 mg/kg. The highest concentrations, 329 mg/kg and 754 mg/kg, were detected in the 5 ft to 6 ft BGS interval at locations PBI-2 and PBI-3 (Figure 3). Concentrations greater than 20 mg/kg were present in soil at seven of the 10 sampling locations. As previously mentioned, soil samples were collected from 2 to 3 ft BGS, 5 to 6 ft BGS, and 8 to 9 ft BGS and each soil boring was advanced to 10 ft BGS. The ranges of arsenic concentrations by depth interval were as follows:

- 2 ft to 3 ft BGS: 1.4 mg/kg to 28.9 mg/kg
- 5 ft to 6 ft BGS: 4.8 mg/kg to 754 mg/kg
- 8 ft to 9 ft BGS: 0.5 mg/kg to 75.4 mg/kg.

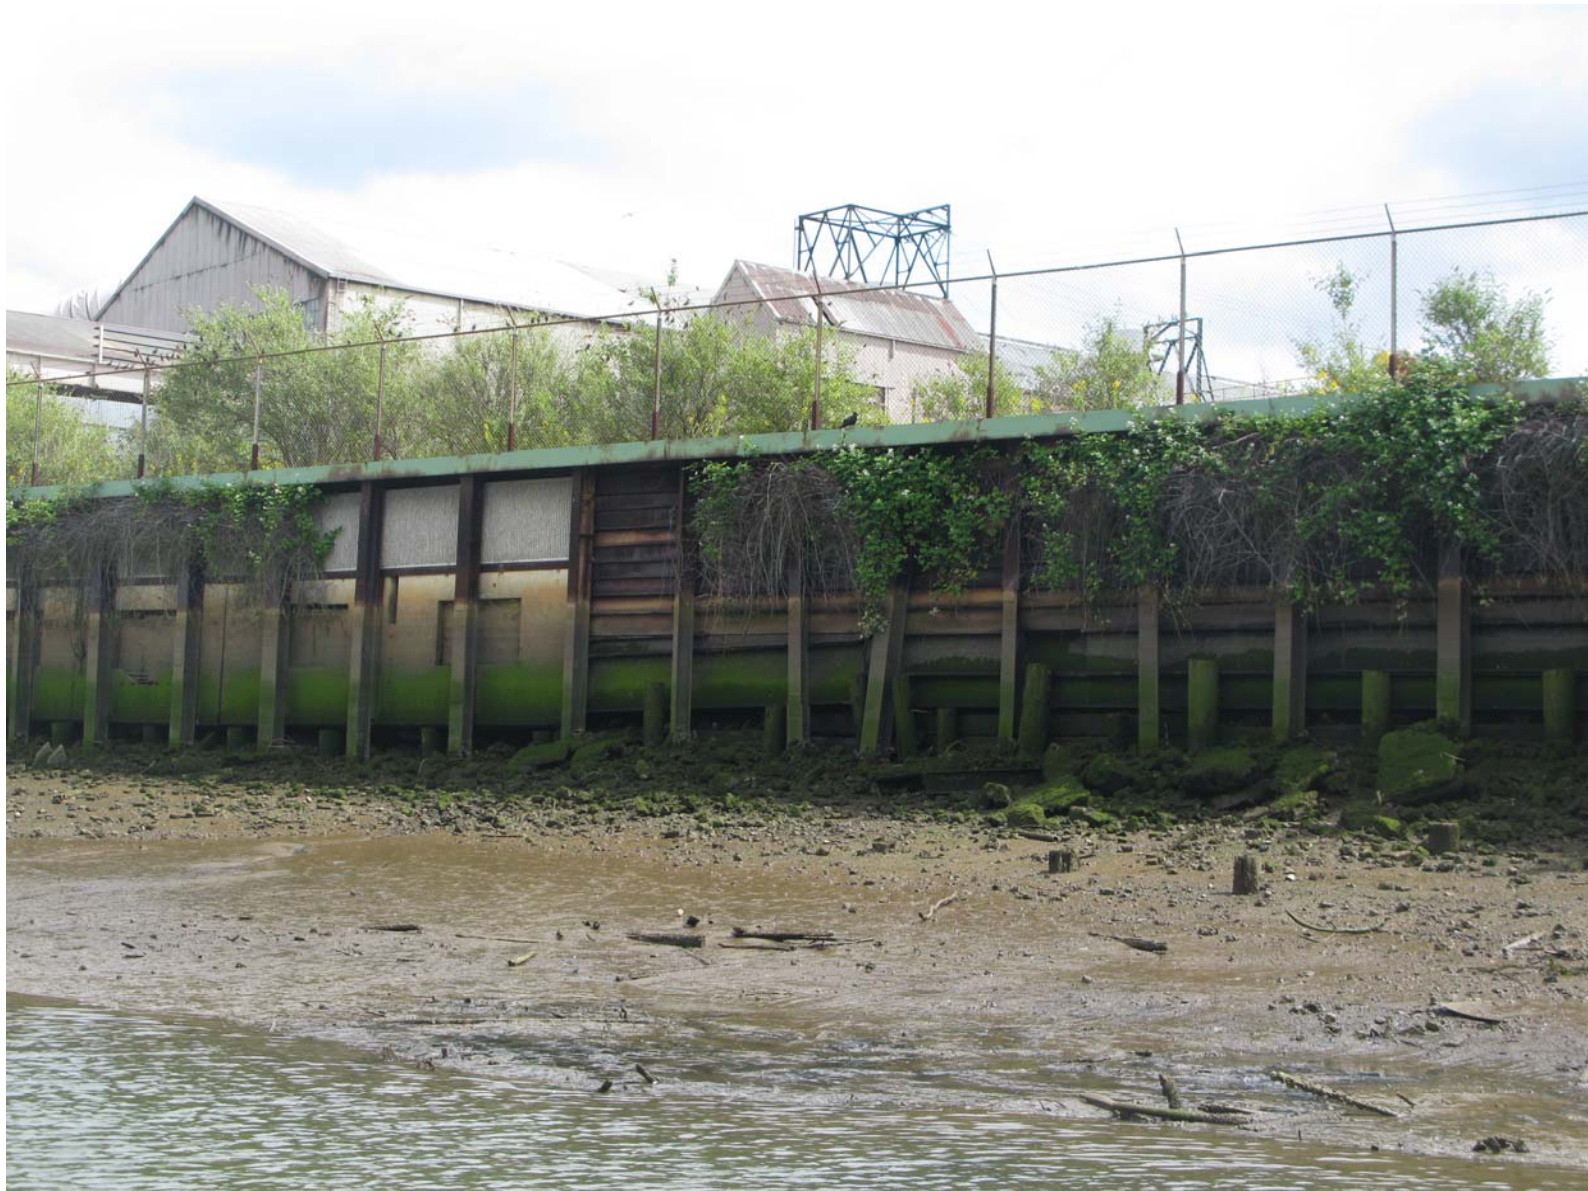
- Elevated arsenic concentrations are present in LDW sediments west of the Port property. Arsenic concentrations in the sediments adjacent to the Port property are the highest found in the LDW, with the highest concentration of 19 times the Sediment Quality Standard of 57 mg/kg. Arsenic concentrations in LDW sediments near the Boeing Thompson and Isaacson properties (Ecology 2009a) are shown on Figure 3. The shoreline of the Port property is apparently eroding into the LDW, as shown in the June 29, 2009 photograph included as Figure 4.

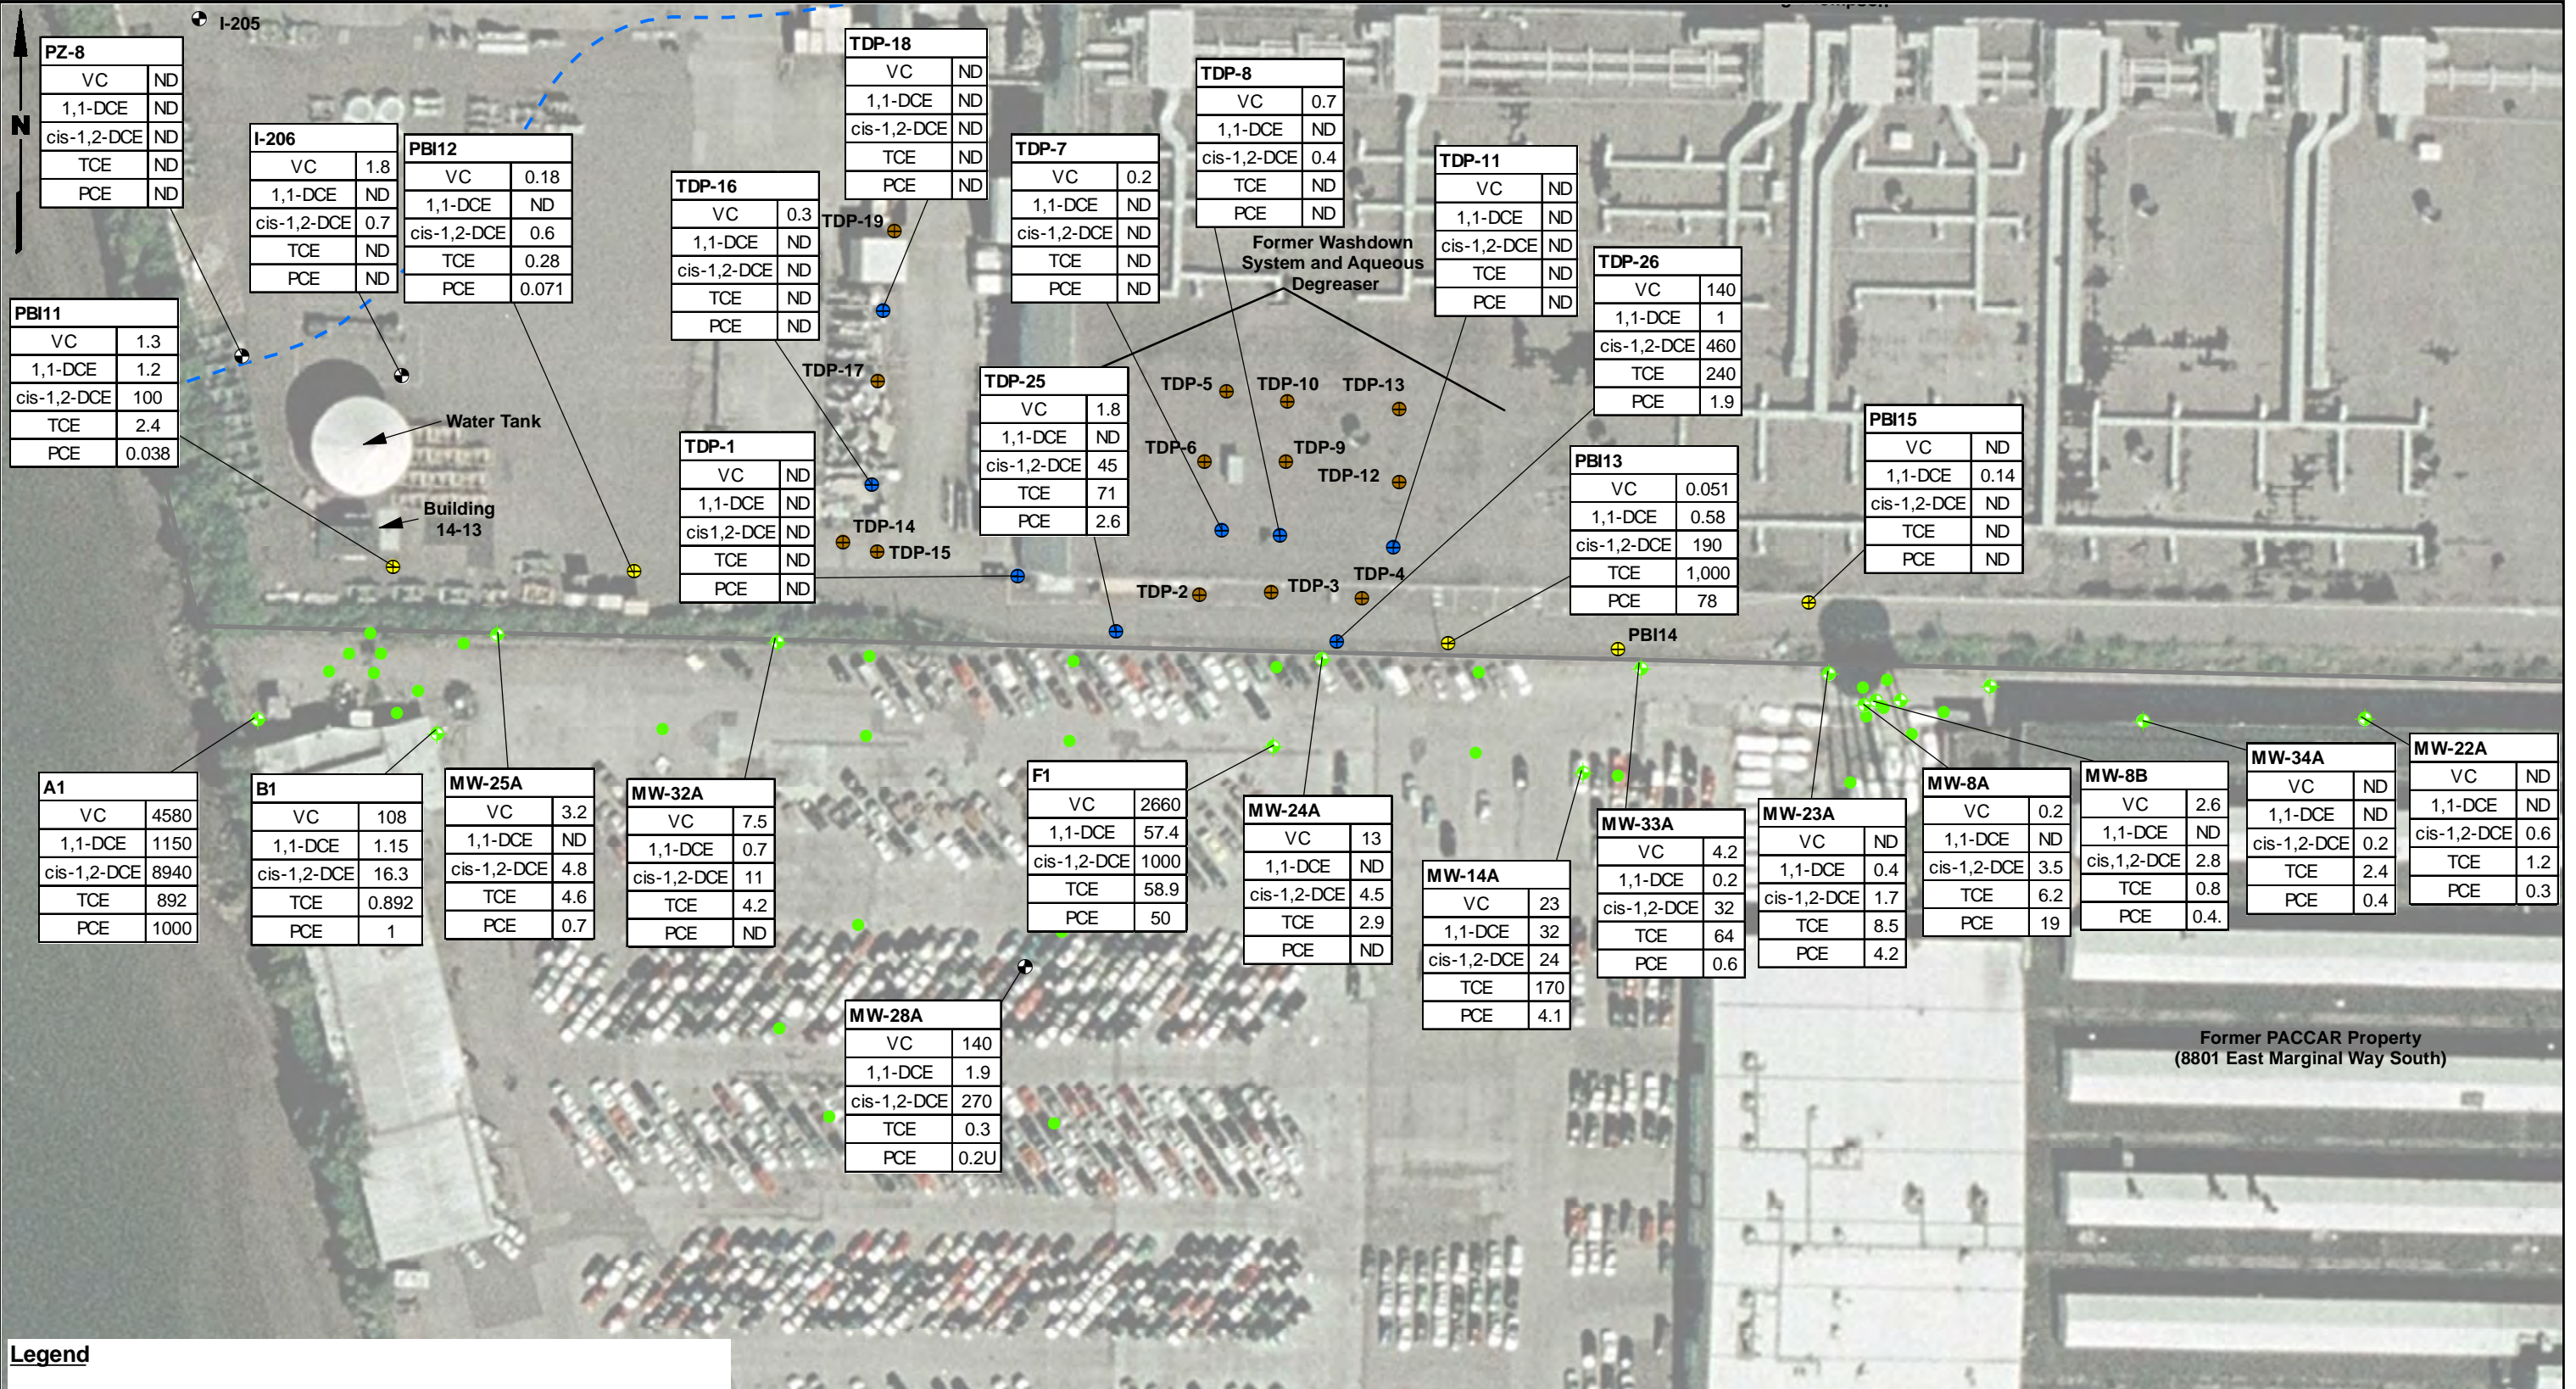
Boeing Thompson-Isaacson Property Tukwila, Washington	Boeing Thompson / PACCAR Property Boundary Sampling Locations and Groundwater Analytical Results	Figure 6
--	---	--------------------

More HVOCs were detected in the groundwater samples than were detected in the soil samples. Vinyl chloride was detected at three locations PBI-11, PBI-12, and PBI-13 at concentrations of 1.3 micrograms per liter ($\mu\text{g}/\text{L}$), 0.18 $\mu\text{g}/\text{L}$, and 0.051 $\mu\text{g}/\text{L}$, respectively. DCE was detected at PBI-13 and PBI-15 at concentrations of 0.58 $\mu\text{g}/\text{L}$ and 0.4 $\mu\text{g}/\text{L}$, respectively, and cis-1,2-dichloroethene was detected at PBI-11 and PBI-13 at concentrations of 100 $\mu\text{g}/\text{L}$ and 190 $\mu\text{g}/\text{L}$, respectively. TCE and PCE were detected only in the groundwater sample collected at PBI-13 at concentrations of 1,000 $\mu\text{g}/\text{L}$ and 78 $\mu\text{g}/\text{L}$, respectively. Groundwater concentrations are shown on Figure 6.

- Located near the western portion of the property boundary, the highest groundwater concentrations of vinyl chloride and cis-1,2-DCE at the Boeing Thompson property were 1.3 µg/L and 100 µg/L, respectively, at PBI-11; the concentrations at A1 on the PACCAR property were 4,580 µg/L and 8,940 µg/L, respectively.

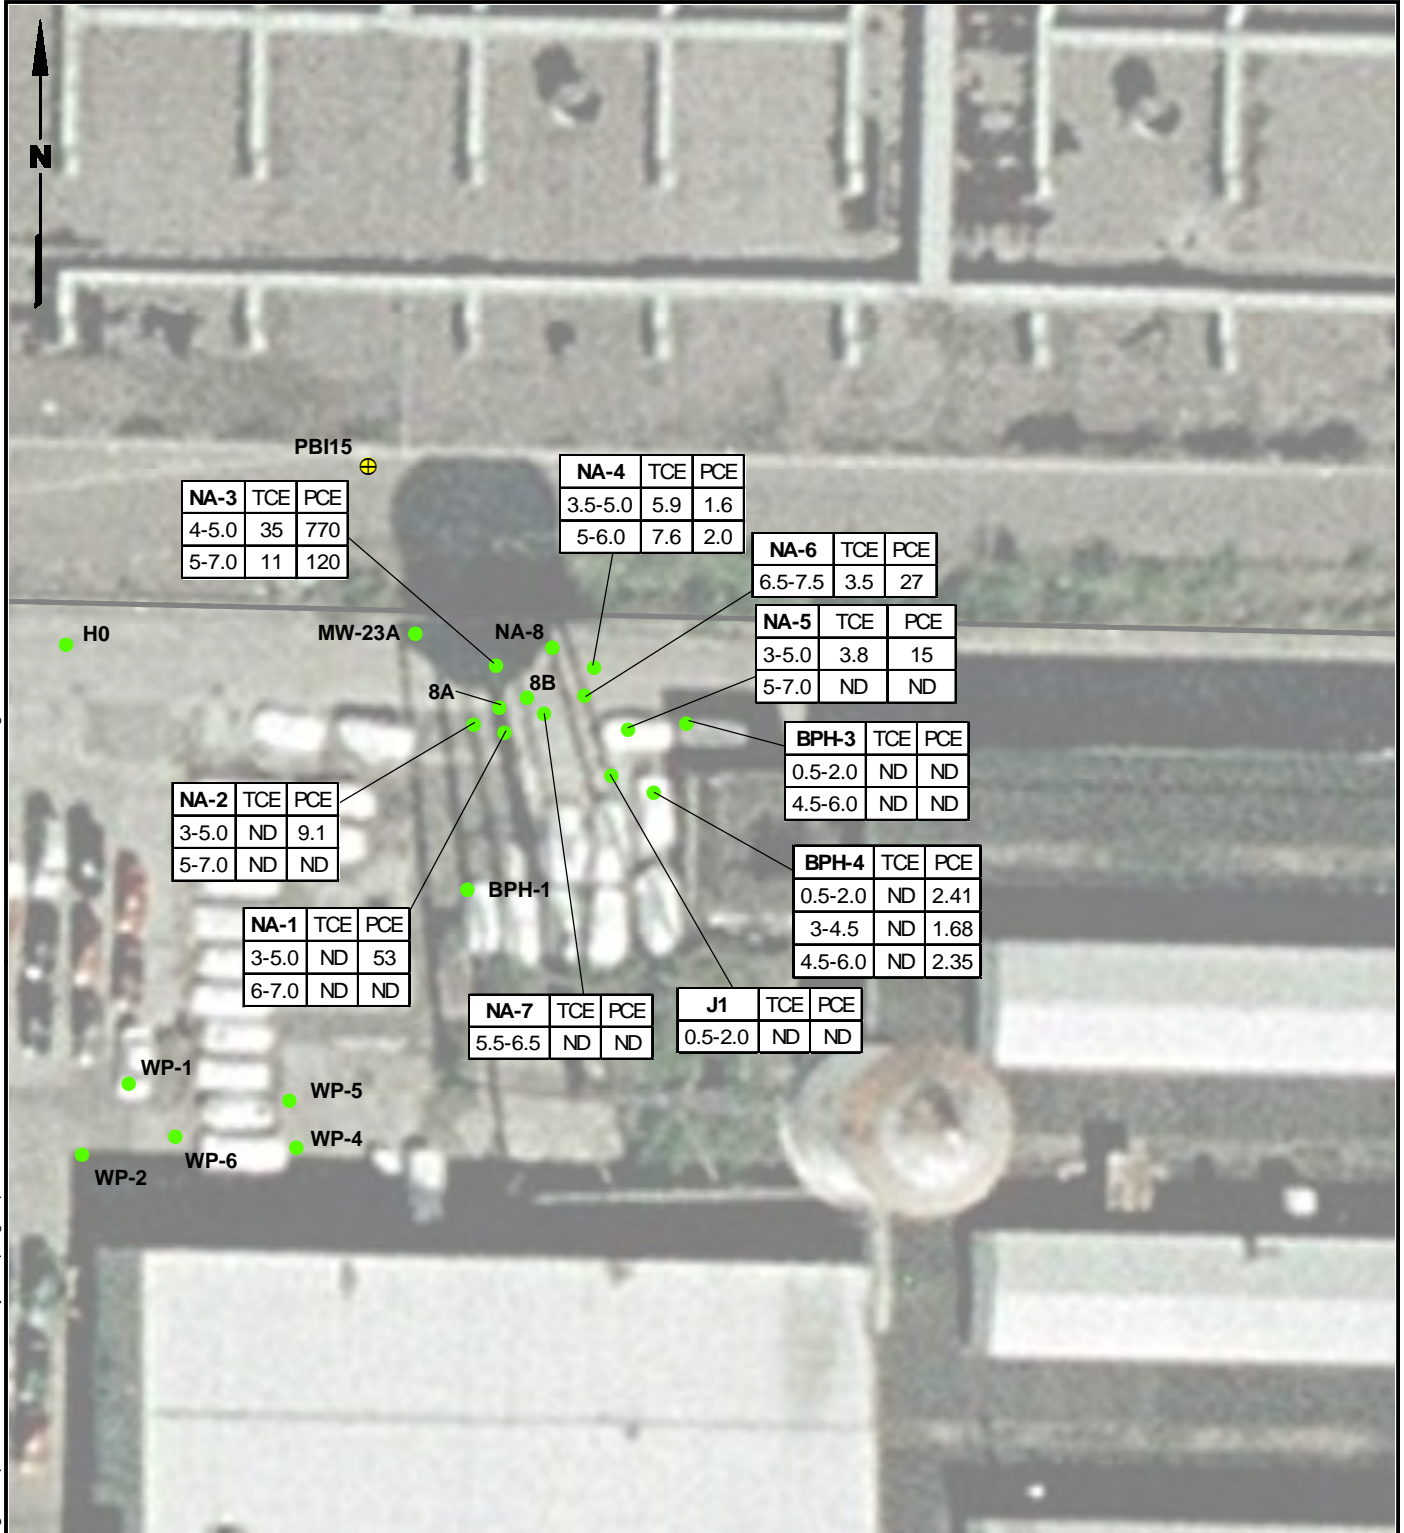
Figure
7

- The PCE and TCE concentrations in soil at PACCAR are three orders of magnitude greater than the highest concentrations detected at the Boeing Thompson property, as shown on Figures 5 and 7. The highest concentrations at Boeing Thompson were found adjacent to the property boundary. The highest soil concentrations of TCE at locations near the Boeing Thompson/PACCAR property boundary are shown on Figure 9.
