SECOND PERIODIC REVIEW REPORT FINAL

Tacoma Boatbuilding Company/Ace Tank. Facility Site ID#: 1224 Cleanup Site ID#: 3672

1840 Marine View Drive Tacoma, Washington 98421

August 2016

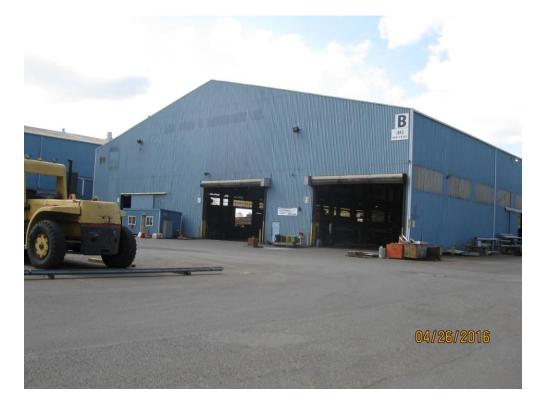
Photo 7: Fabrication Building and Asphalt Cap – from the southwest

Based upon the site visit conducted on April 26, 2016, the asphalt/concrete surface covers at the Site are intact and in good condition. The exterior portions of the Site are no longer used for shipbuilding, sandblasting, or other waste generating activities. Metal fabrication takes place inside several of the structures, but there is no evidence of waste materials being tracked out into the open where stormwater may carry them to the Hylebos. The surface materials at the Site continue to eliminate direct exposure pathways (ingestion, contact) to contaminated soils. They also appear to be effective in eliminating storm water percolation into contaminated soils below the cap. A photo log is available as Appendix 6.8.
